BRIDGE INSPECTION REPORTS

VROOMAN ROAD BRIDGE OVER THE GRAND RIVER

**SFN 4337107
LEROY TOWNSHIP
LAKE COUNTY, OHIO**

December, 2002

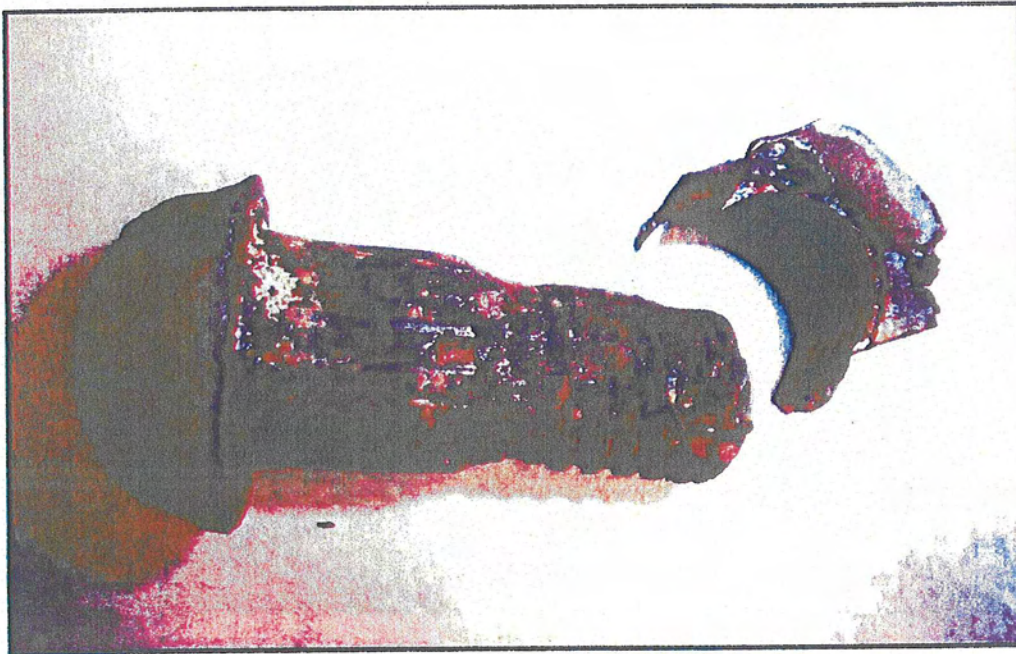
The bridge deck is supported by floor beams as well as transverse timber bearings at the pier and abutments. Each span has six-W27x94 intermediate floor beams connected to extensions of the truss verticals. Between floor beams are timber spreader beams that maintain load distribution among the deck planks (See Photo 3). A framing plan with member identification is shown in Figure 1. The floor beams are spaced at 12'-7 1/4" center to center, and are attached to truss vertical extensions with 14-dardelet bolts at each end. A dardelet bolt is a rivet-bolt fastener more appropriately classified as an "interference body" bolt. They are bearing connectors with upset ridges on the shanks that deform during installation to insure full bearing. Their button heads allow for cold driving during erection (See Photo 5).

**Photo 5 – Corrosion to Shank of Removed Dardelet Bolt
(Note Upset Ridges at Left and Remnants of Nut)**

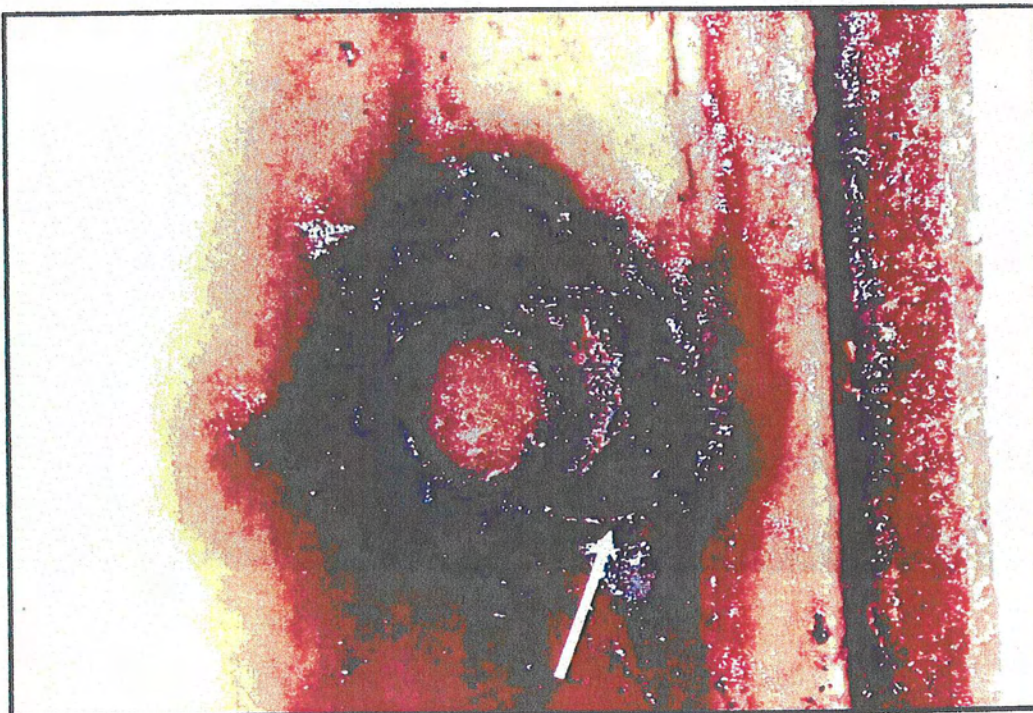
At several locations, the base metal adjacent to the bolt holes of the truss vertical, now exposed due to missing nut corrosion, has signs of misfabricated and unrepaired holes (Photo 6). These mispunched holes result in a slotted opening and reduce the friction area that holds the bearing dardet bolt in place. Also, these slotted holes provide access for accelerated corrosion to the base metal and the bolt shank.

**Photo 6 – Deficient Dardelet Nut with Misfabricated Bolt Hole Exposed
(Highlighted by Arrow)**

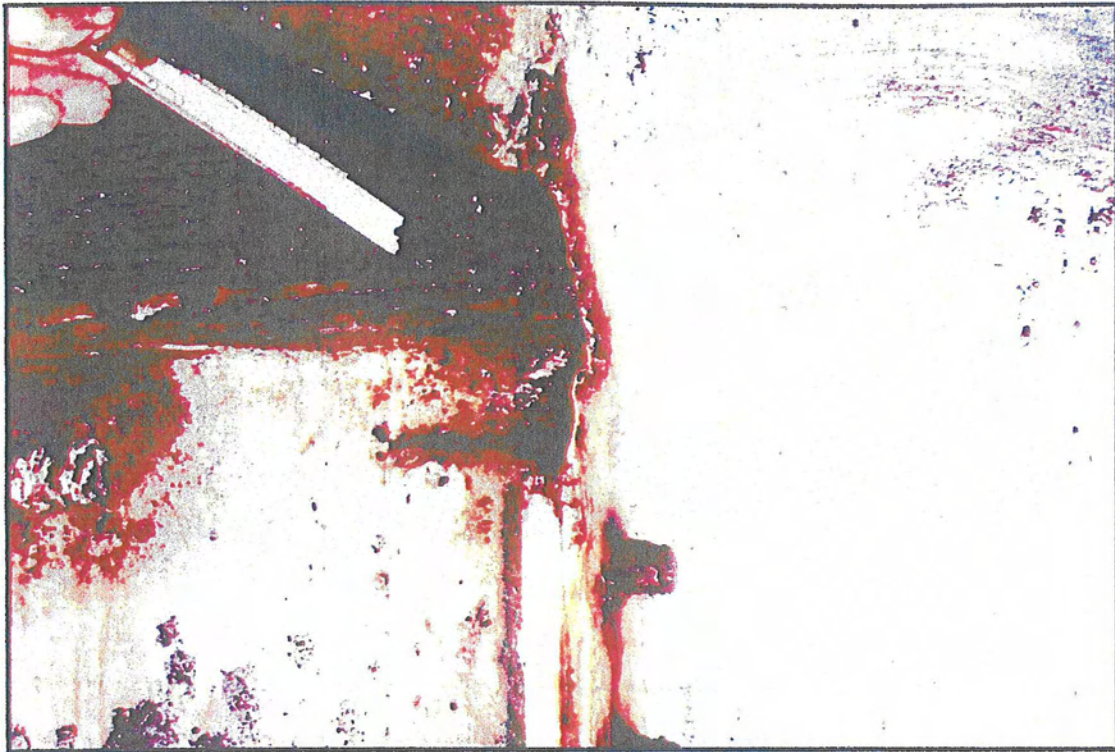
On the vertical extensions, the interior flange between the truss gusset plate and floor beam lug angles often have section loss both arrested and active (Photo 7). This deterioration is caused by debris accumulations on top of the floor beam top flange. Maximum section loss is approximately 50% and 15% of the flange and total sections respectively.

**Photo 7 - 1 1/2" Deep Loss to Vertical Flange from Debris on Top of Floor Beam,
Span 2, East L₄' (Note Missing Nut to Dardet Bolt)**

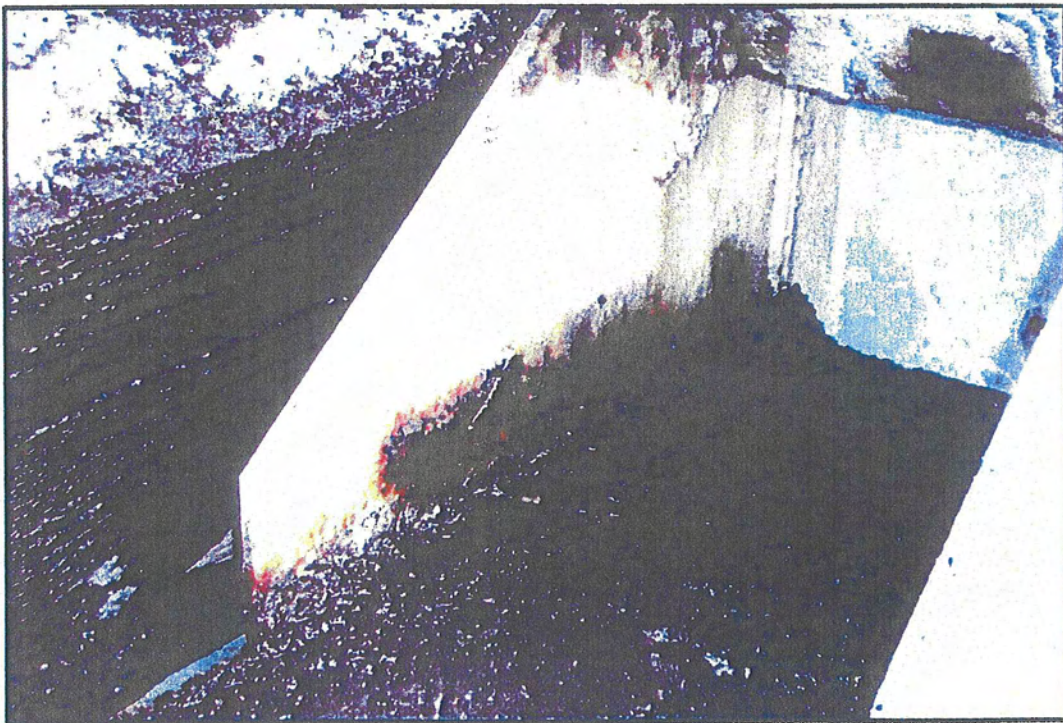
Photo 8 - 1/16" Loss to Gusset Plate Above Lower Chord, Panel Point West L₂, Span 1

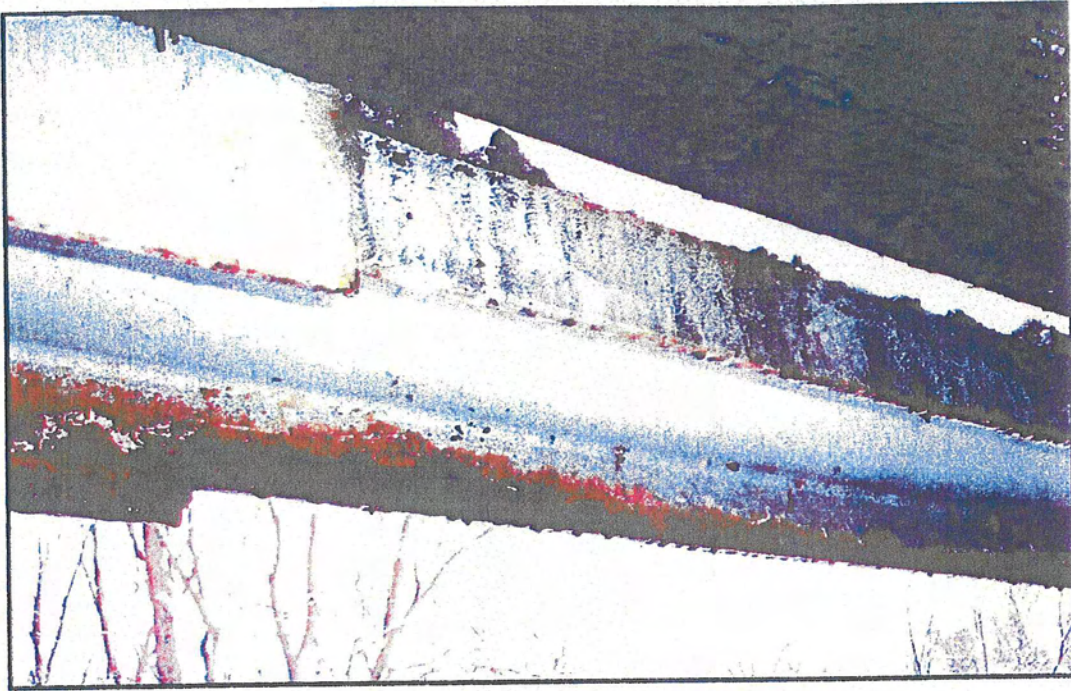
Photo 9 - Corrosion to Lower Chord

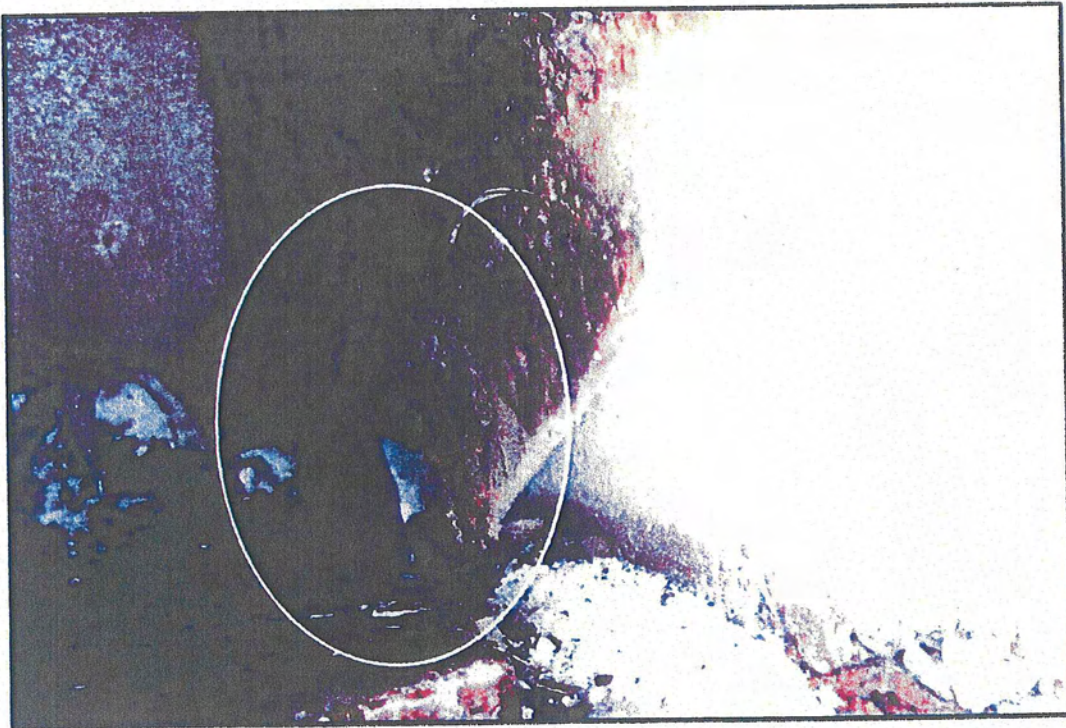
The truss bearings are in poor condition. In Span 1, both gusset plates at West L₀ (Photo 10) and the west gusset plate at East L₀ have extensive corrosion below the lower chord connection and above the bearing channel. The east gusset plate at East L₀' in Span 2 also has significant corrosion. Though no deformation was observed, buckling failure similar to that occurred at the Fay Road Bridge (North) structure may eventually happen.

**Photo 10 - Hole to West Gusset Plate (Circled) Between Lower Chord and Bearing,
Panel Point West L₀, Span 1**

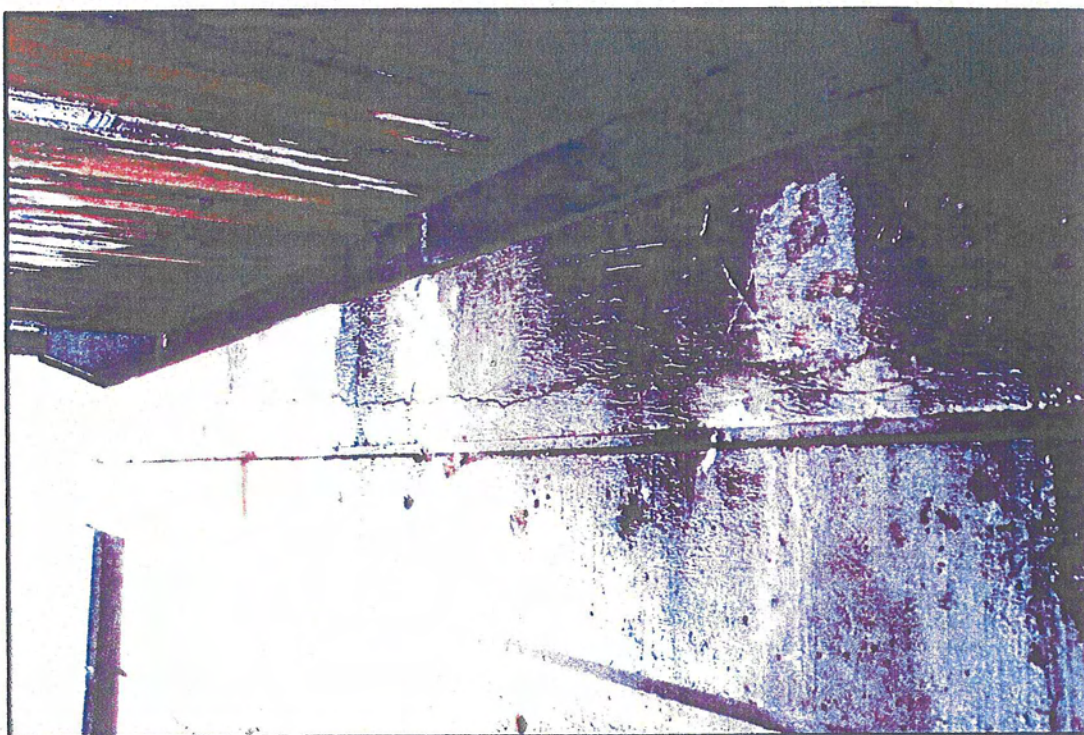
The pier seat is in fair condition. On both sides of the pier, horizontal cracks 10" from the top result in slight delamination (Photo 11).

Photo 11 – Crack & Delamination Above, North Face of Pier Seat

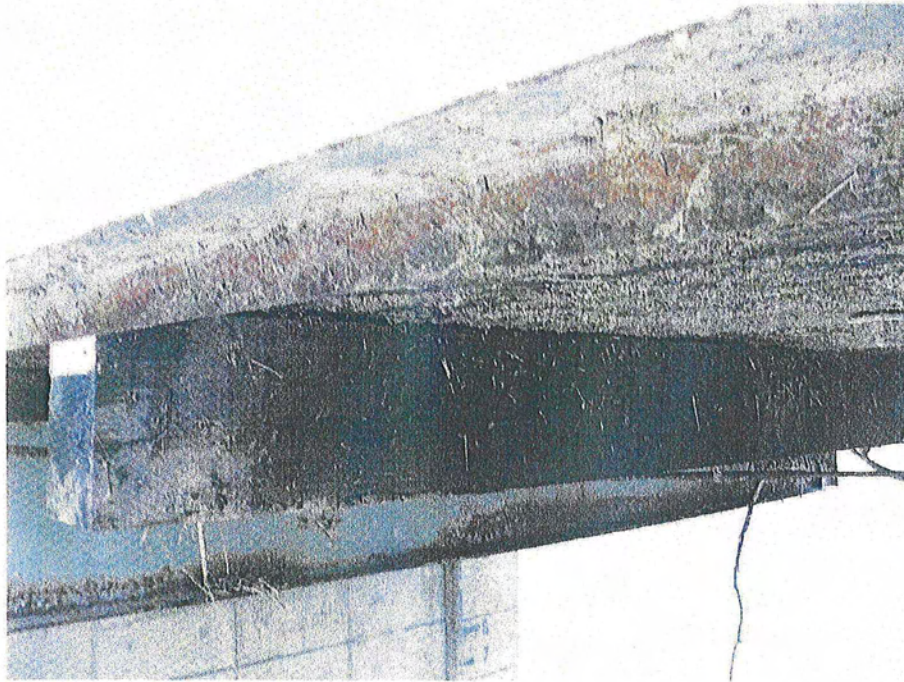
Floor – The longitudinal timber floor is in fair condition. Several of the timber floor distribution members located between floorbeams are rotated, likely from impacts during the flood, leaving a gap between the members and decking up to ¼" in some locations. (See Picture #2.) All fasteners connecting the distribution members to the timber deck were inspected and remain tight. The underside of the floor is covered in flood debris.

Picture #2 - Rotated floor distribution member at span 2, L₃.

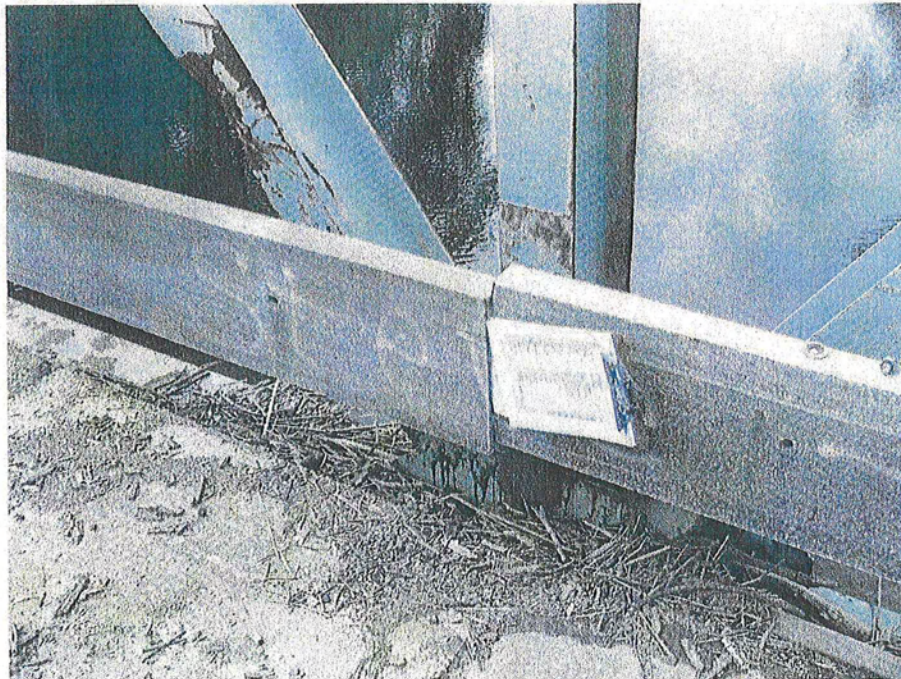
Railing – The bridge railing is in poor condition. Several of the bolts connecting the C15x33.9 rail to the W6x15 support rail have been broken by vehicle impacts. Between L₃ and L₆ in span 1 of the west truss, six consecutive bolts are broken off, allowing the channel to sag approximately 2 inches. (See Picture #3.)

Picture #3 - Loose west bridge railing due to missing bolts.

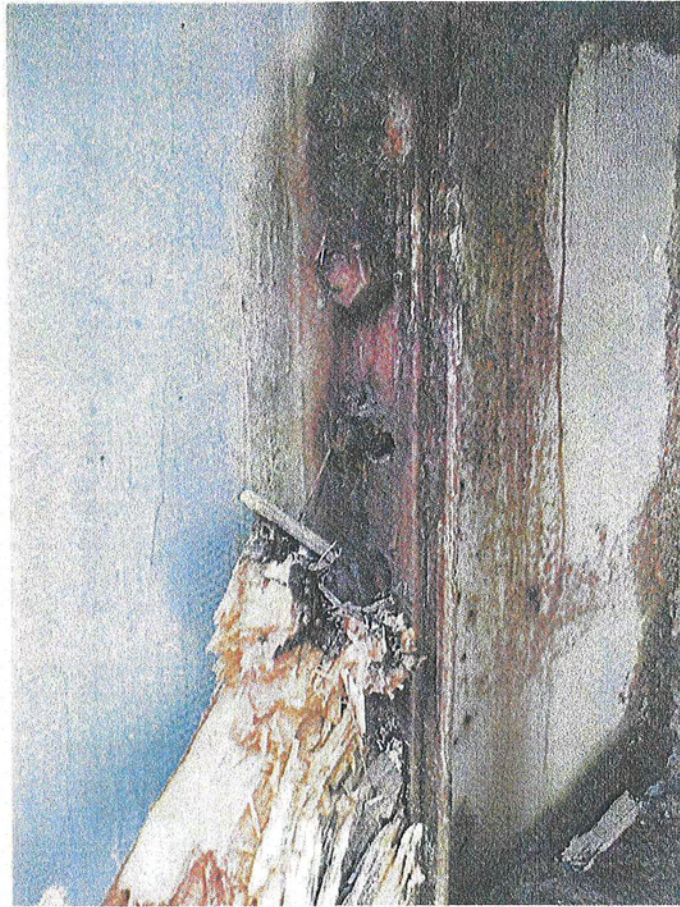
Floorbeam Connections – The floorbeam connections are in poor condition. Approximately 36% of the bridge's connectors have significant section loss to the dardet bolt or nut. At 11 of the structure's 24 floorbeam ends, 7 or more of the 14 connectors have significant section loss. (See Table 1 and Picture #4.) The east connection of floorbeam 4 in span 1 has a missing connector. At the west connection of floorbeam 4' in span 2 a connector was replaced with a stainless steel bolt. The floorbeam connections to the truss verticals have several holes that were redrilled in the verticals during original construction. The result is an oversized hole for a bearing type connection. (See Picture #4.)

Picture #4 - Deteriorated floorbeam connectors at L₆' span 2, east truss.

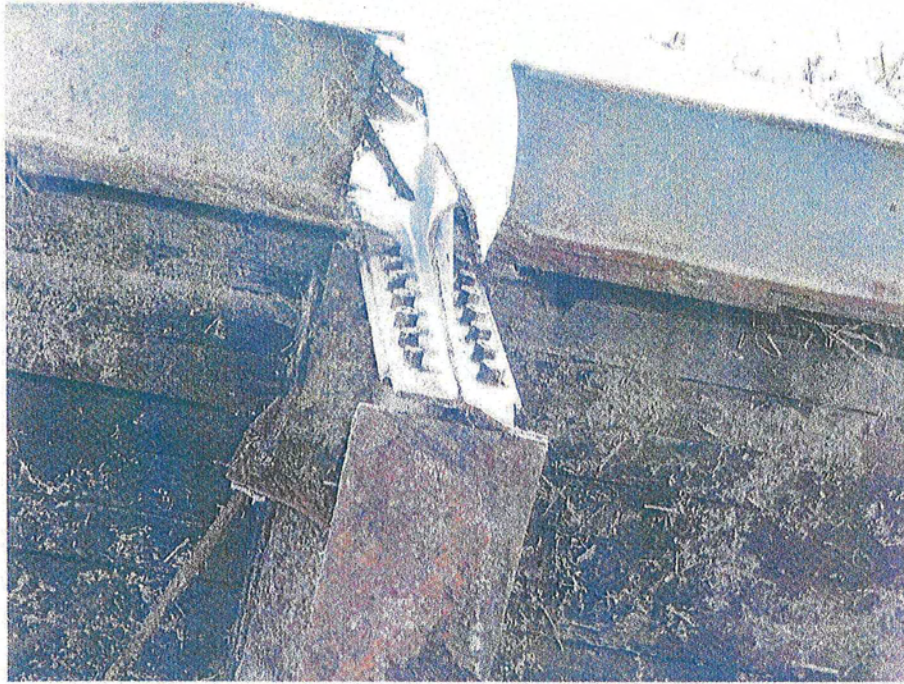
- L₄-U₄ span 1, west truss has several gouges and a bent east flange from vehicle impact.
- L₂-U₂ span 2, west truss was previously bent by vehicle impact. The member has been straightened and a steel plate was added to the web at the lower chord level.
- L₄-U₄ span 2, east truss was damaged at the floorbeam connection by flood debris. (See Picture #5.)

Picture #5 - Flood damaged vertical L₄-U₄, span 2, east truss.

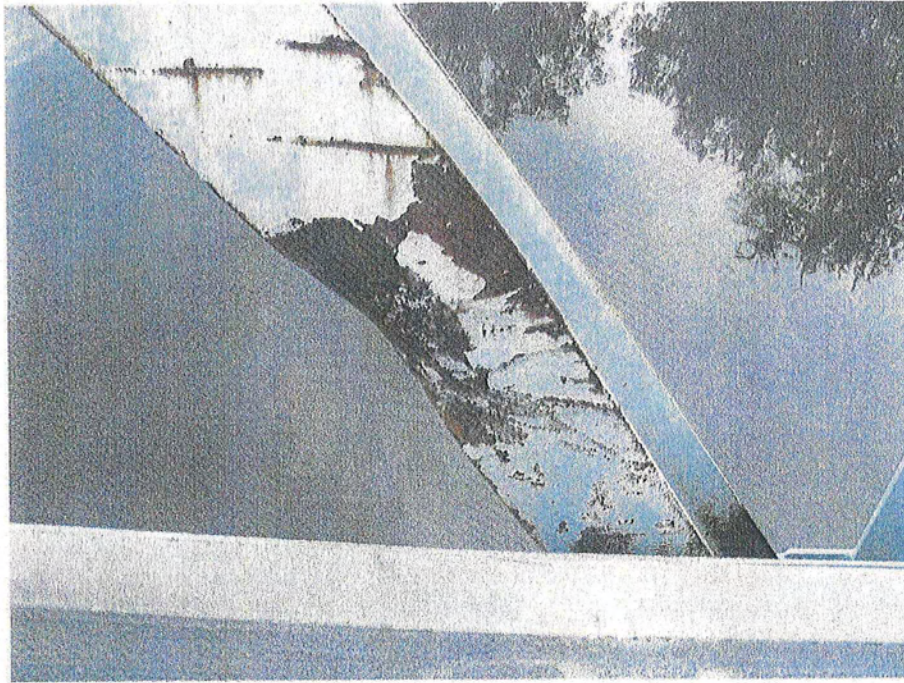
- U₁-L₂ span 1, east truss has a bent west flange.
- L₄-U₅ span 1, west truss has gouges from vehicle impact.
- U₅-L₆ span 1, west truss has vehicle impact damage. (See Picture #6.)
- L₂-U₃ and U₃-L₄ span 2, west truss appear to have been heat straightened to repair previous damage.
- L₆-U₇ span 2, east truss has a bent east flange.
- L₆'-U₅' span 2, west truss was bent by vehicle impact. (See Picture #7.) The impact put a kink in the entire member and caused noticeable rotation at the upper chord gusset plate connection. All welds appeared to be intact. This is a tension member so the kink does not reduce the members load carrying capacity.

Picture #6 - Damaged U₅-L₆ span 1, west truss.

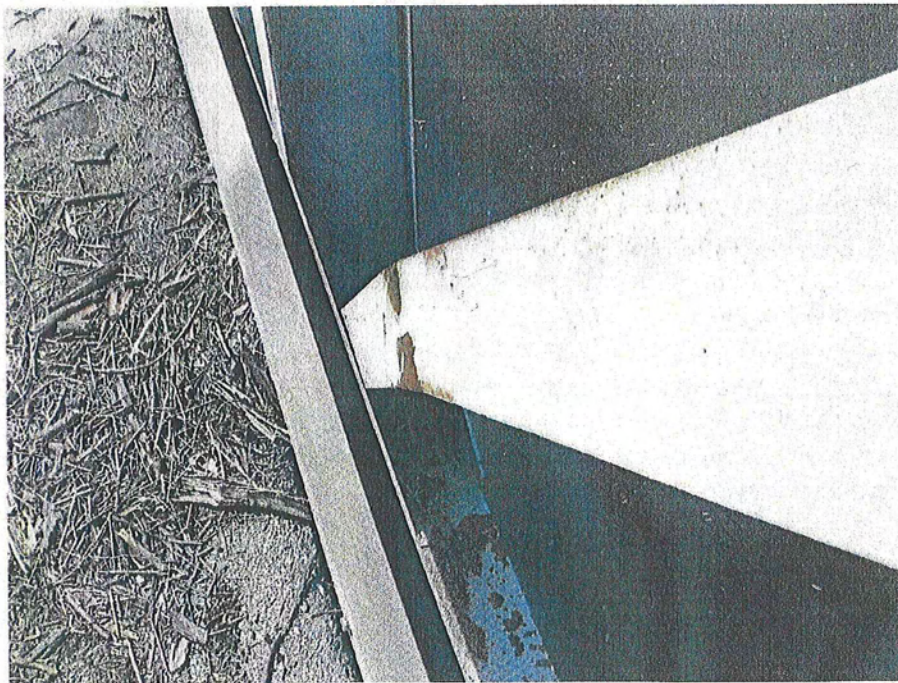
Picture #7 - Damaged L₆'-U₅' span 2, west truss.

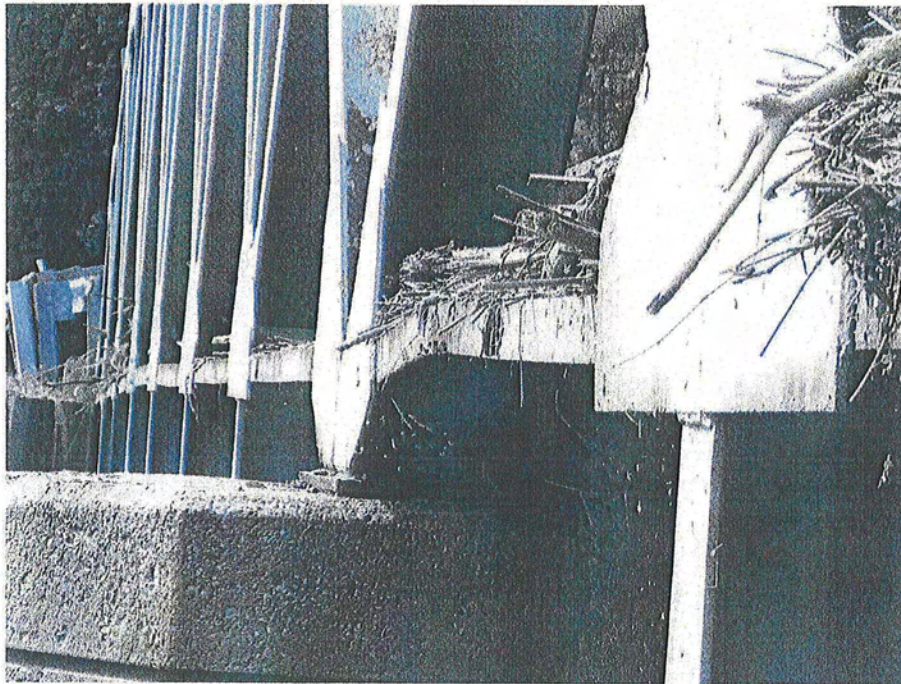
Lower Chord – The truss lower chords are in fair condition. Several members have significant section loss due to corrosion including L₀-L₂ span 1, east and west trusses and L₀'-L₂' span 2, east truss. L₀-L₂ span 2, east truss is bent upward, likely from a log jam in the river. (See Picture #8.) This is a tension member so the kink does not reduce the member's load carrying capacity.

Picture #8 – Damaged L₀-L₂ east, span 2. Note amount of debris on bottom chord.

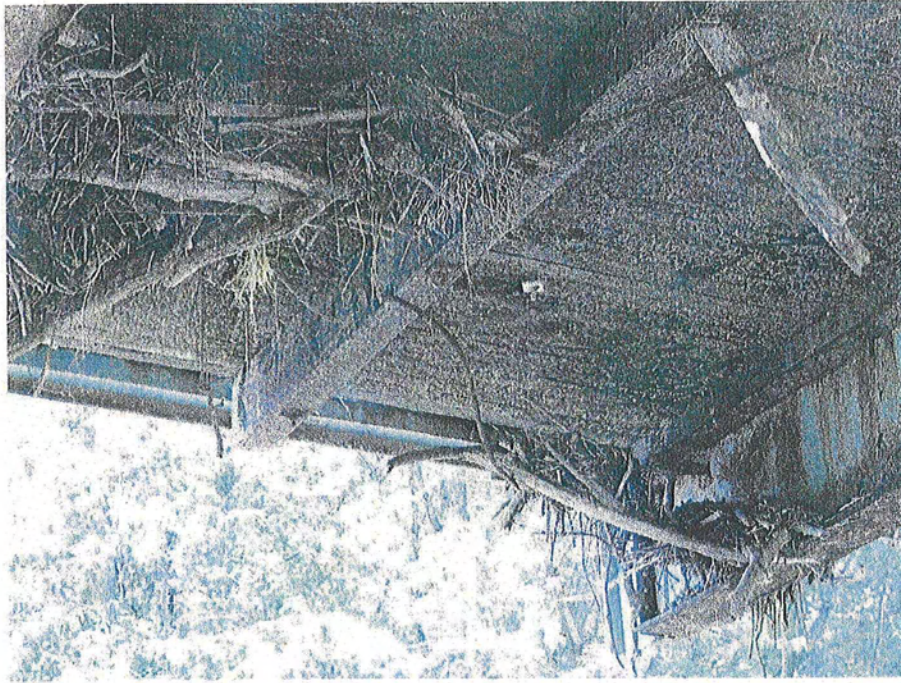
Lower Lateral Bracing – A combination of deterioration and flood damage has rendered the trusses' lower lateral bracing ineffective. Ten of the original 28 lower lateral braces are missing with the remaining braces bent, sagging and full of debris. (See Picture #9.) The structure remains in horizontal alignment due to the diaphragm bracing provided by the timber floor system.

Picture #9 - Damaged lower lateral bracing and flood debris, span 2.

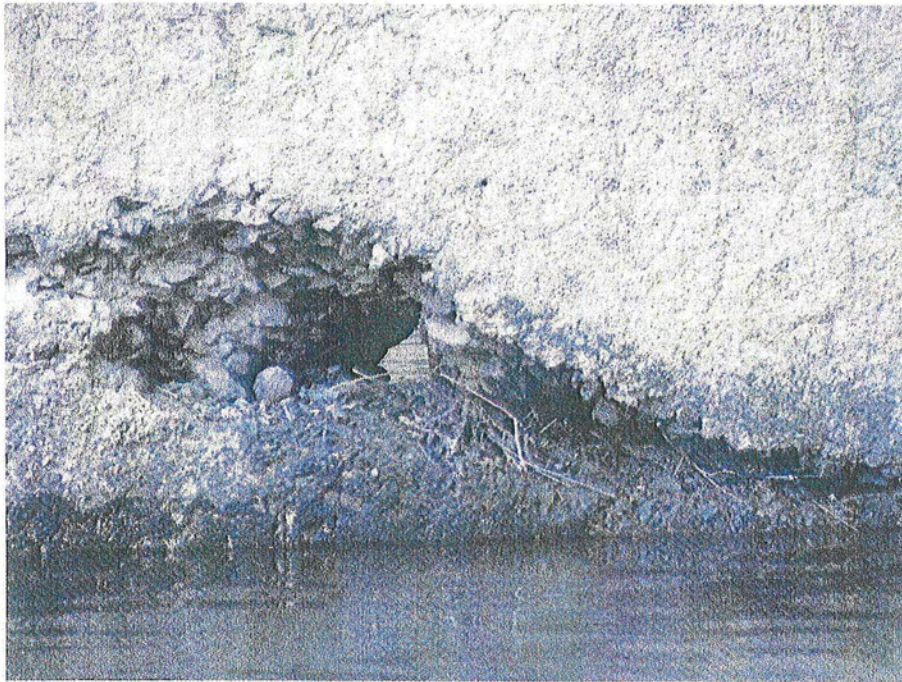
Pier – The reinforced concrete wall-type pier is in fair condition. There is a 6 inch hole completely through the pier approximately one foot above normal water. The hole appears to be from original construction. (See Picture #10.) The pier also has several spalls on the east end from flood debris impacts.

Picture #10 - Hole through base of pier.

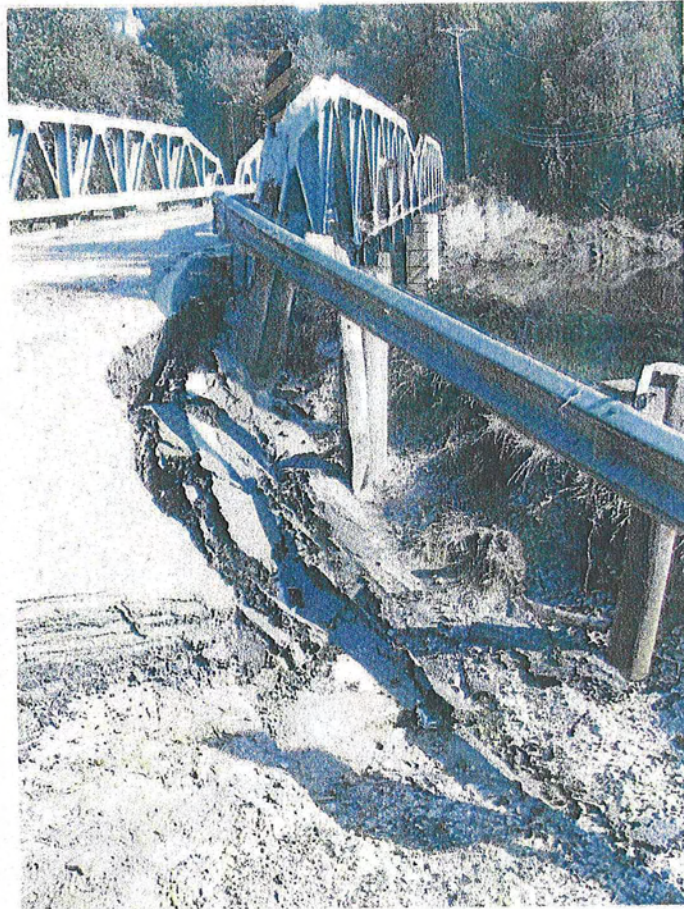
Pavement, Guardrail, and Embankment – The approaches are in critical condition following the recent flooding. Several areas of embankment were washed out, undermining the pavement and guardrail. (See Picture #11.)

Picture #11 - Flood damage to rear approach roadway.

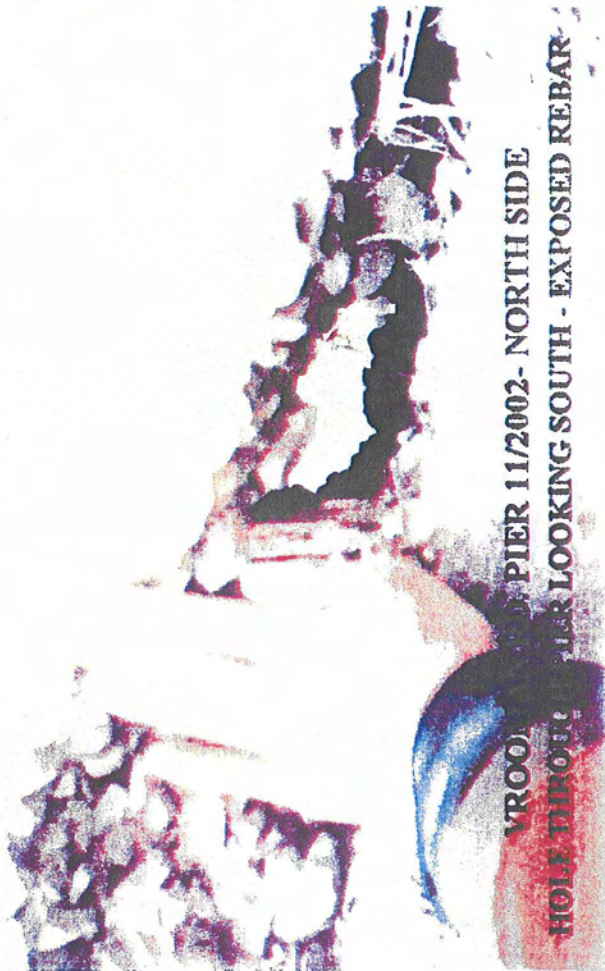
.6' ABOVE WATERLINE THERE IS A 3.0' LONG-
.5' DEEP-.5' HIGH SPALL. 1 PIECE EXPOSED
RUSTED REBAR. HOLE THROUGH PIER.

VROOMAN RD. PIER 11/2002 - NORTH SIDE
HOLE THROUGH PIER LOOKING SOUTH - EXPOSED REBAR
