**PURPOSE AND NEED  
FOR THE  
VROOMAN ROAD BRIDGE REPLACEMENT PROJECT**

**PERRY AND LEROY TOWNSHIPS, LAKE COUNTY, OHIO**

**(PID 5669)**

**REVISED** – September 9, 2010

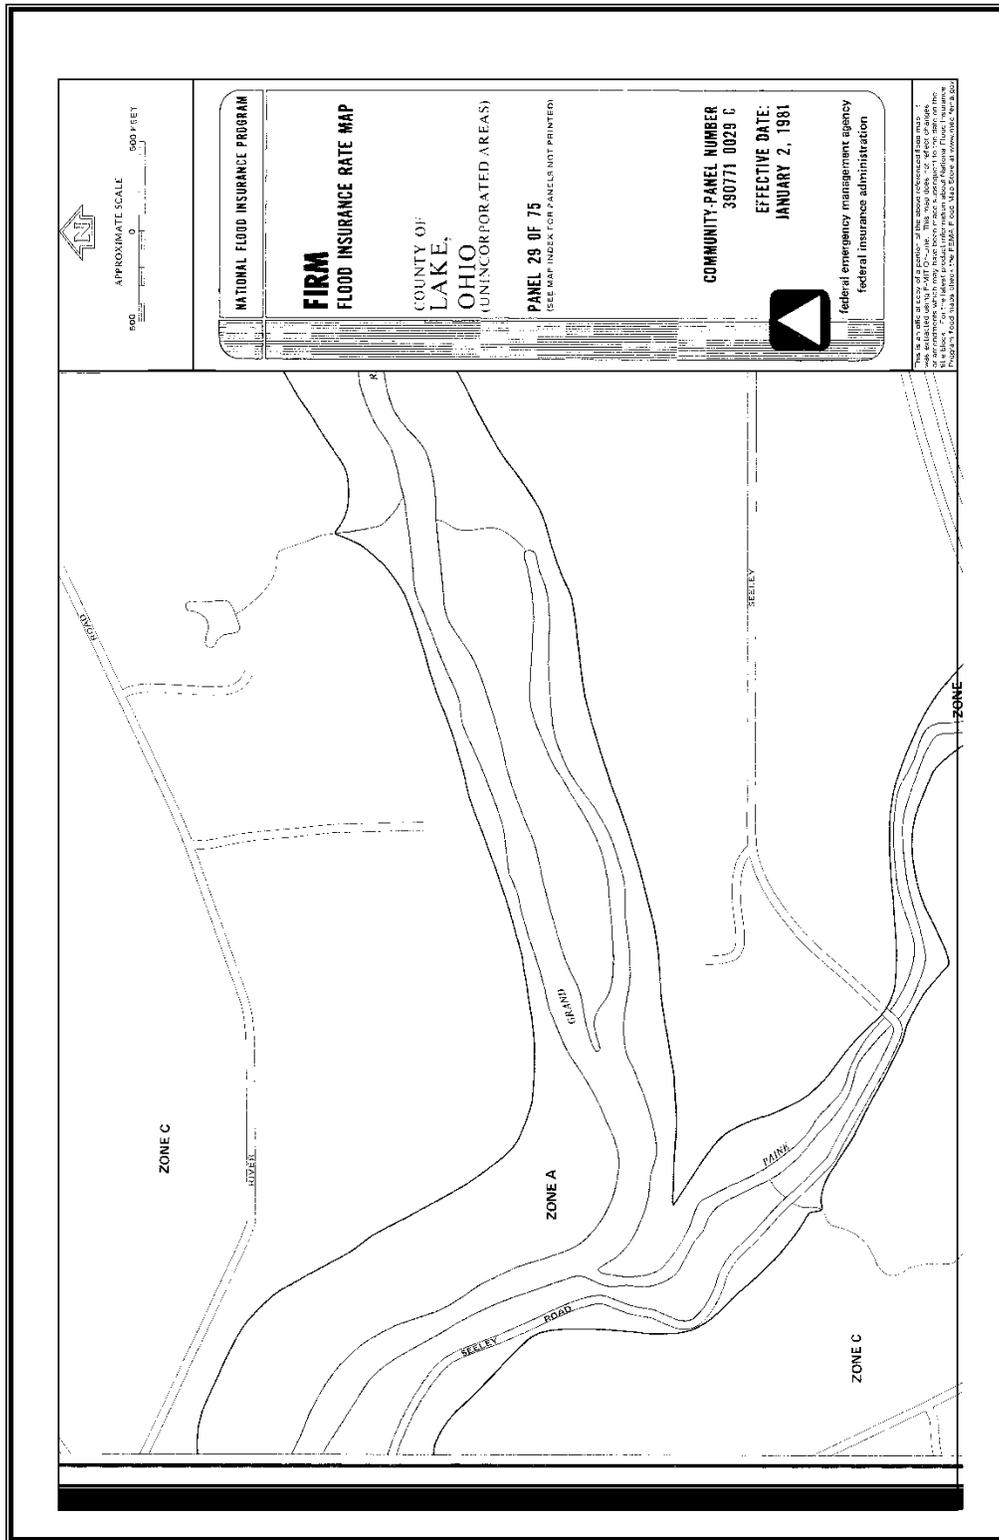
FIGURE 4B: FLOOD PLAIN MAP

The bridge is located within the Grand River flood plain and the bridge deck and approach roadways are below the 100-year flood elevation. See **Figures 4A and 4B**. Over the last 5 years, the bridge and Vrooman Road have been closed on average 2 to 3 times annually in the spring and/or fall, with the typical closure lasting 1 to 2 days. In 2005 the bridge was closed 4 times. In 2006 the bridge was closed from July to December due to extensive damage to the bridge and approach roadway caused by severe flooding of the Grand River. Following a flood event and bridge closure, debris and mud needs to be removed from Vrooman Road, the approaches, and often from the bridge, the abutments and the center pier. This long-term exposure to flooding has resulted degradation to the bridge members and an increase in maintenance and associated cost to the bridge.

The minimum profile for a replacement structure would need to be established so that the low structure elevation would provide one foot of freeboard above the 25 year flood level. So the low structure elevation would need to be above elevation 642.02. Structure depth would then determine the roadway profile elevation. Structure depth is a function of span length and span arrangement. The minimum structure depth for a 240' continuous span structure would be in the range of 7.75' to 9.00'. This would then establish the required low profile elevation somewhere between 649.75 and 651.00, representing a change in profile grade elevation of at least 10' on the approaches and at least 8.75' at the bridge. Current design criteria prohibit a profile that allows the approaches to flood.

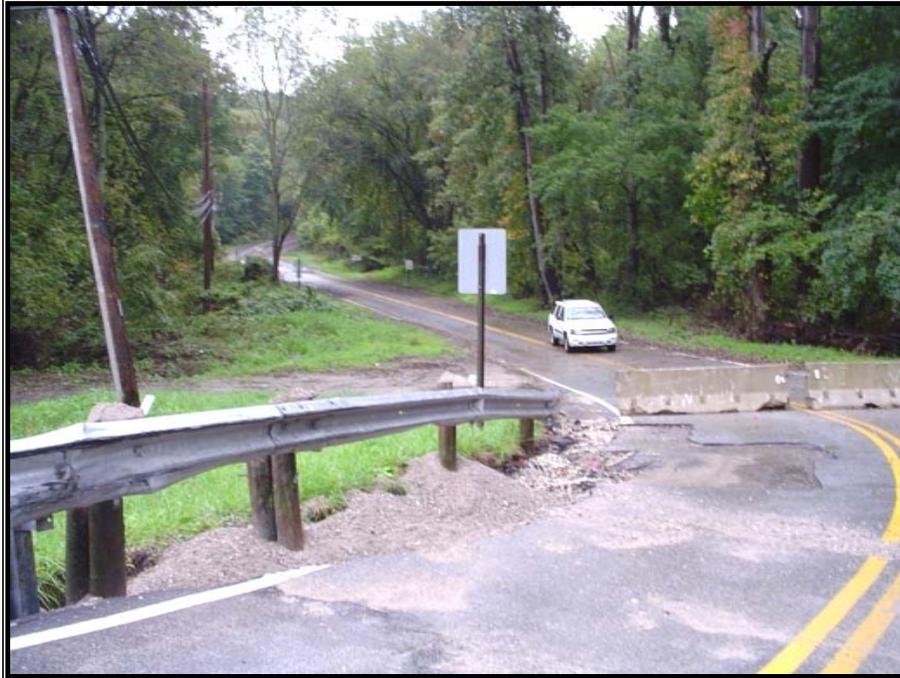
Photograph 1 - Vrooman Road south of the existing bridge, looking south west.

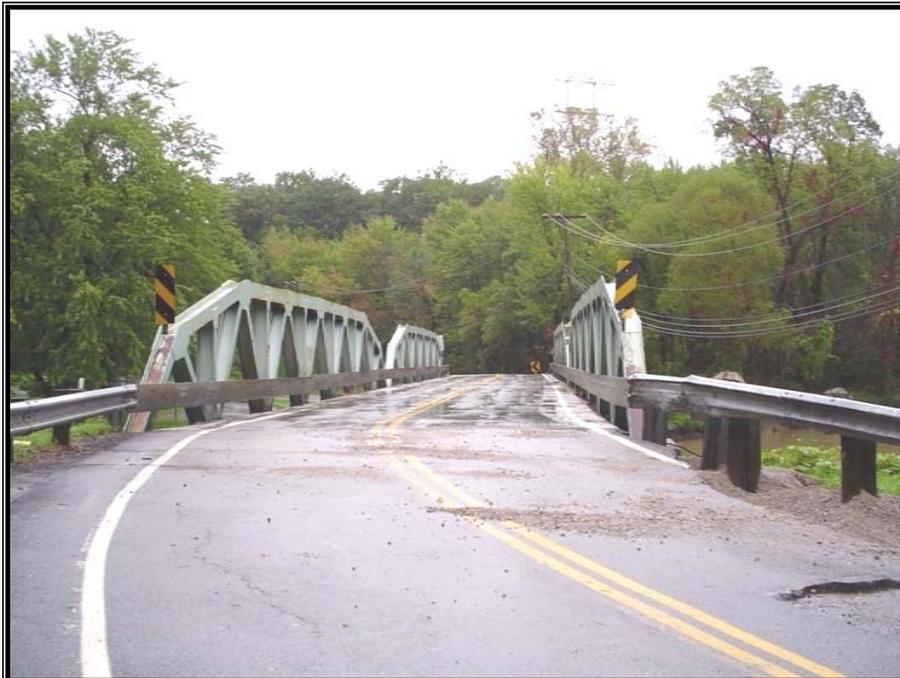
Photograph 2 - Vrooman Road Bridge and the southern approach, looking north.

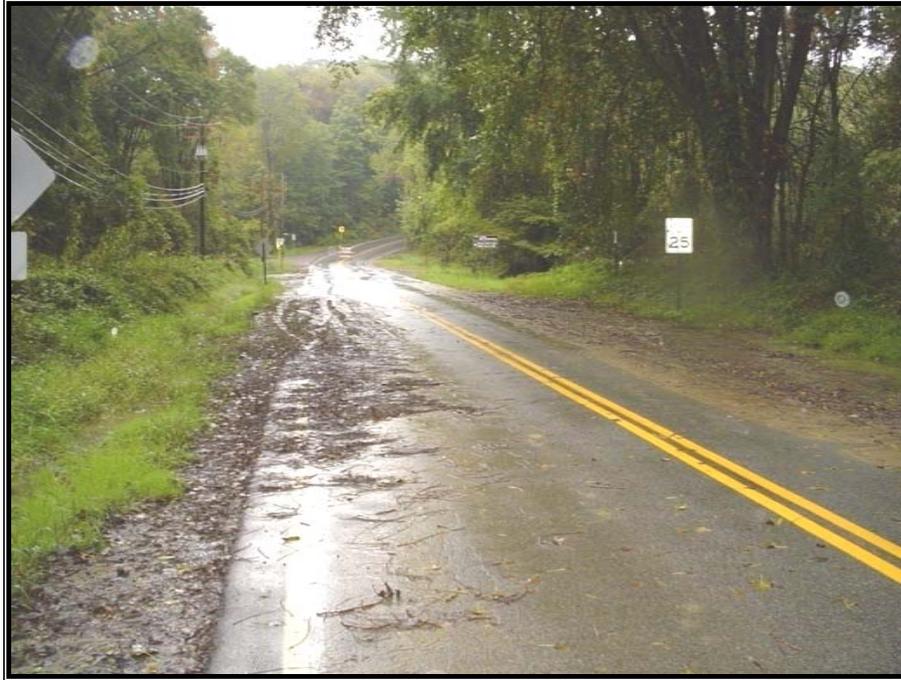
Photograph 3 - Vrooman Road south of the existing bridge, looking southeast. Seeley Road is on the left side of Vrooman Road.

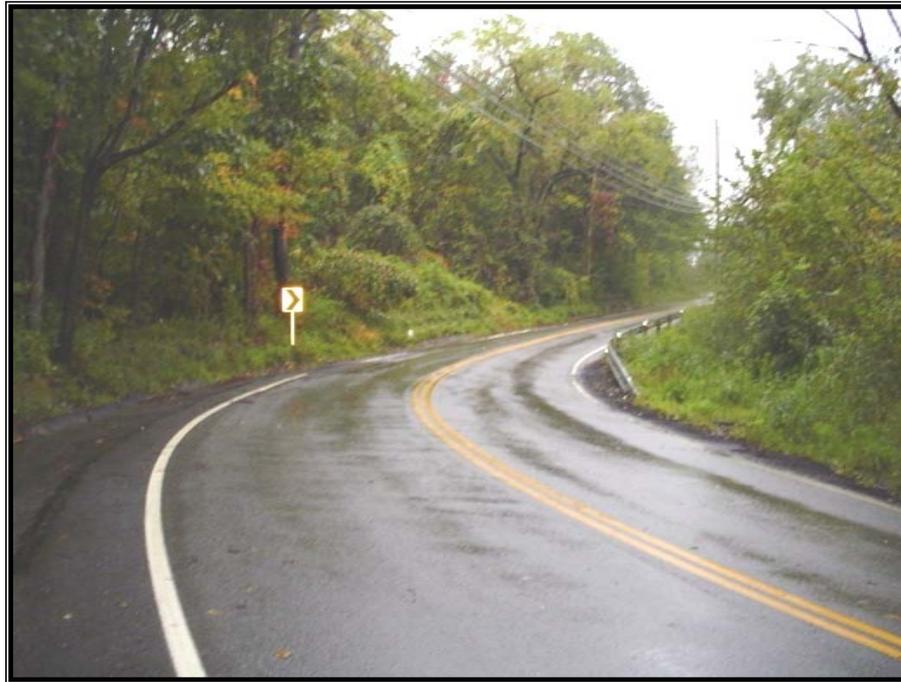
Photograph 4 - Vrooman Road at the intersection of Seeley Road, looking south. The intersection is at the curve at the bottom of the hillside.

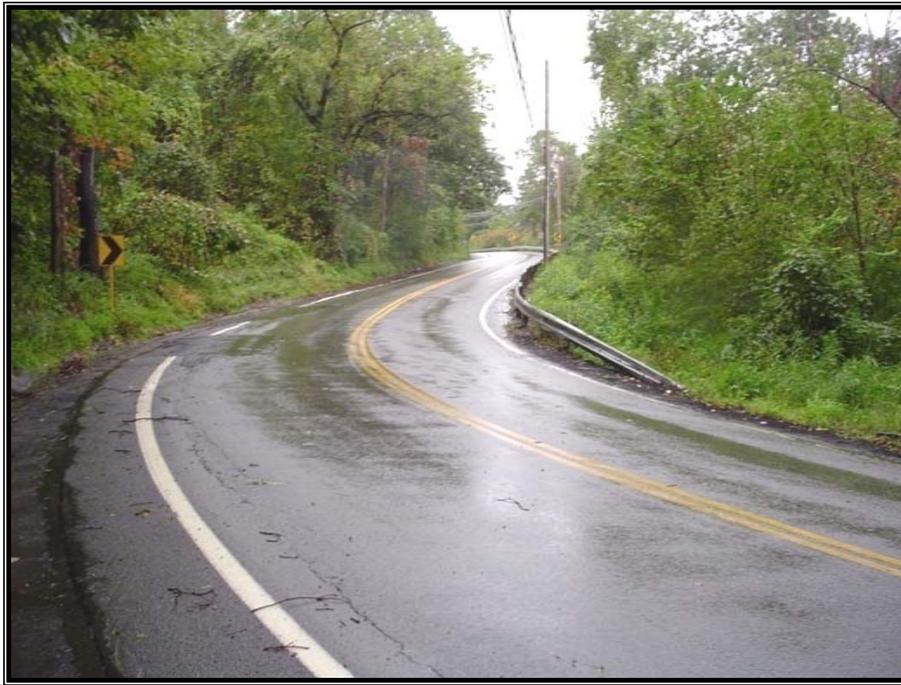
Photograph 5 - Vrooman Road at the southern hillside, looking southwest. Approaches to Vrooman Road Bridge are characterized by steep grades and curving alignment.

The acceptable grade for Vrooman Road given its classification and description as a level road in the ODOT's *Location and Design Manual Volume I* is an 8% grade. Currently, Vrooman Road has a 12% grade on the south side of the Grand River Valley and a 15% grade on the north side. The steep grades make it difficult for motorists with standard transmission vehicles to operate the vehicle safely and properly on the hills, especially at the intersection with SR-84. All vehicle types are affected in poor weather conditions. Vehicles have slid backwards when forced to stop while climbing the grade north of the river in snowy or icy conditions.

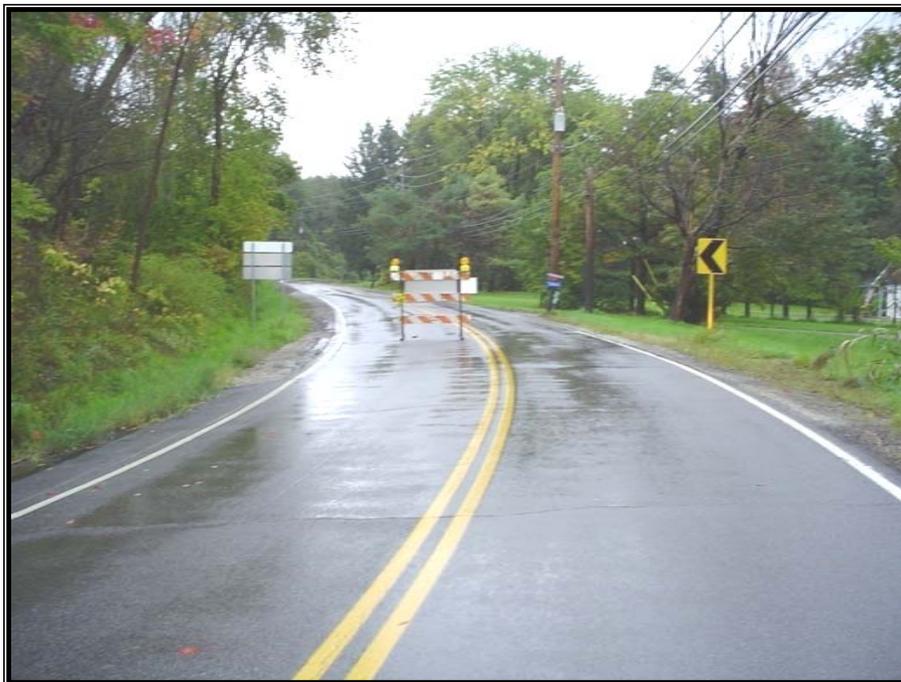
Photograph 6 - Vrooman Road at the top of the southern hillside, looking south.

The existing roadway is approximately 30' wide including two 10'-6" lanes and 4'-6" graded shoulders. The paved shoulder width is approximately 1'-6". Existing roadway conditions are shown in **Photographs 1 through 14**. The LCEO estimates that the stretch of Vrooman Road within the Project Study area requires approximately \$75,000 more in annual maintenance costs than similar lengths of non-deficient roadway. Additional costs are attributable to: increased salting and plowing because of steep grades; special pavement and drainage treatments because of steep grades; repair costs resulting from flooding; guide rail maintenance costs resulting from high number of accidents; and costs associated with closing, cleaning and reopening the road during flood events. ODOT maintenance personnel indicate that no above normal maintenance is required on SR-84 within the Project Limits.

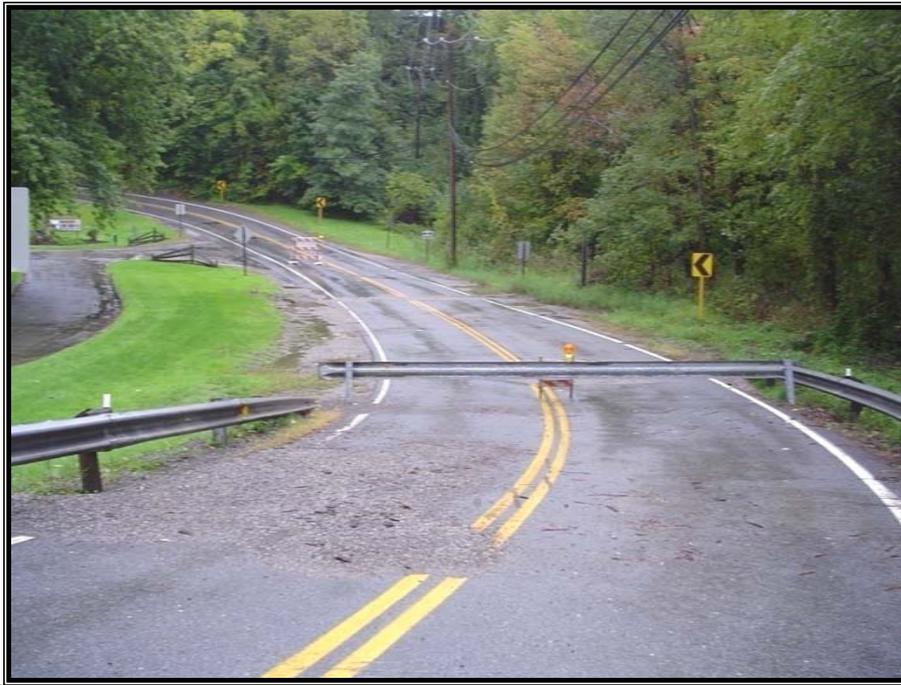
Photograph 7 - Vrooman Road Bridge at the northern approach, looking northwest.

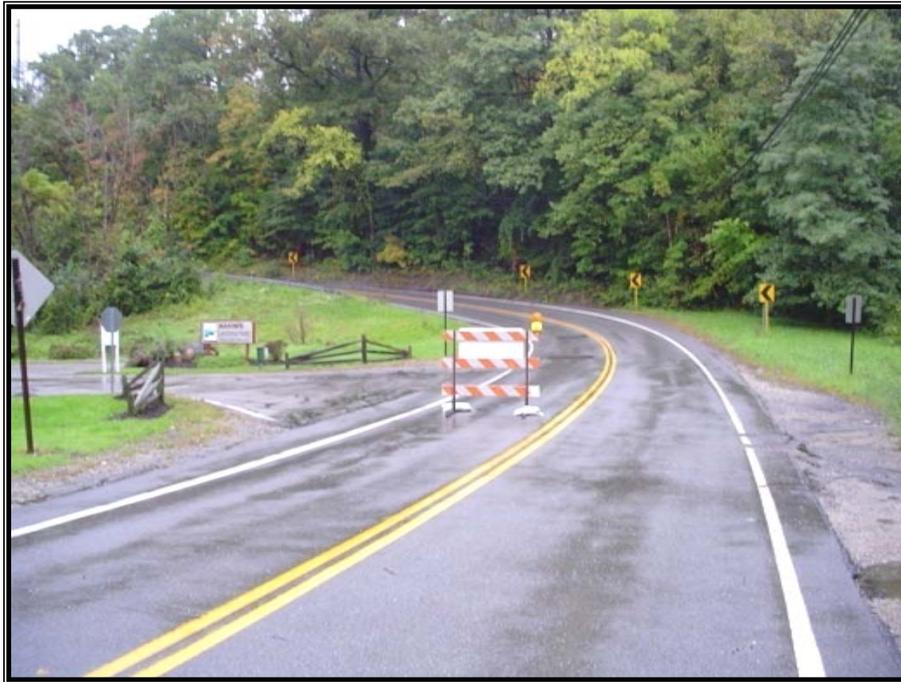
Photograph 8 - Vrooman Road north of the Vrooman Road Bridge, looking northwest. This section of Vrooman Road includes the entrance to Mason's Landing Park on the left and the bottom of the northern hillside, from SR-84 in the background.

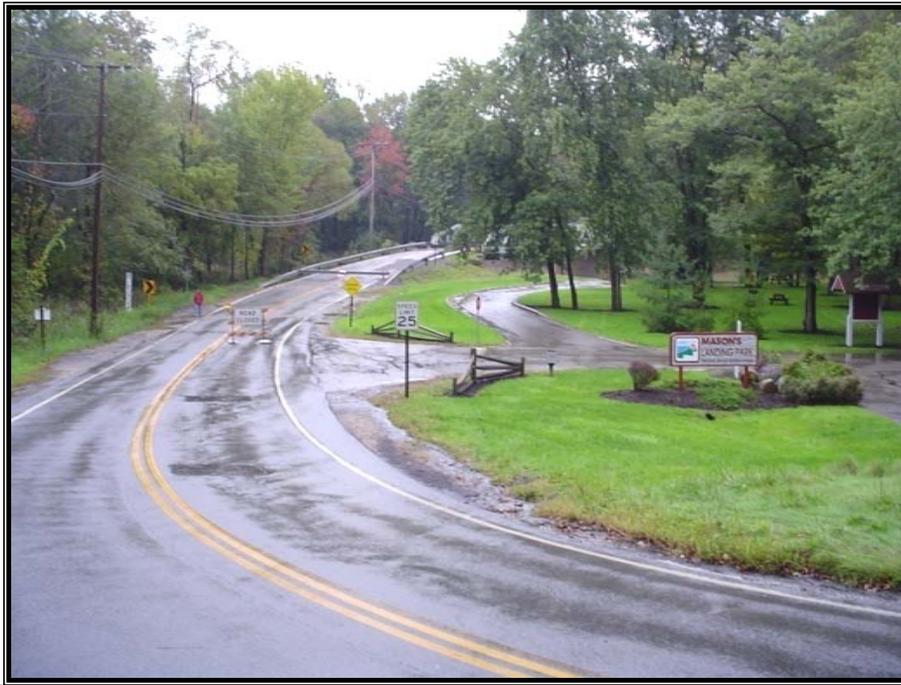
Photograph 9 - Vrooman Road at the bottom of the northern hillside looking southeast. Vrooman Road Bridge is in the background and Mason's Landing Park entrance on the right.

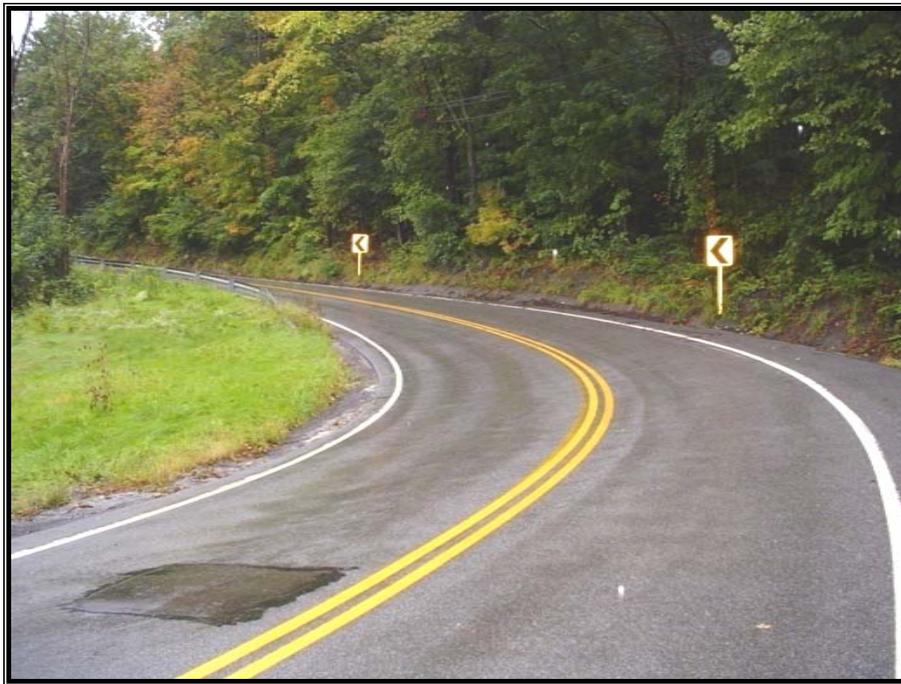
Photograph 10 - Vrooman Road at the base of the northern hillside, looking northwest. This curve in the road is at the bottom of a steep grade.

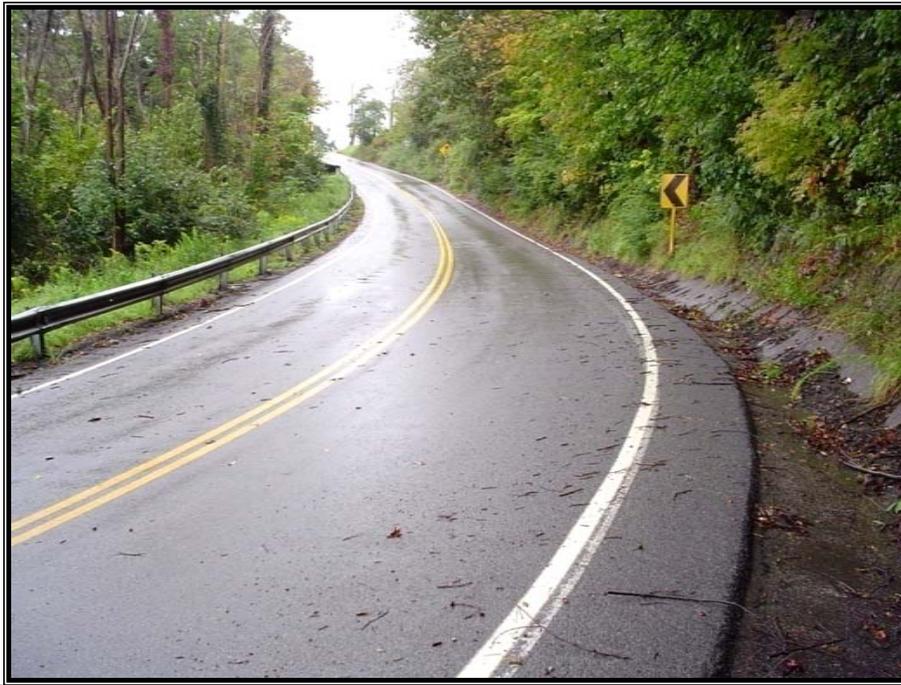
Photograph 11 - Vrooman Road at the bottom of the northern hillside, looking west. The retaining wall is on the left side of the roadway.

A retaining wall is located on the north side of the Grand River Valley along the south side of Vrooman Road and roughly parallel to SR-84. This wall was constructed in or around 1972, and is approximately 250' long and 25' high. The wall is structurally deficient and exhibits some signs of movement. LCEO has repaired the retaining wall twice over the last 5 years, at a total cost of approximately \$10,000, for an average annual cost of \$2000. Repairs have included installing additional bracing and tiebacks. Photographs 15 through 17 show the existing condition of the retaining wall. The wall is a critical structure supporting Vrooman Road out of the river valley. This retaining wall structure stabilizes the intersection of Vrooman Road and SR-84. Failure of this retaining could possibly result in the closure of both SR-84 and Vrooman Road.

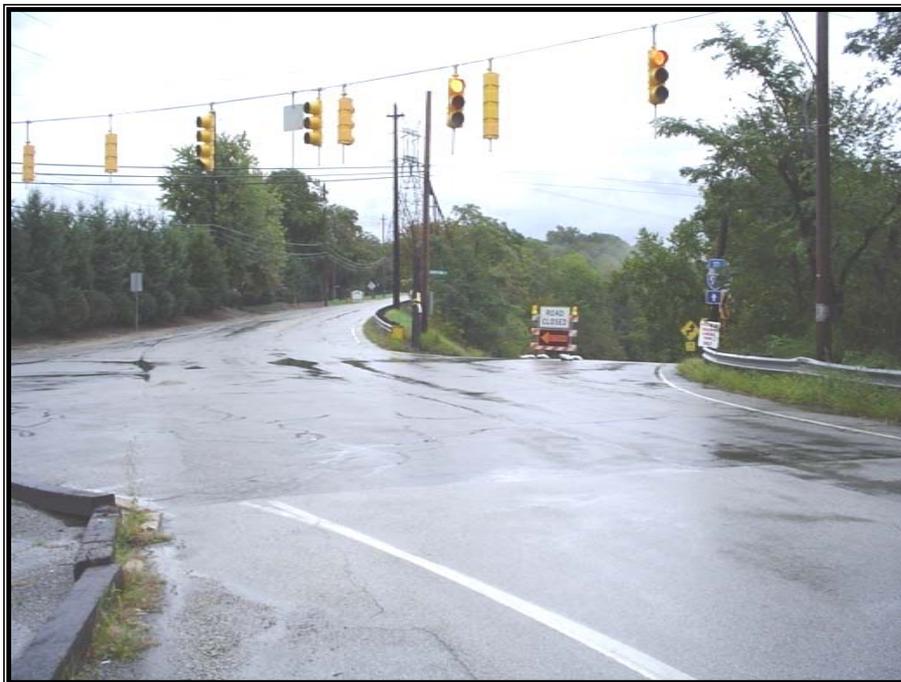
Photograph 12 - The intersection of SR-84, Vrooman Road, and Madison Avenue at the top of the northern hillside, looking northeast. Note poor intersection geometry.

The sight distance from Vrooman Road at the intersection of Vrooman Road and SR-84 is practically non-existent due to the angular approach of Vrooman Road up the Grand River Valley. The proper site distance for a left turn is 500 feet and for a right turn is 430 feet as given in the Ohio Department of Transportation's *Location and Design Manual Volume I*.

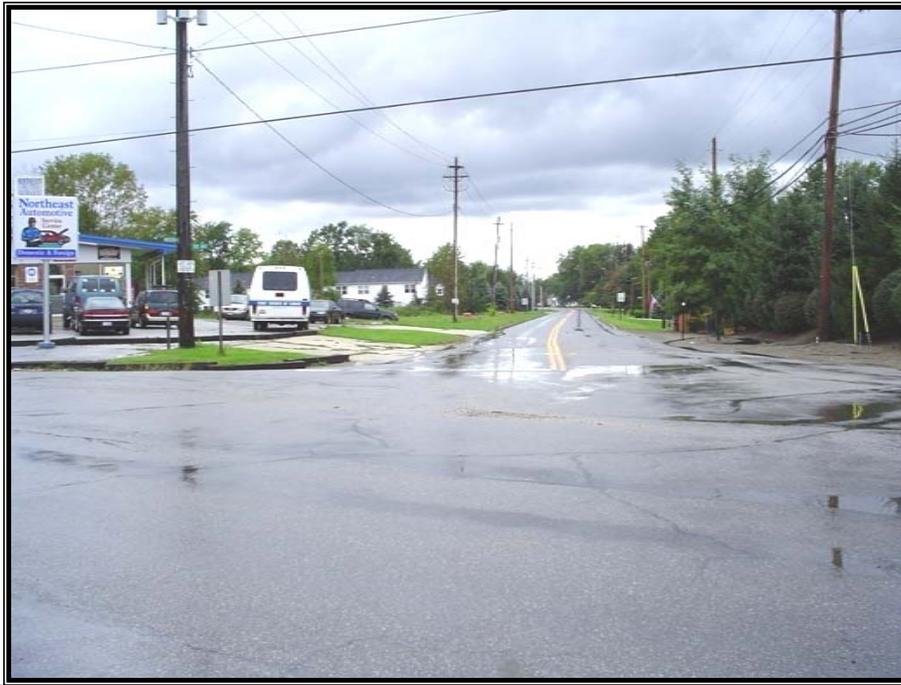
Photograph 13 - The intersection of SR-84, Vrooman Road, and Madison Avenue at the top of the northern hillside, looking west along Madison Avenue.

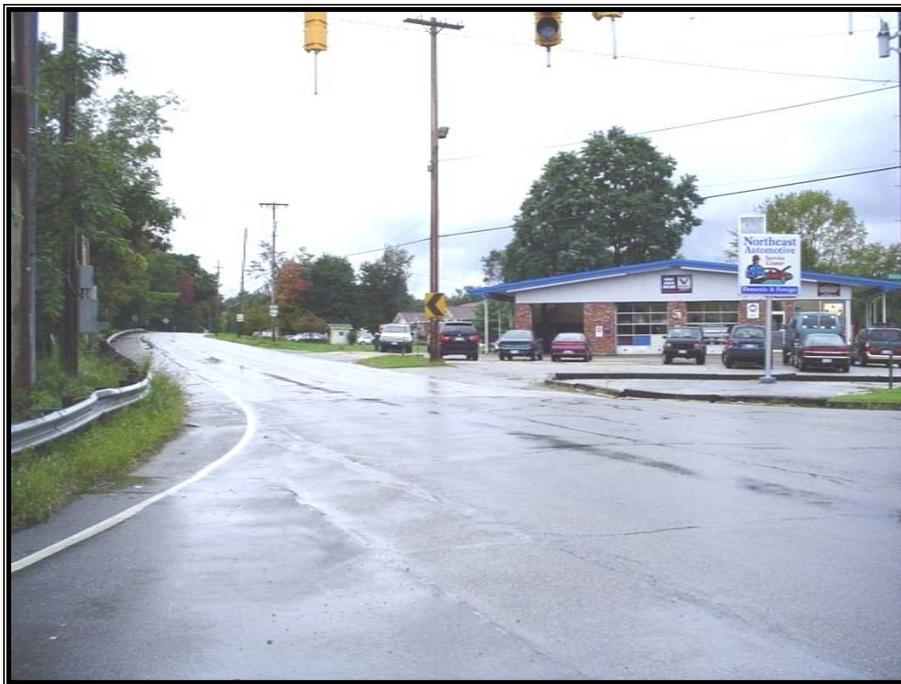
Photograph 14 - The intersection of SR-84, Vrooman Road, and Madison Avenue at the top of the northern hillside, looking south west along SR-84.

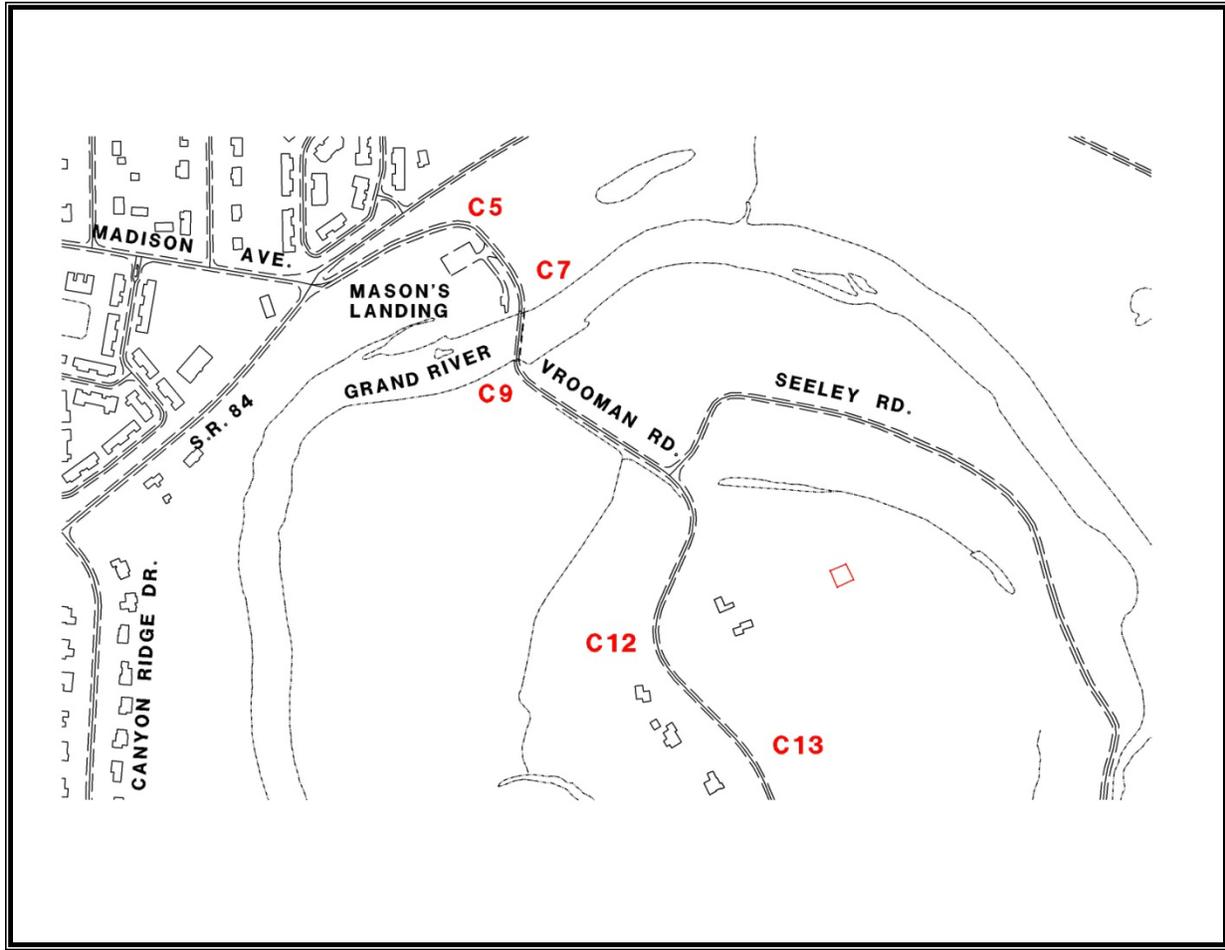
Figure 5: Map of Existing Horizontal Curve Locations

All of the five curves are below the minimum acceptable radius based on applicable design criteria for Vrooman Road as given by ODOT's *Location and Design Manual Volume I*. **Figure 5** shows the locations of the curves.

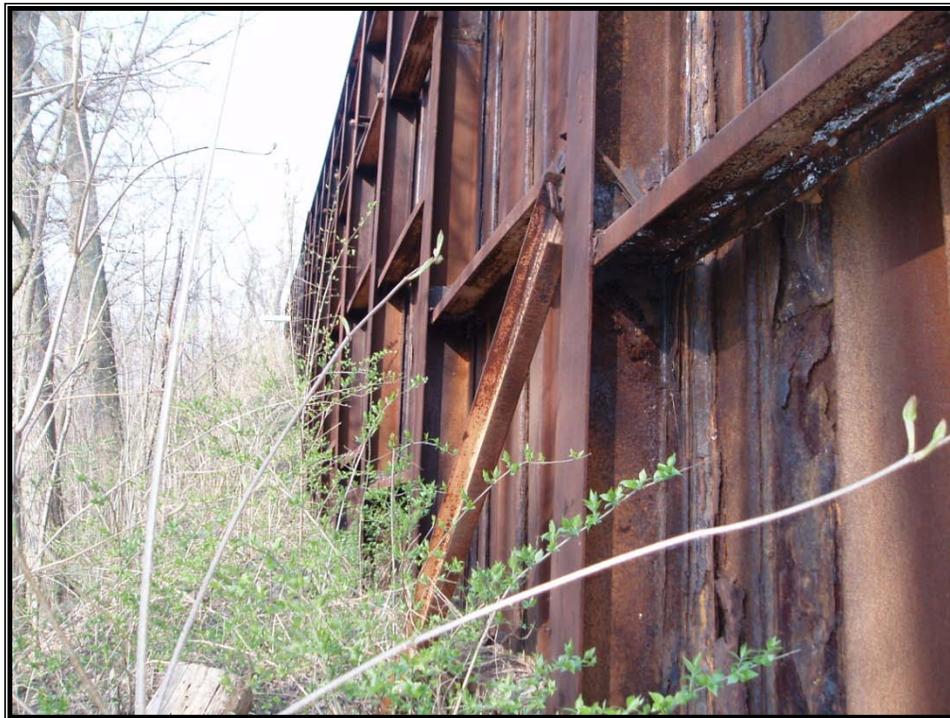
Photograph 15 - The base of the Vrooman Road retaining wall, looking west.

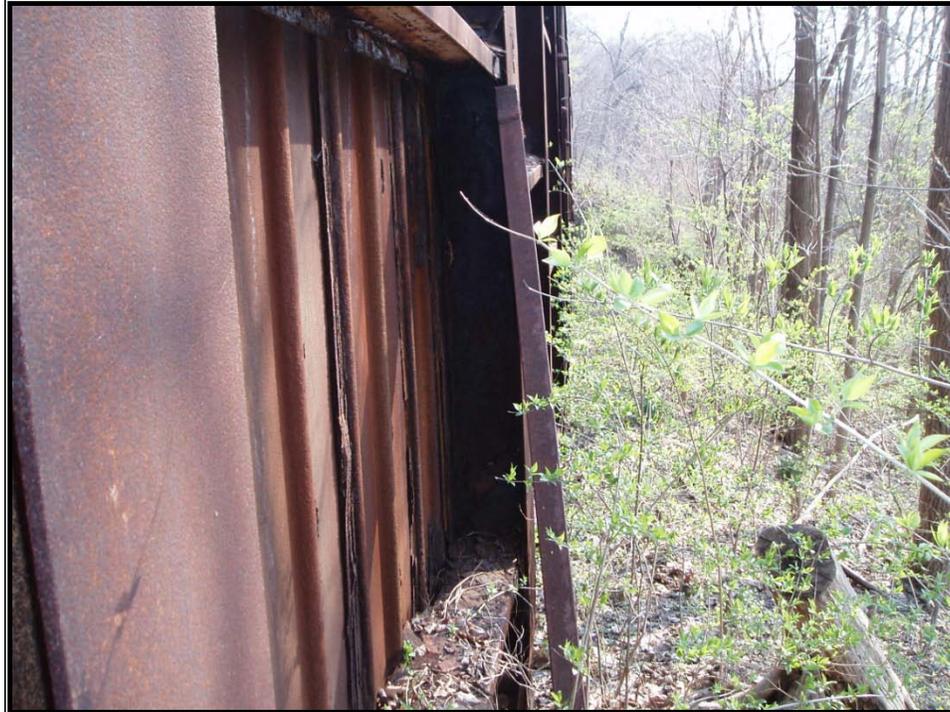
Photograph 16 - The base of the Vrooman Road retaining wall, looking east.

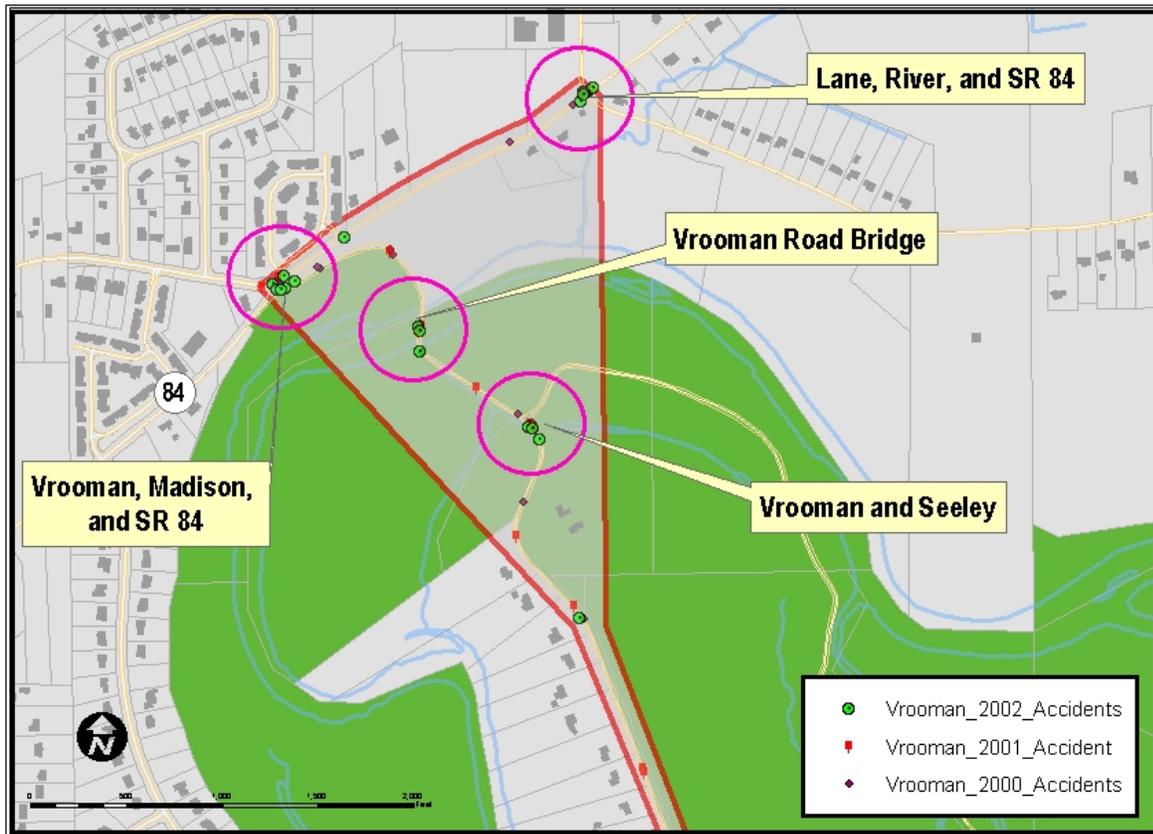
FIGURE 6: THREE YEAR ACCIDENT LOCATIONS (2000-2002)

Over a three-year period, eight accidents or more at a given intersection/location is noteworthy. Geometric problems at Locations 1 and 4 may be the cause for increased crash numbers over this time period. Geometric problems along with substandard lane widths may contribute to accidents at the Vrooman Road Bridge location. The high accident numbers at the intersection of Lane, River, and SR-84 (Location 2) may be caused by the unusual intersection angles of the two side roads. Anecdotal evidence from the County Sheriff and LCEO suggest that a substantially higher number of accidents occur, but go unreported, along this stretch of Vrooman Road.
