**PHASE I ENVIRONMENTAL SITE ASSESSMENT
FOR THE
VROOMAN ROAD BRIDGE REPLACEMENT
LEROY AND PERRY TOWNSHIPS, LAKE COUNTY, OHIO**

JULY 22, 2008

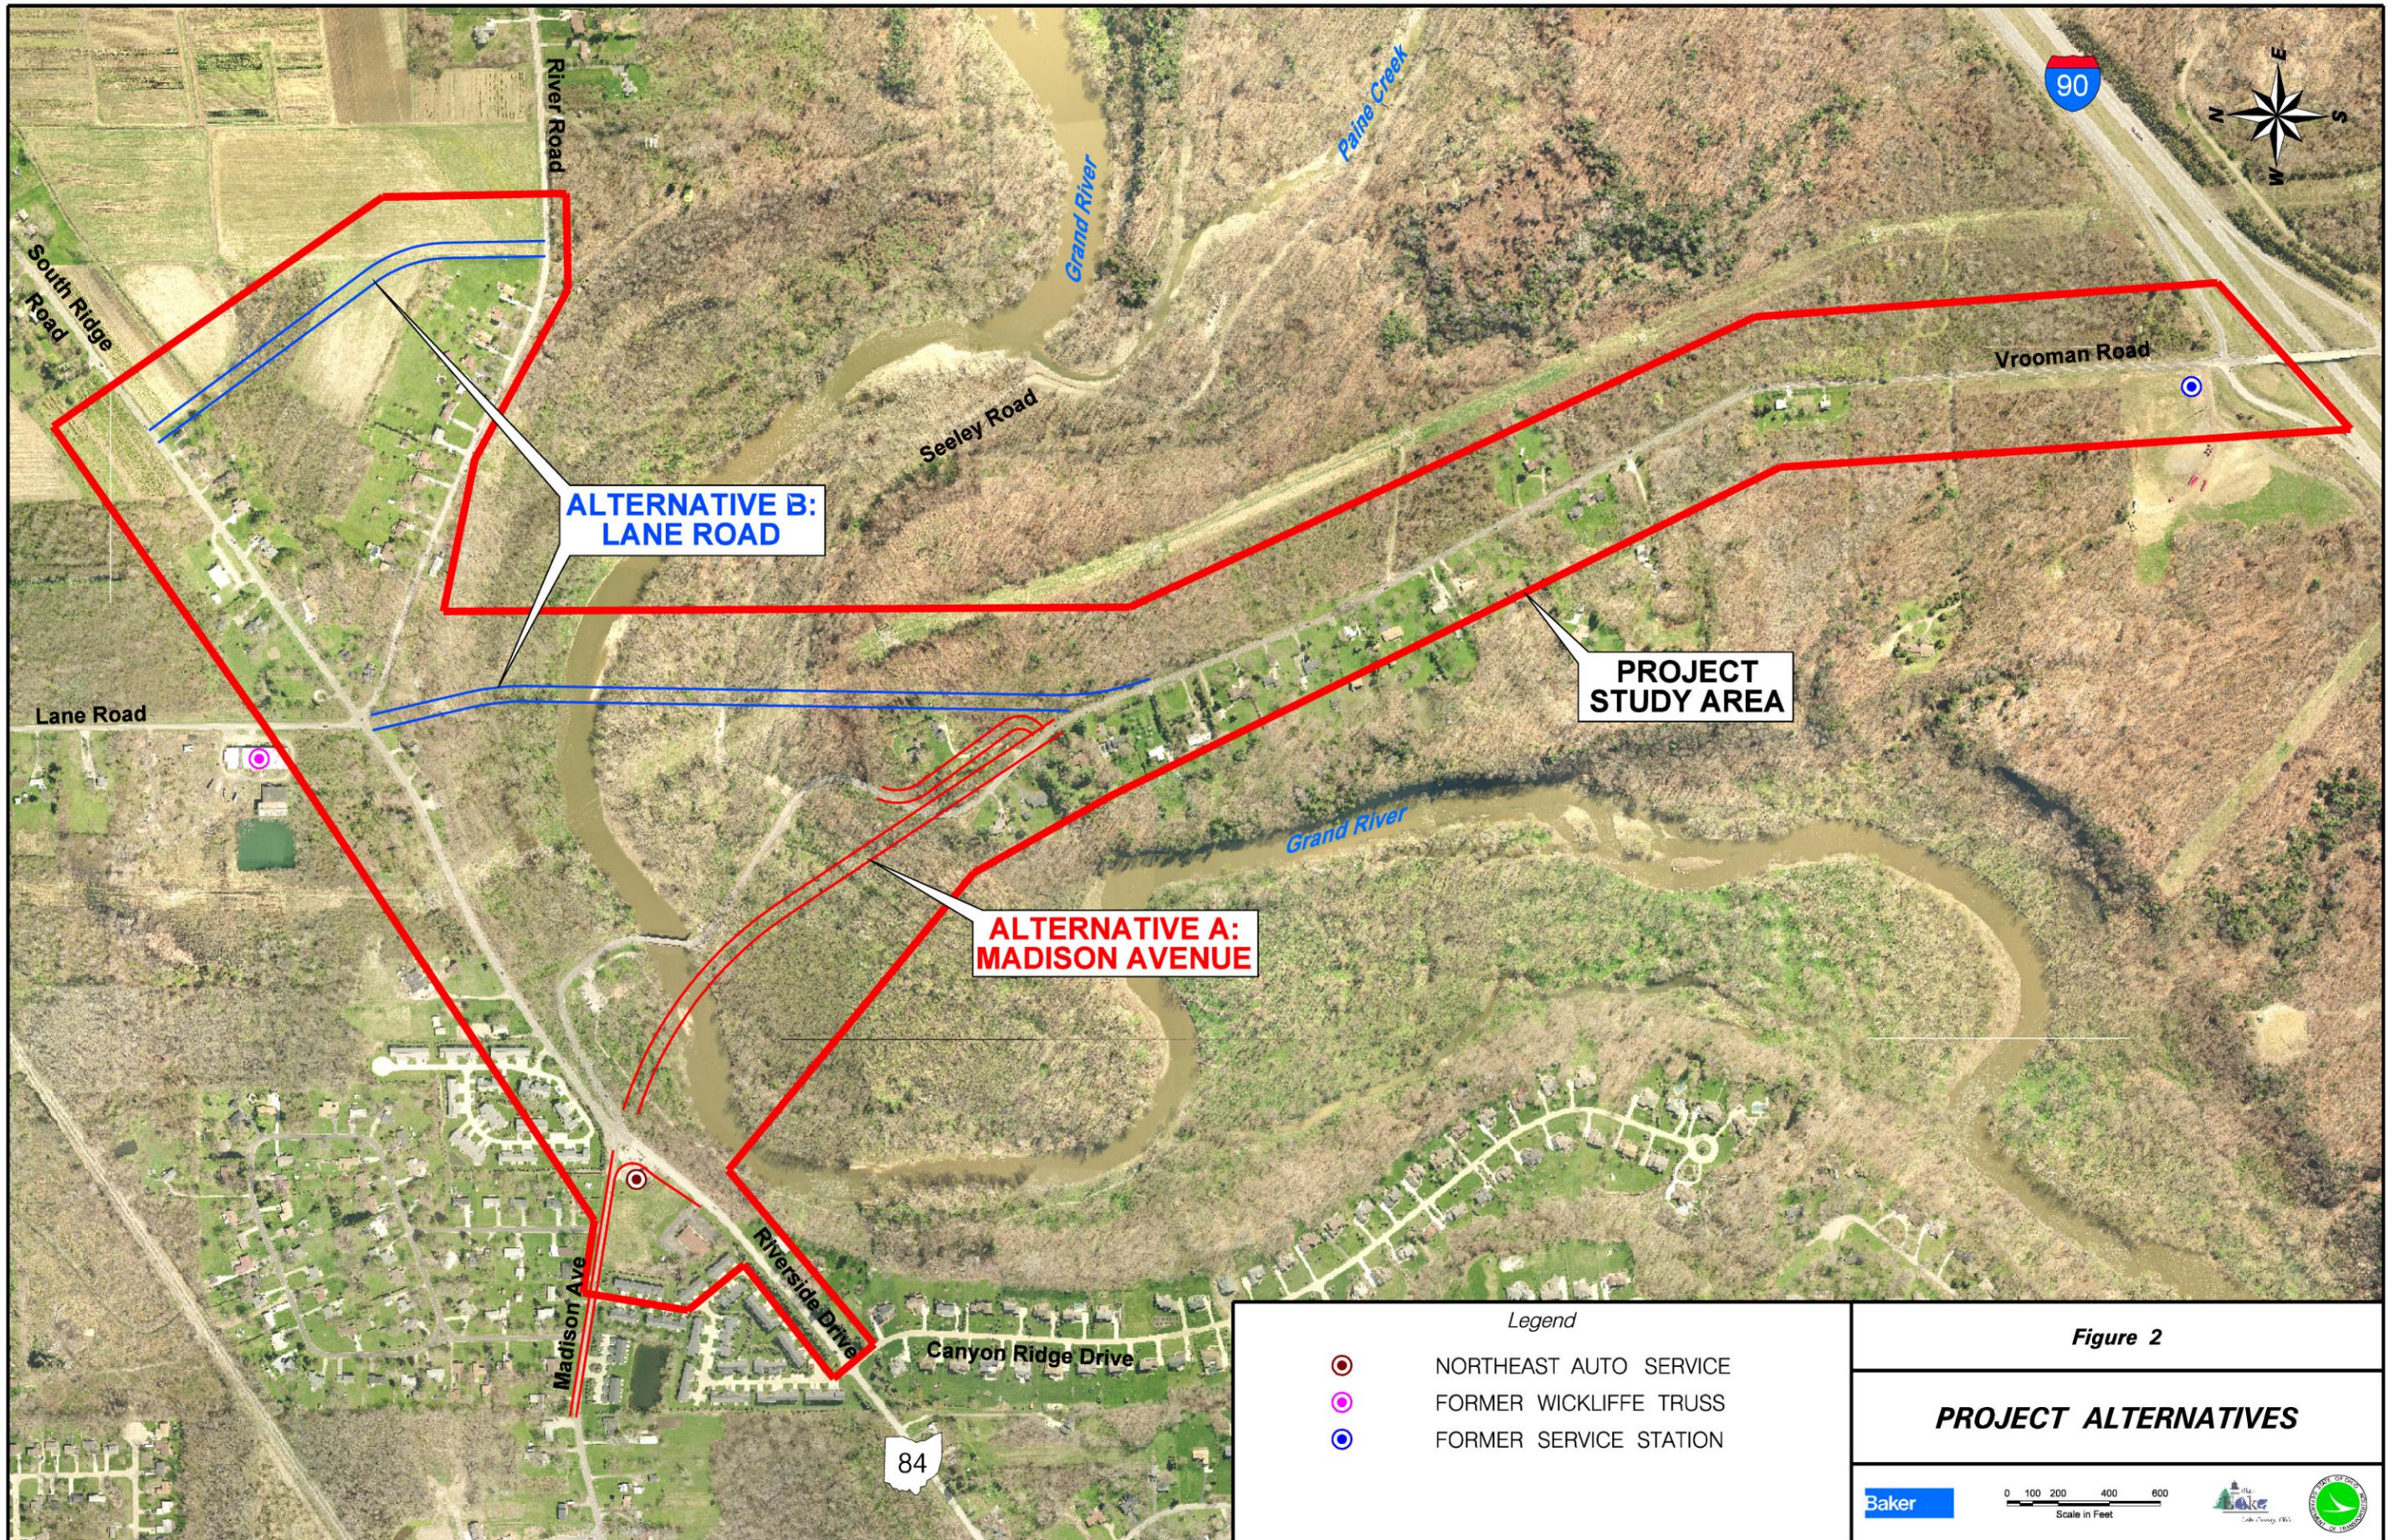
**ALTERNATIVE B:
LANE ROAD**

- Alternative B – Lane Road Alternative – Alternative B involves replacing the existing bridge with a high level bridge, spanning the Grand River and tying into Lane Road at State Route 84. This alternative also realigns River Road to tie into State Route 84 east of the intersection with Lane Road and Vrooman Road.
- No Build Alternative – The no build alternative would involve routine maintenance, leaving the road in its current condition.

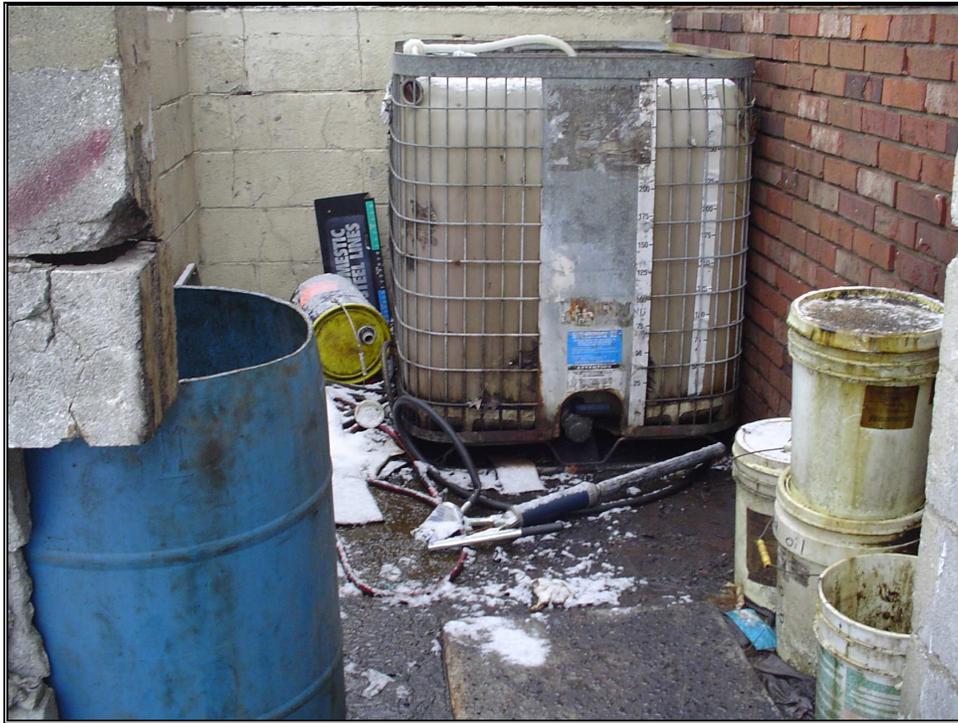
along the western edge of the building. Evidence of spillage was observed near these containers. No evidence of current underground storage tanks was observed during the site visit; however, patched concrete, indicative of historic USTs was observed on the eastern portion of the property. No evidence of current on-site monitoring wells was observed on the property. A site plan and photographs for the Northeast Auto Service property are included in Appendix D.

3. View of outdoor chemical storage area. Note staining on ground.

Based on the parcel reconnaissance, historic reviews, regulatory reviews, and interviews conducted for the Northeast Auto Service property, additional investigation of this property is warranted. Current and historic activities at this facility have included the storage and use of petroleum products. Based on this usage, a Phase II ESA is recommended for this property. Specifically, Phase II ESA work should involve the following protocol:

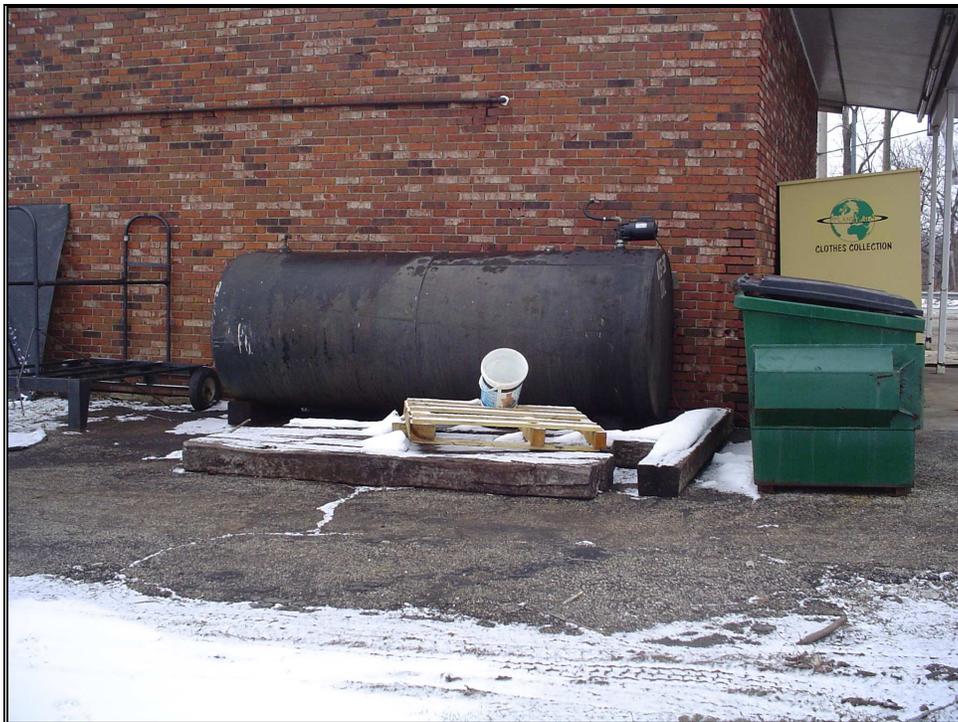
Baker conducted a site visit of the Northeast Auto Service facility on March 24, 2008. Baker observed one 1,000-gallon used oil aboveground storage tank located immediately adjacent to the west of the building. Baker also observed one 275-gallon tote and several miscellaneous containers ranging in size from 5 to 30-gallons of automotive chemicals

4. North facing view of used oil AST located on site.

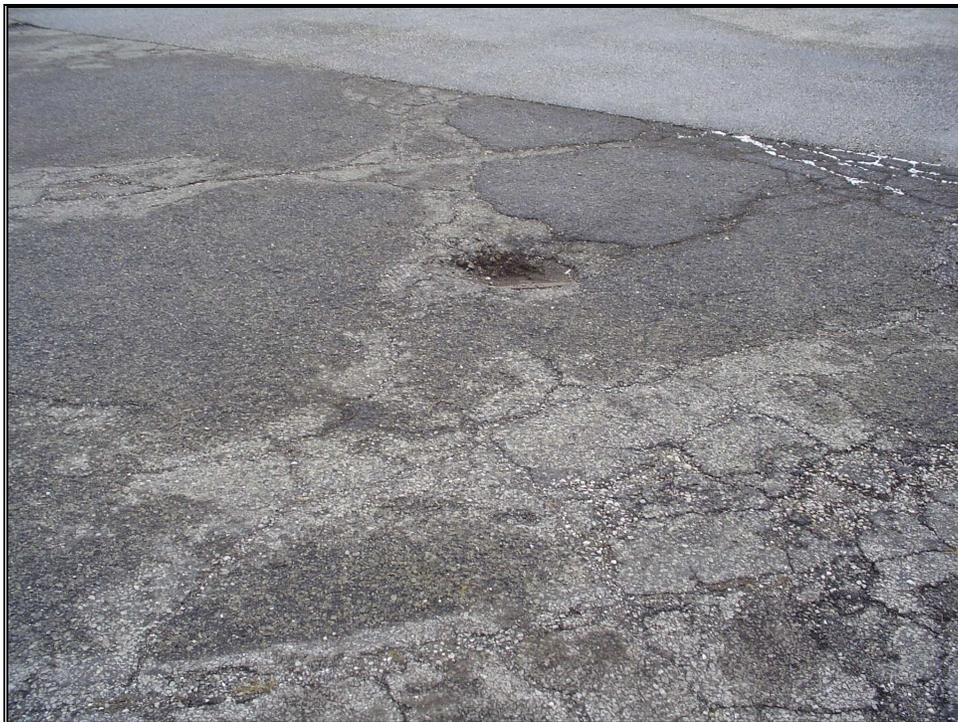
8. Former monitoring well located in driveway.

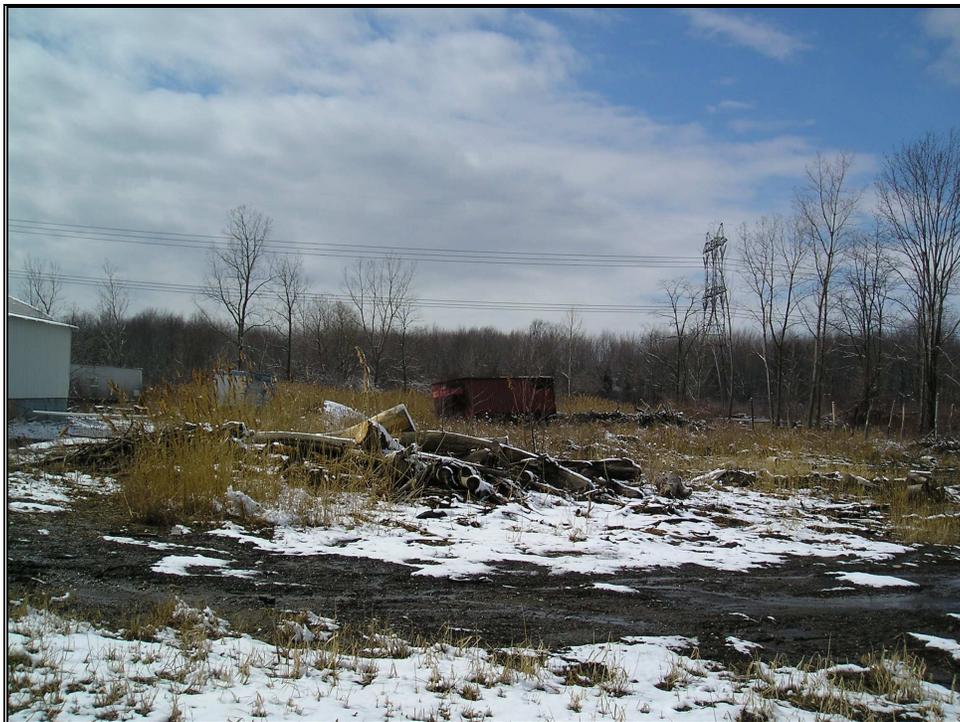
4. Miscellaneous debris piles located on northern portion of property.

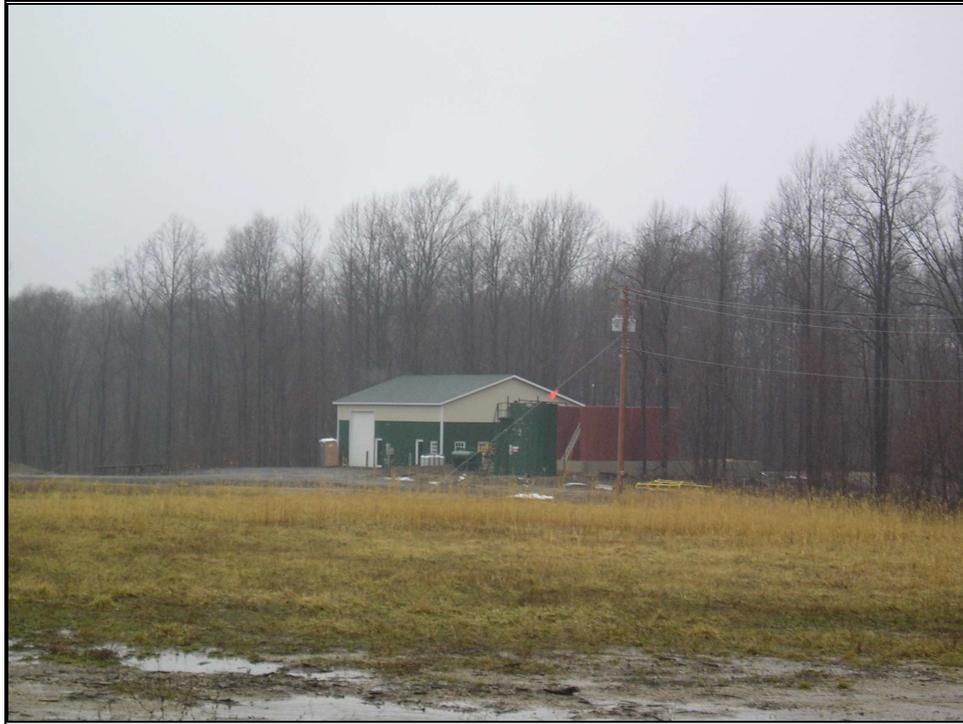
Photo 3: West facing view of building located on-site (Note aboveground storage tanks).

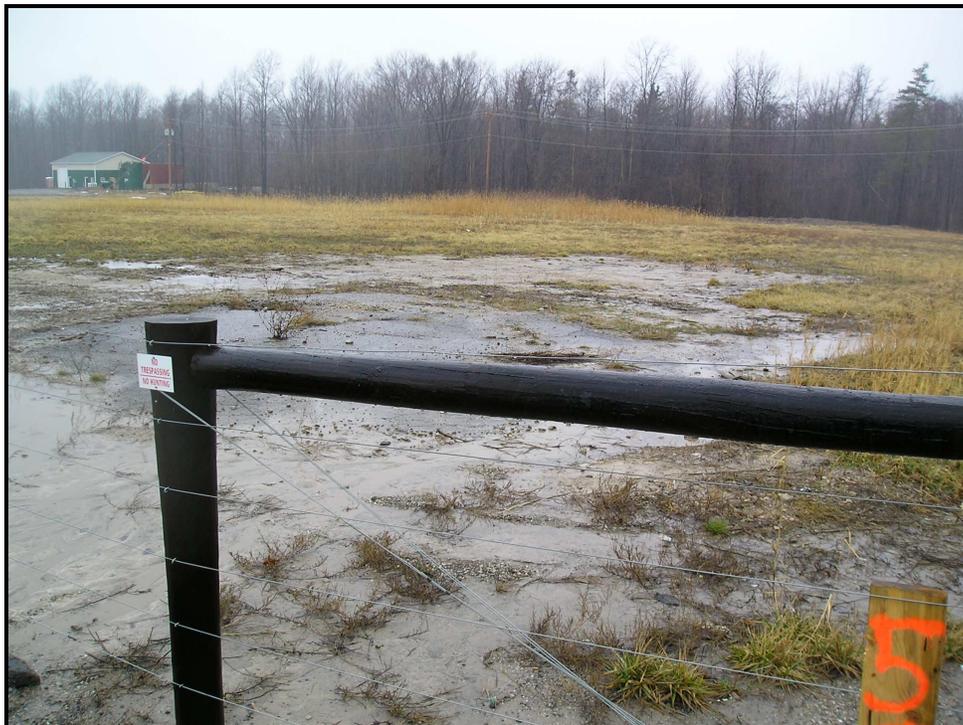
Historic activities at this facility have included a gas station. Based on the parcel reconnaissance, the historic ownership of the property by Exxon, as well as a disturbed area adjacent to the right-of-way (consistent with aerial photos depicting a building), a Phase II ESA is recommended for this property. Specifically, Phase II ESA work should involve the following protocol:

Photo 4: Disturbed area located adjacent to the Vrooman Road right-of-way.
