Marsh Creek- Frontal Lake Erie
HUC-12: 041100030501
Nine-Element
Nonpoint Source Implementation Strategic Plan (NPS-IS)

Version 1.0
April 11, 2017

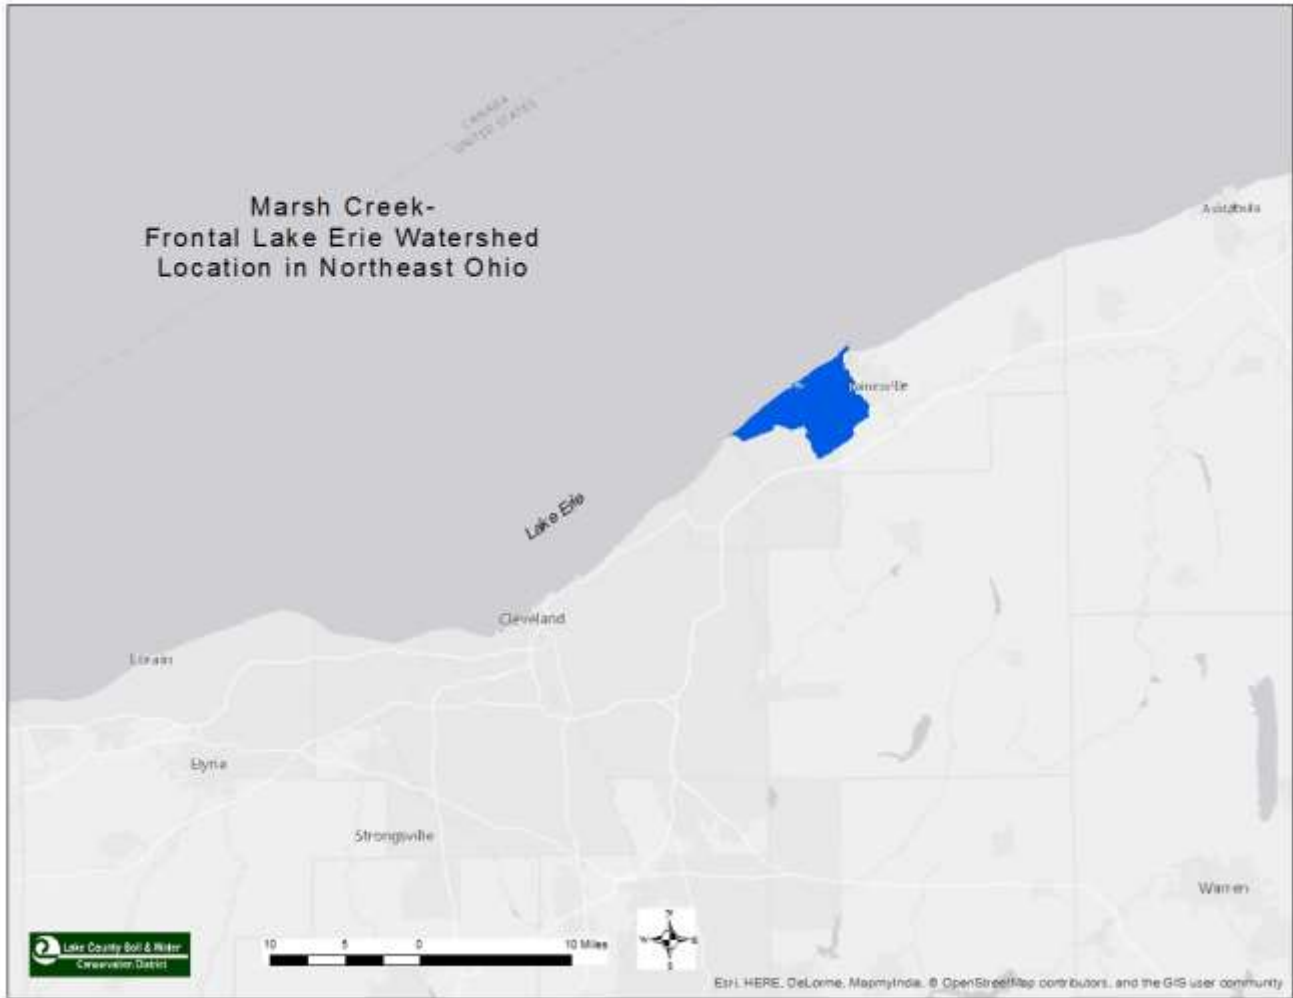
Figure 1: Location of Watershed

The Marsh Creek-Frontal Lake Erie Watershed is located in north-central Lake County in Northeast Ohio (Figure 1). The Hydrologic Unit Code (HUC)-12 is 041100030501. It encompasses the Marsh Creek, Blackbrook, Two Town, and Lake Erie Direct between Grand River and Mentor Marsh subwatersheds. The watershed drains 28.3 square miles. All watersheds drain directly into Lake Erie (Figure 3).

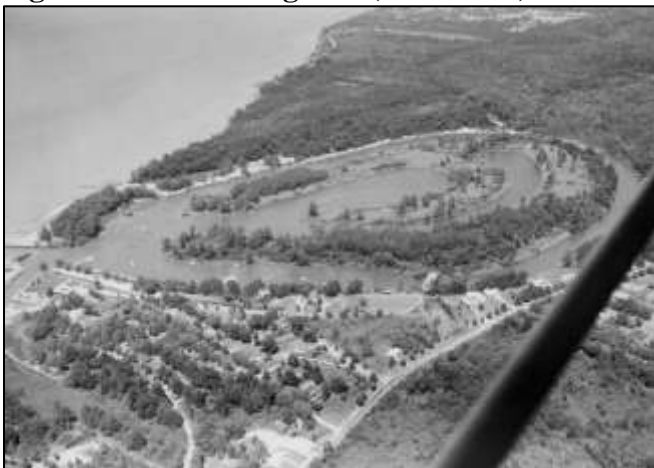
Figure 2: Mentor Lagoons (circa 1957)

The Mentor Lagoons are another feature of the marsh and create a distinctive mark on the landscape (Figure 2). The area was partially developed in the early 1920's by local wealthy residents, as a "Venice of the North". It was never completed and serves today as a marina owned by the City of Mentor.

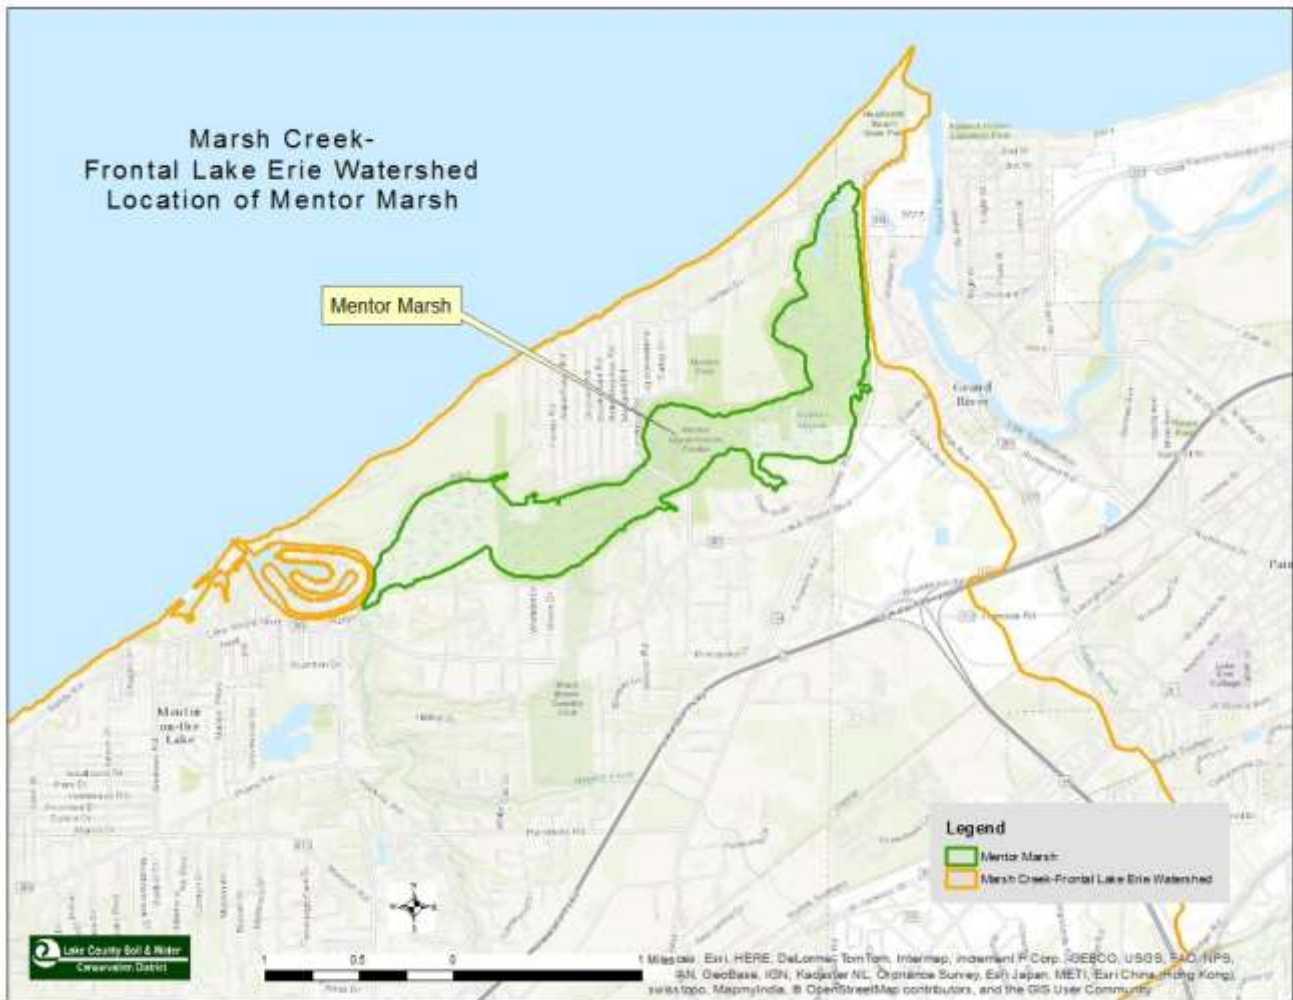
Figure 5: Location of Mentor Marsh

The watershed contains the Mentor Marsh, an 868 acre exceptional natural marshland within the watershed (Figure 5). The Mentor Marsh is a wooded wetland/swamp complex that formed in an abandoned channel of the Grand River and was isolated from Lake Erie by the accretion of beach sand. It is the largest marsh in Northeast Ohio and is an important habitat for birds, fish and aquatic invertebrates. In 1966, Mentor Marsh received national recognition when it became one of the first areas in the country to be designated as a National Natural landmark by the United States Department of the Interior. On May 19, 1970, the Ohio General Assembly passed the Natural Areas Act, which

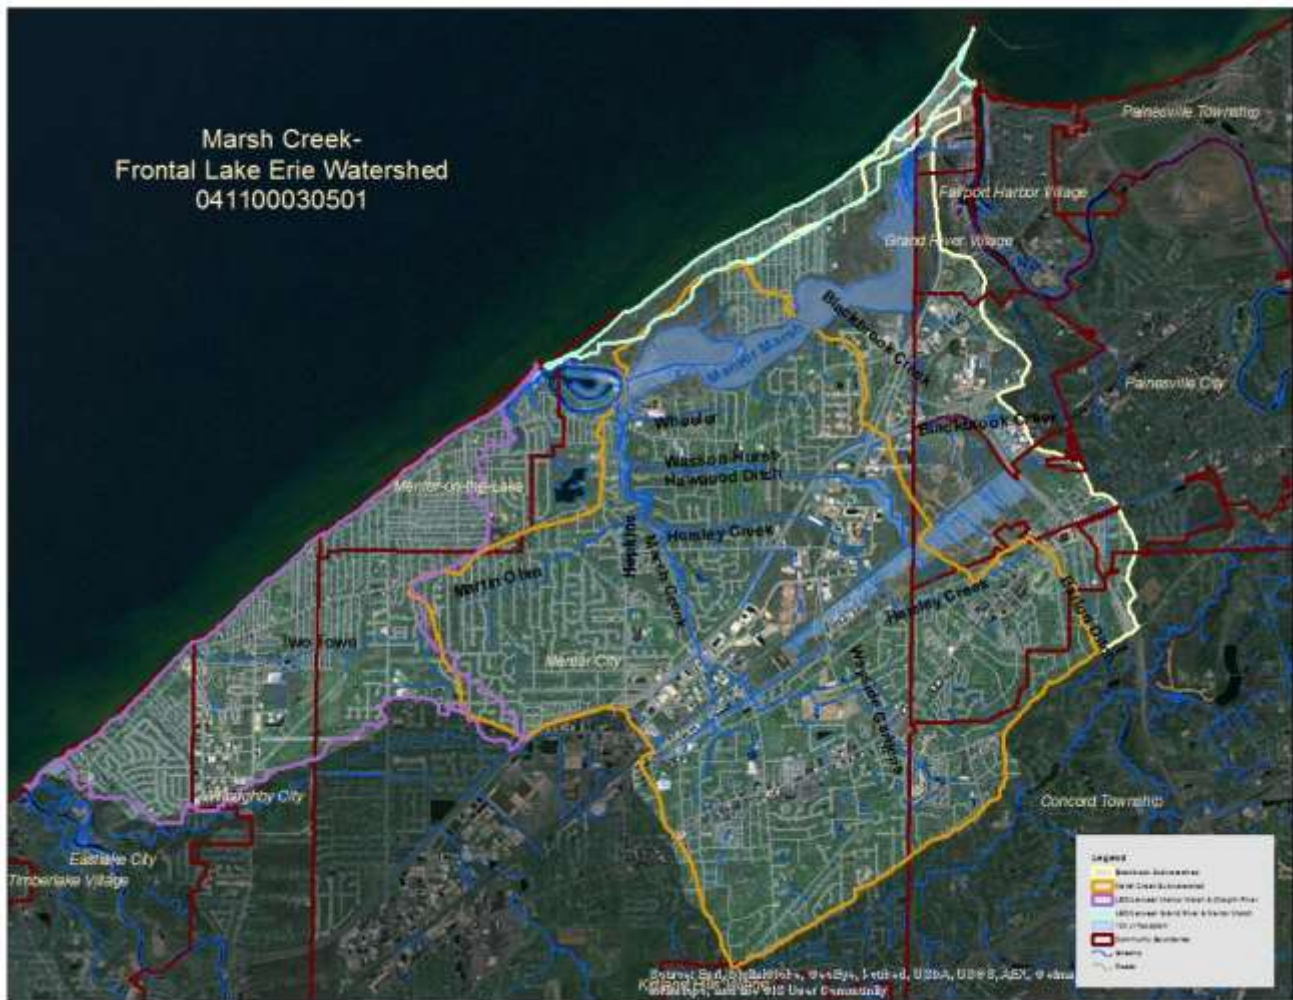
Figure 12: Orthophoto of Watershed

The watershed is nearly completely developed, as is apparent from an orthophoto view (Figure 12). Imperviousness of a watershed has an effect on the physical and biological characteristics of a stream. Increases in impervious cover cause decreases in conditions. Channel instability will occur when the impervious area is greater than 10%. Sharp declines in macroinvertebrate diversity occur when imperviousness is greater than 8%. (Vulnerability Analysis report, Center for Watershed Protection, 2002.) U.S. Geological Survey StreamStats data show the imperviousness in selected subwatersheds as follows:

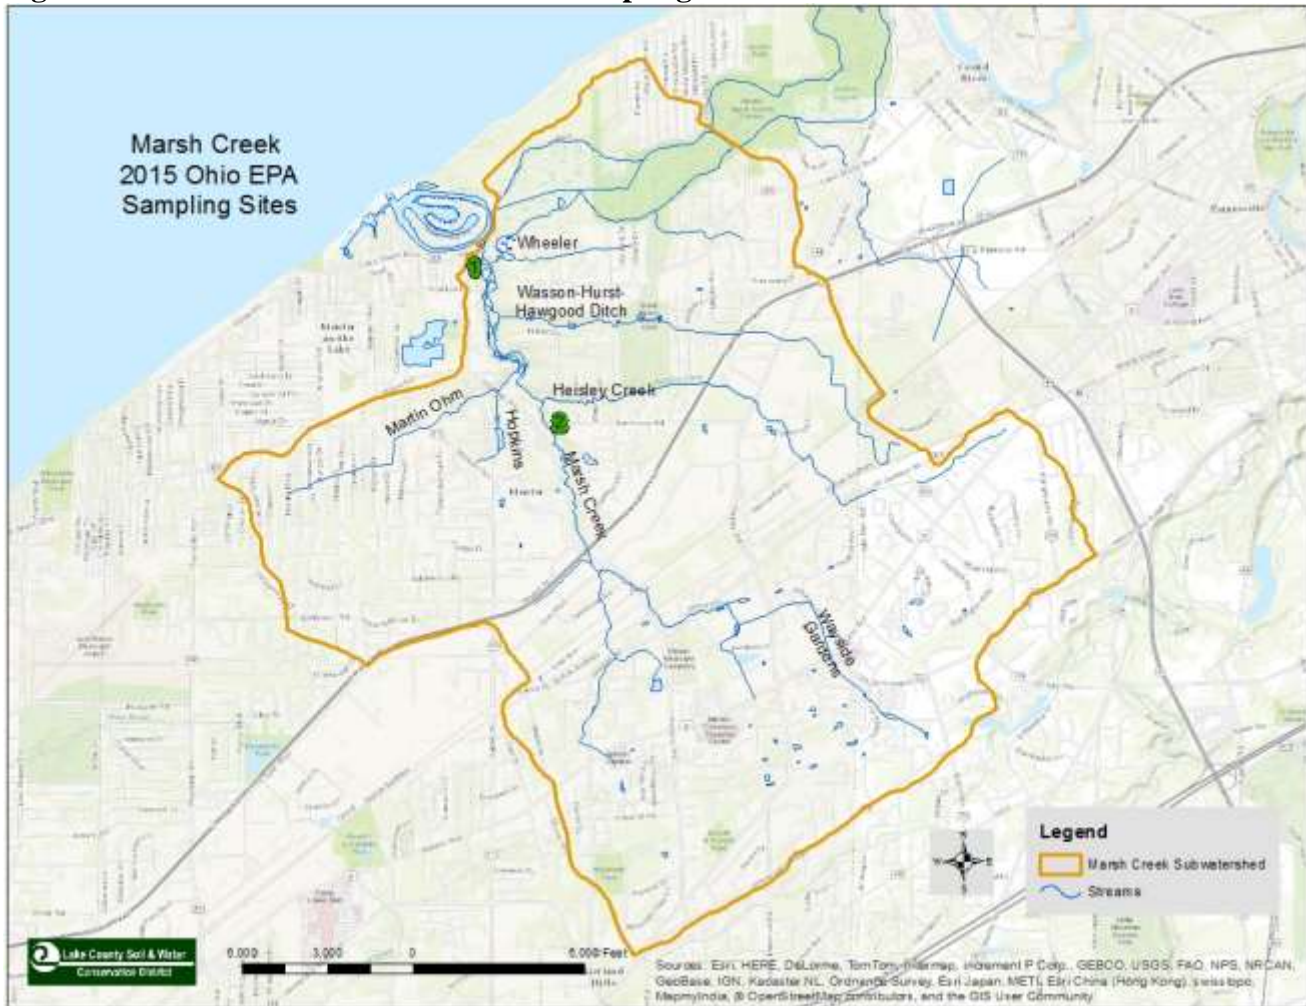
Figure 16: Marsh Creek 2015 Ohio EPA Sampling Sites

Marsh Creek was sampled by the EPA in the 2015 field season (Figure 16). Marsh Creek was found to be in non-attainment in the draft of causes/sources (Figure 15), causing- in part, this subwatershed to be designated as the Critical Area for this plan.

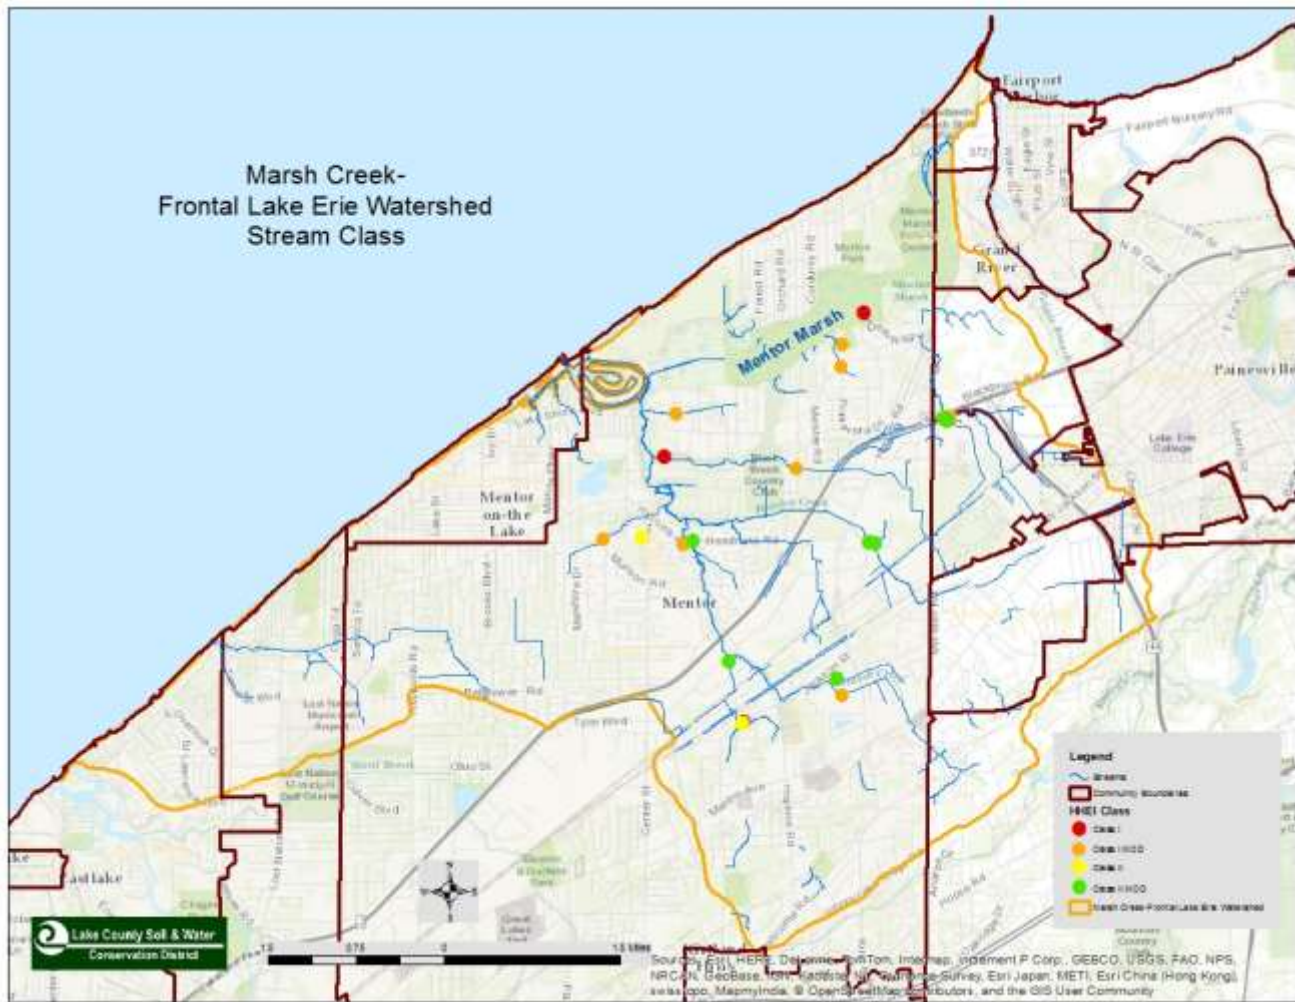
Figure 19: Stream Class

Class	%
Class I	14.3
Class I Modified	43
Class II	9.5
Class II Modified	33.2
	<hr/> 100

Lake SWCD worked with the EPA to develop and collect Headwater Habitat Evaluation Index (HHEI) data for Lake County watersheds to establish a baseline database of existing conditions. HHEI data was collected by Lake SWCD staff in the Marsh Creek and Blackbrook subwatersheds in the summer of 2007. 21 sites were assessed, with the majority in Marsh Creek. There were no sites assessed as Class III. 76.2 % were assessed as Modified (Figures 18 and 19). See Figure 20 and the following text for an explanation of the Ohio Stream Classification system.

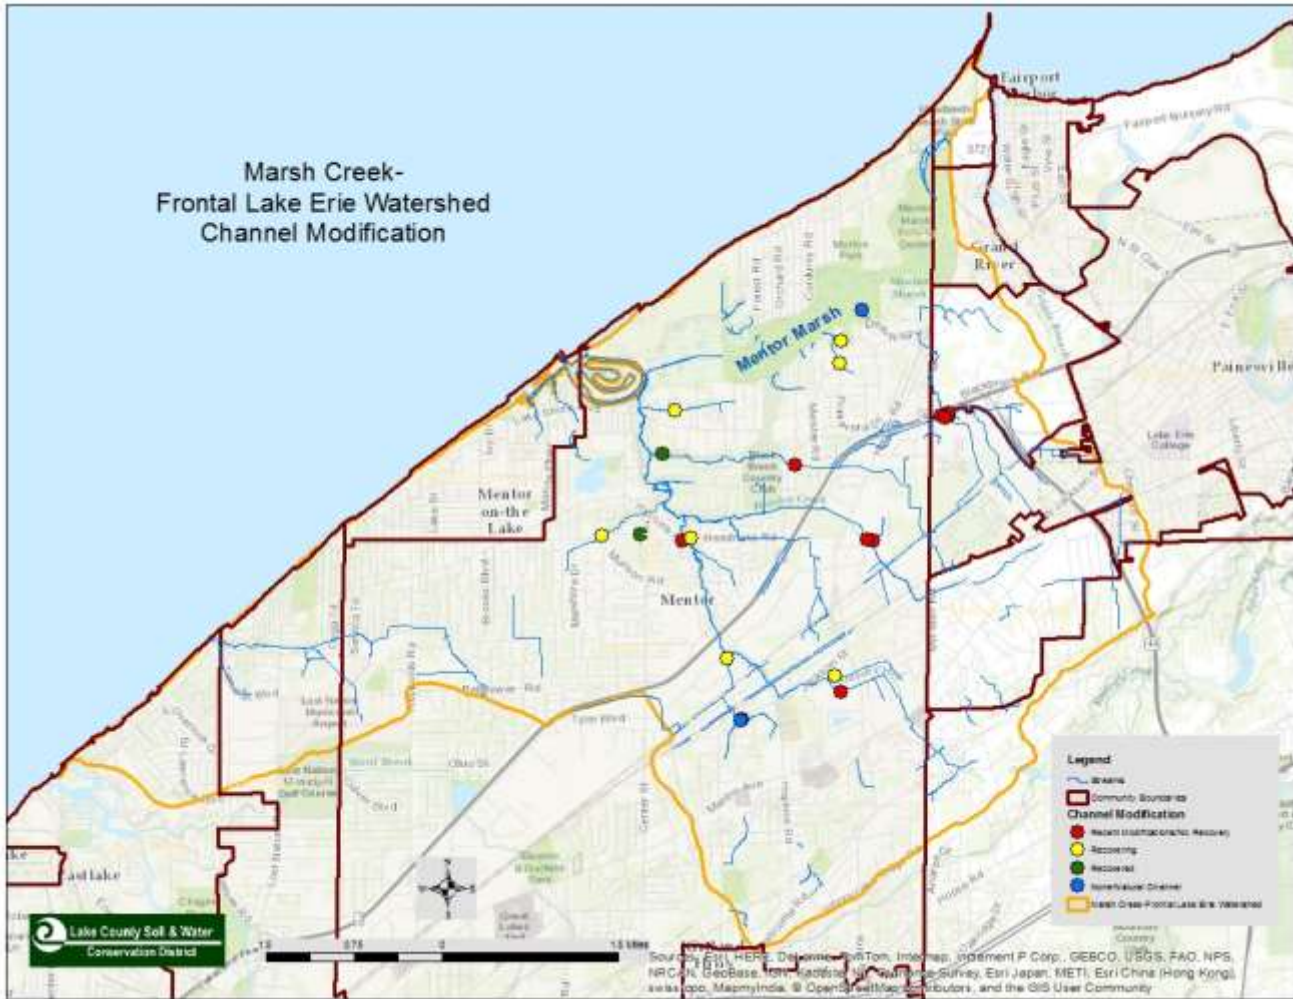
Figure 21: Channel Modification

When channels have been historically altered by man, they are categorized as “Modified”. This can include a status of “Recovered”, where the stream shows evidence of channel alteration, but has fully recovered many of the natural stream channel characteristics listed above; “Recovering”, where there is evidence of alteration and the stream is in the process of adjusting, channel sinuosity is lacking and riparian vegetation is in early stages of re-growth; and “Recent or No Recovery”, where alteration is evident and few if any natural characteristics are present. Highly modified streams are characterized by uniform depths, over-wide channels, homogeneous substrates, embeddedness of substrates and low sinuosity. (OEPA. 2009.)

When the HHEI assessment was done in 2007, 43% of the channels were identified as recent with no recovery, 33.2 % as recovering, and 23.8% as recovered or natural channel. Figures 23, 24 and 25 illustrate the different stream classifications within the watershed.

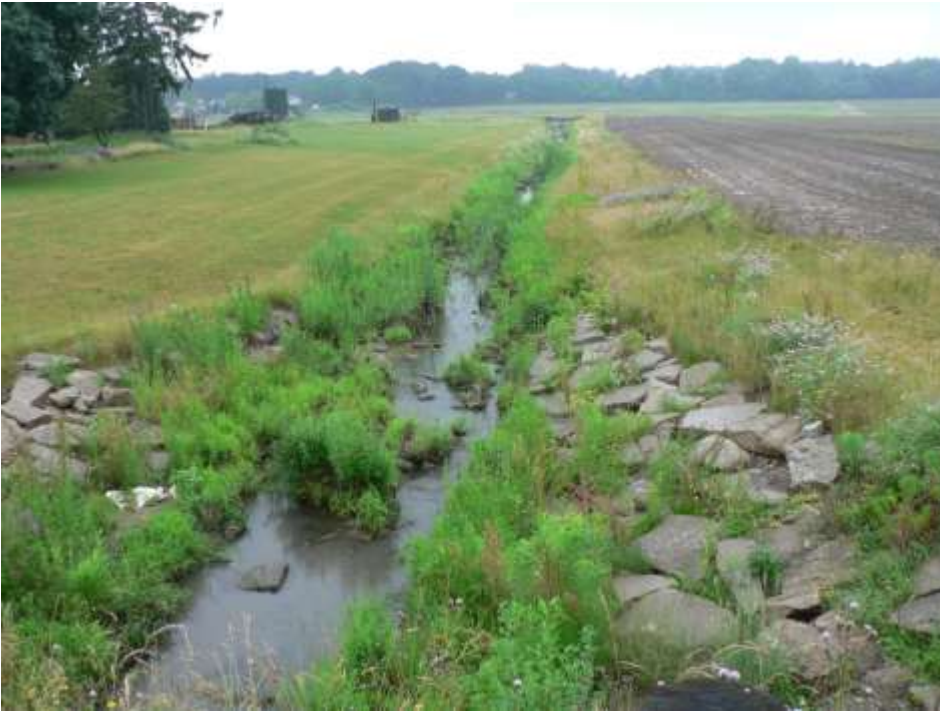
Figure 23: Class I Modified Stream, Recent, No Recovery in Marsh Creek Subwatershed

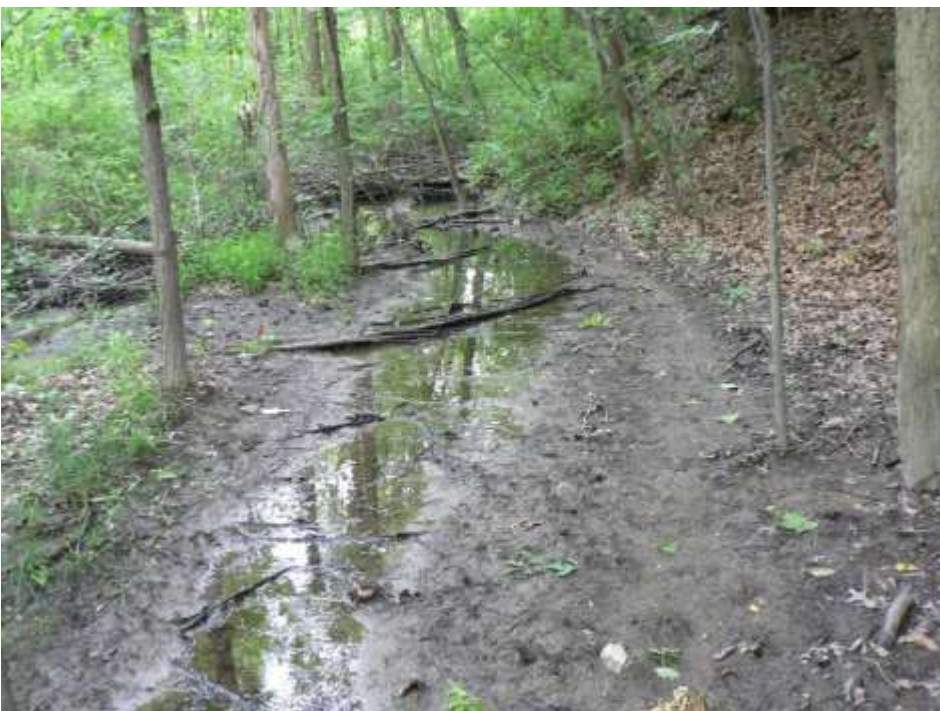
Figure 24: Class II Modified Stream, Recovering in Marsh Creek Subwatershed

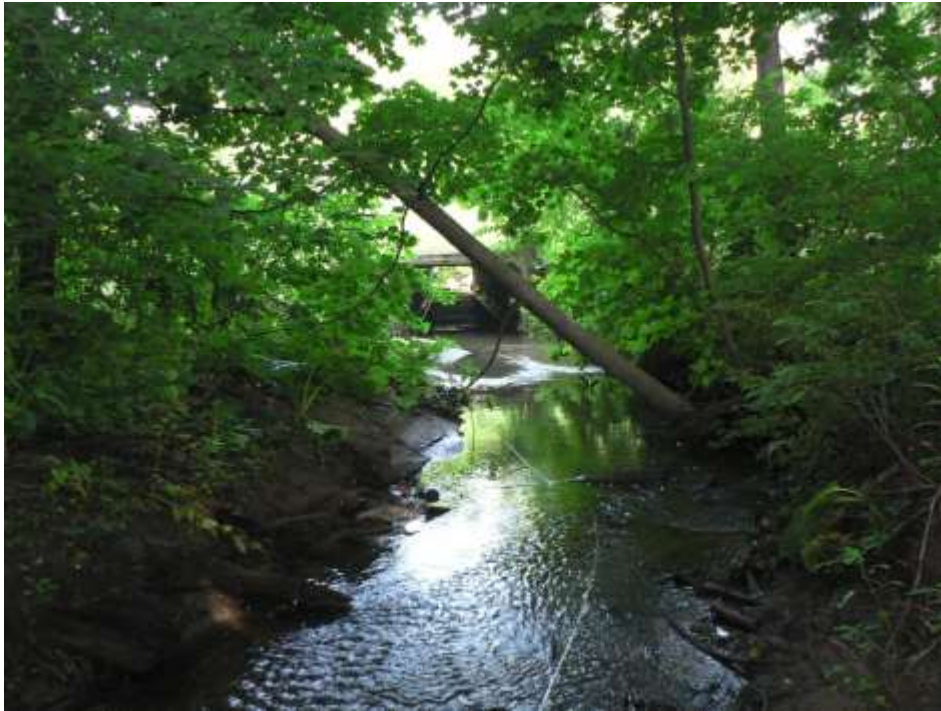
Figure 25: Class I Stream, Natural Channel in Marsh Creek Subwatershed

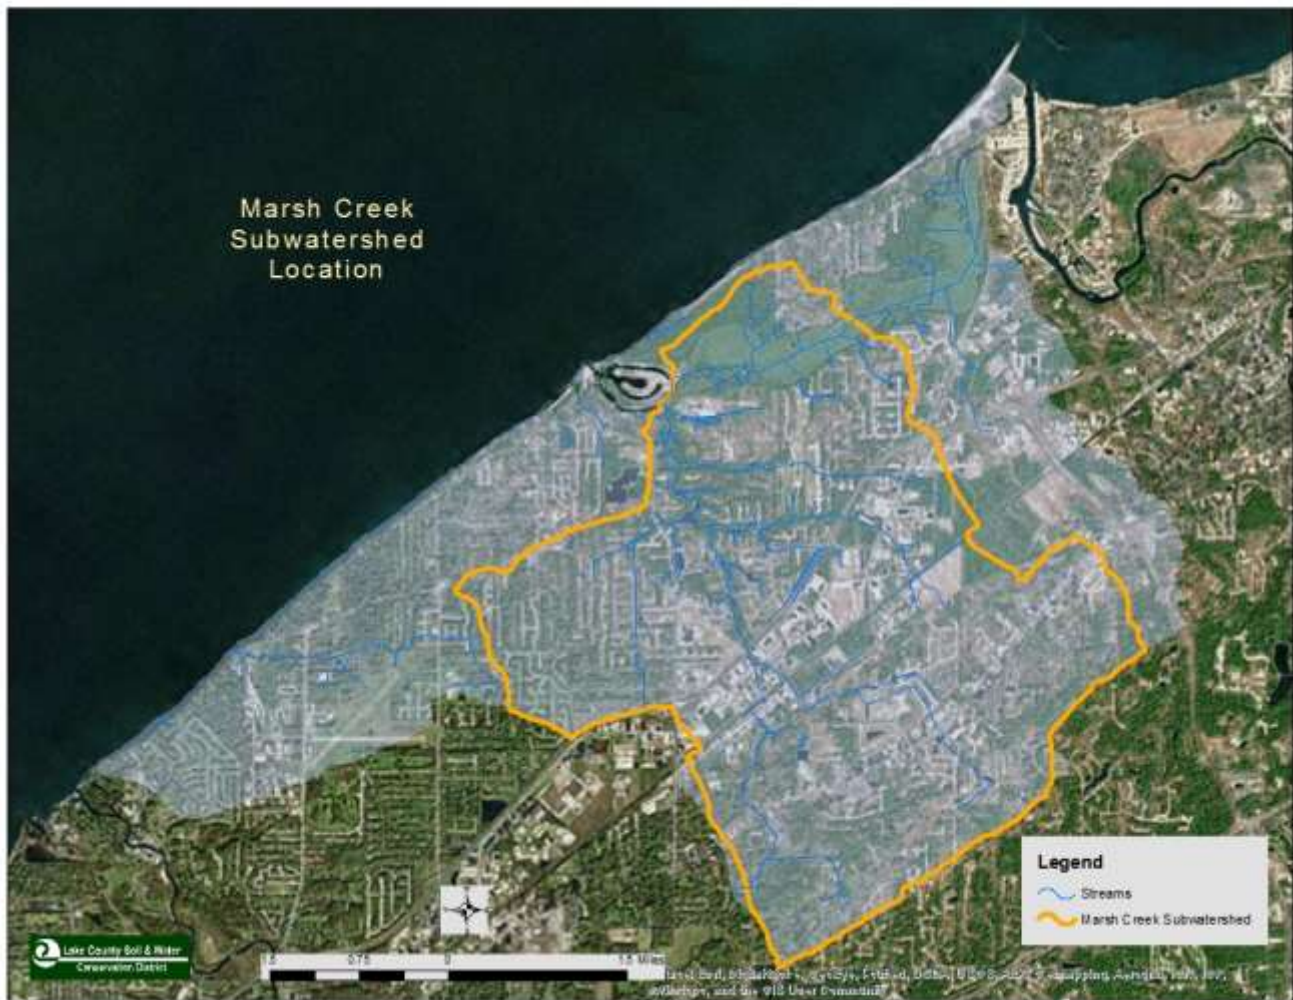
Figure 30: Marsh Creek Subwatershed Location

Marsh Creek drains approximately 10,506 acres or 42.5 square miles. It is located in the central portion of the Marsh Creek-Frontal Lake Erie Watershed (Figure 30). The land use is highly urban, with 53% in residential land uses and 22% in commercial and industrial land uses (Figure 32). The industrial land uses are clustered in the center of the watershed between SR 2 and the railroad tracks. Most of the commercial enterprises are along SR 20, with some in the industrial corridor. The Mentor Marsh, the ancient watercourse of the Grand River, is bisected by the watershed, and approximately 362 acres of the Marsh are in the Marsh Creek Watershed (Figure 31).

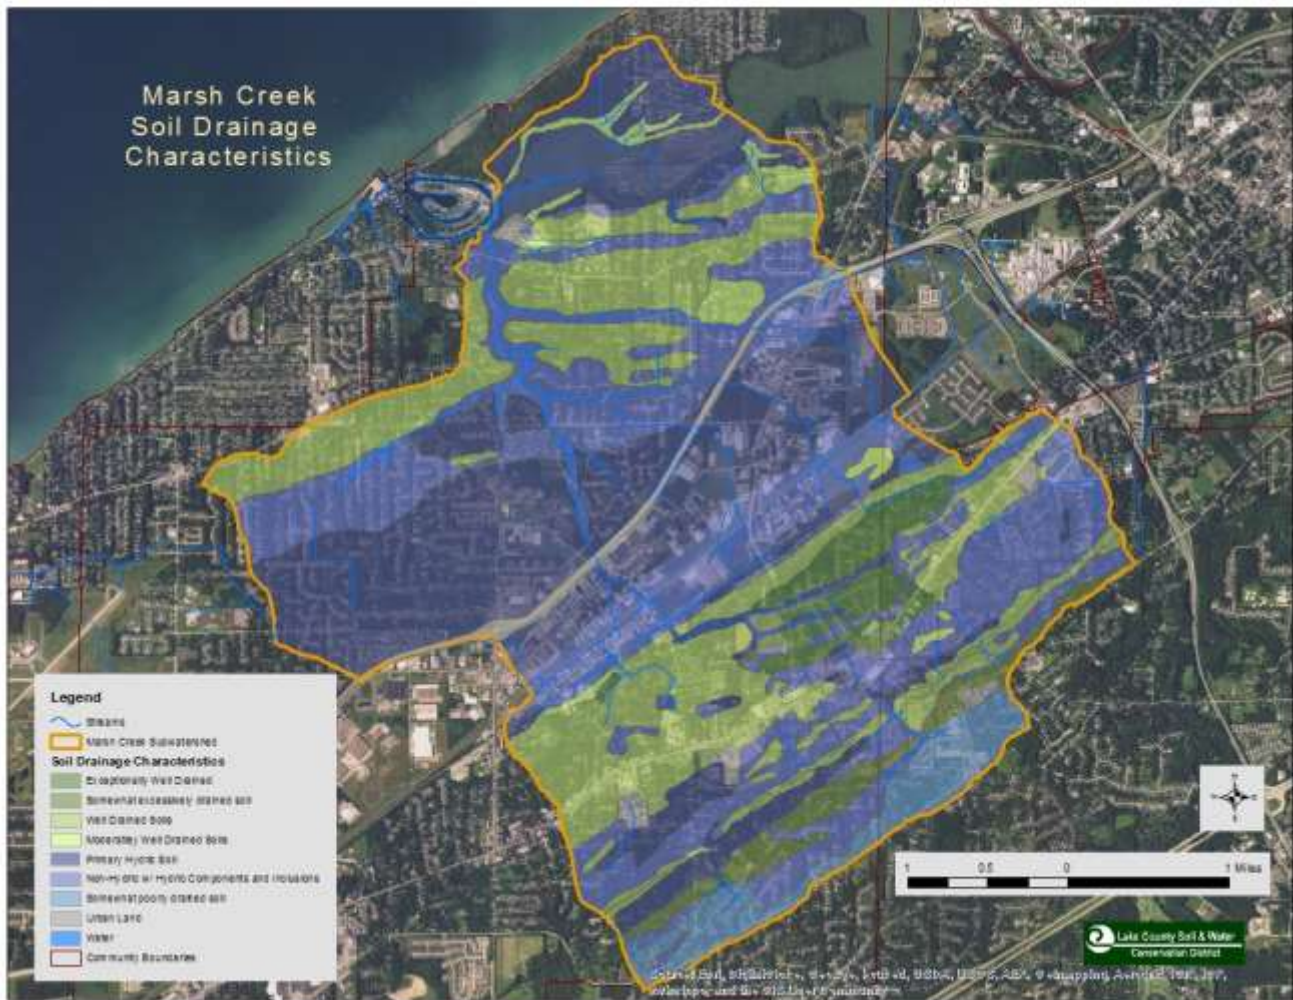
Figure 35: Marsh Creek Subwatershed Soil Drainage Characteristics

31% of the soils have good drainage characteristics, 30% are non-hydric with hydric inclusions and 36% of the soils are hydric, with poor drainage characteristics (Figure 35).

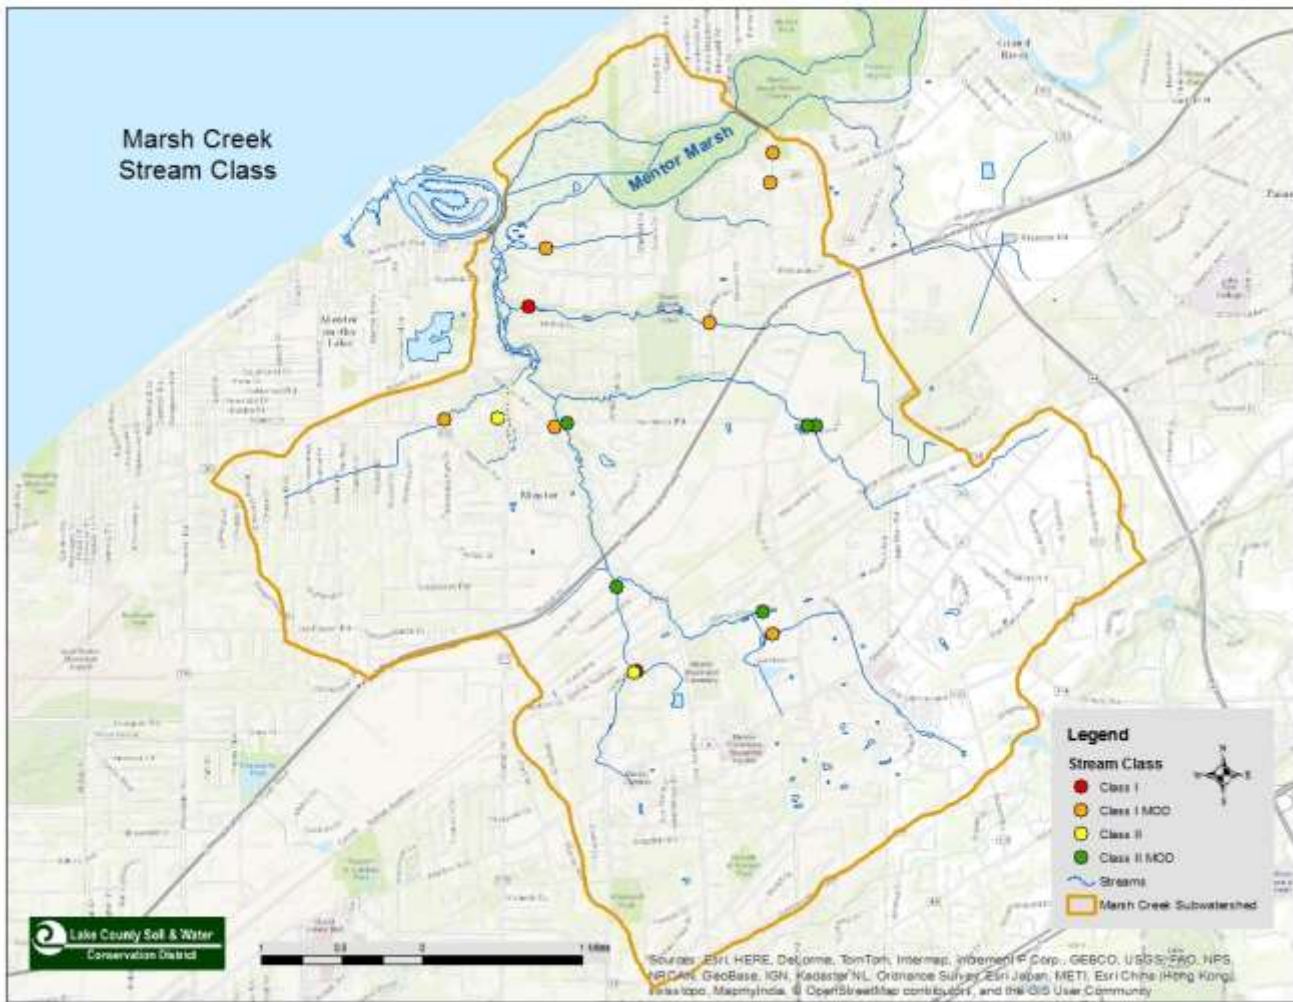
Figure 38: Marsh Creek Subwatershed Stream Class

Lake SWCD collected HHEI data in the Marsh Creek Subwatershed in 2007 (Figure 38). 75% of the sampled streams had been modified, 31% of those were recent with no recovery and 44% were recovering. All streams were Class I or Class II (see Figure 20 and description).
