McKinley Creek-Frontal Lake Erie
HUC-12: 041100030204
Nine-Element
Nonpoint Source Implementation Strategic Plan (NPS-IS Plan)

Approved May 22, 2017

Version 1.0
April 3, 2017

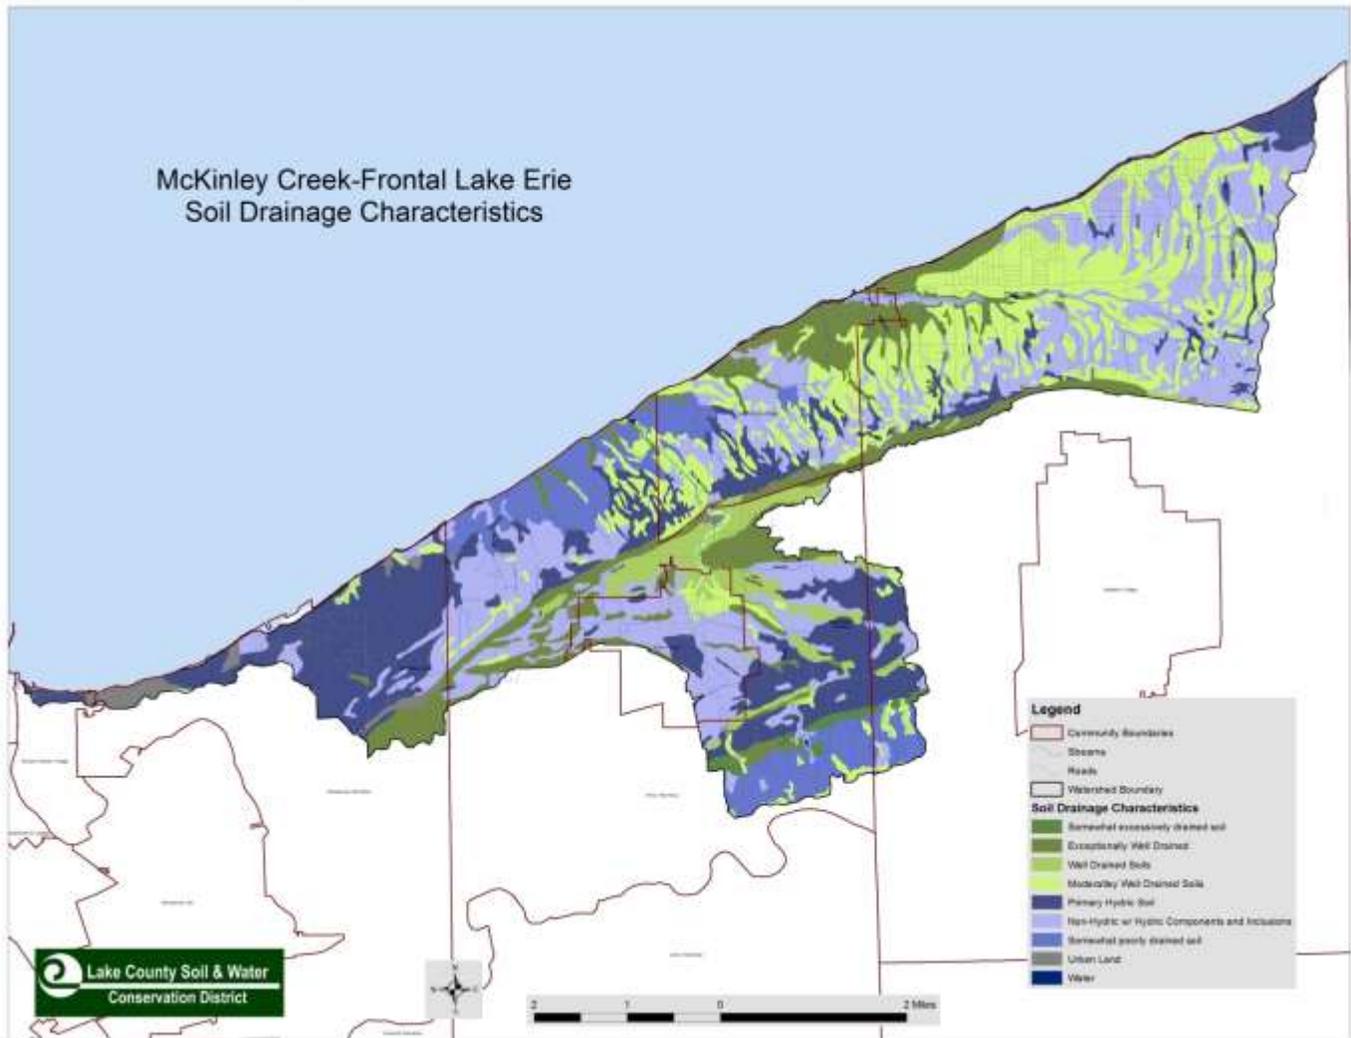
Figure 7. Soil Drainage Characteristics

Hydric soils (in shades of blue, Figure 7) form under prolonged saturated, flooded or ponded conditions and have developed anaerobic (limited oxygen) qualities. They are used to delineate wetlands and are most suitable for non-developed land uses. Many hydric soils have been developed however, and not surprisingly continue to experience wet and flooded conditions.

Soil drainage characteristics information is essential for siting Best Management Practices (BMPs) so that they will work properly. BMPs such as rain gardens and pervious pavers that are based on infiltration are best suited for well drained soils (in shades of green, Figure 7), whereas wetlands and on-site storage BMPs should be utilized in hydric soils.
