Arcola Creek  
HUC-12: 041100030203  
Nine-Element  
Nonpoint Source Implementation  
Strategy (NPS-IS)

**Version 1.0**  
June 13, 2019  
Approved: June 27, 2019

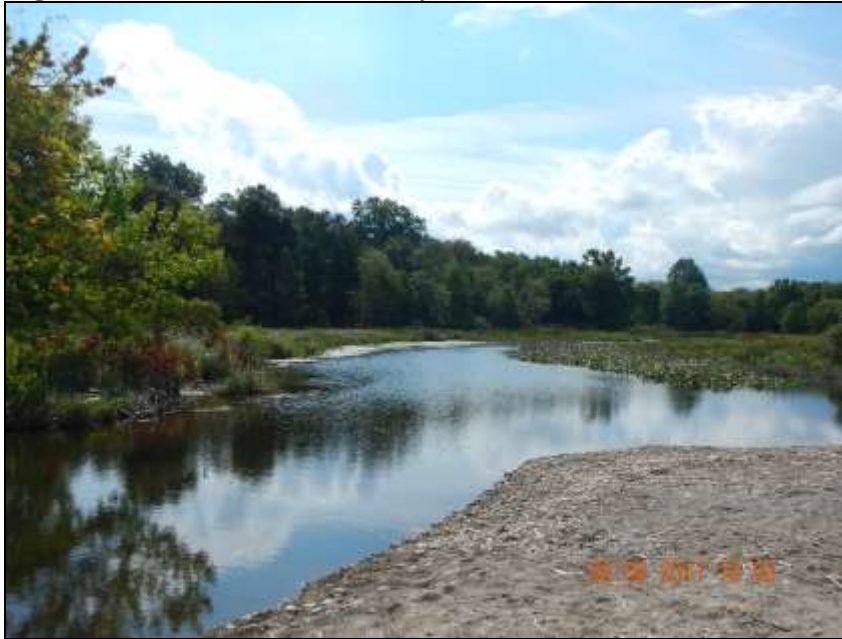
**Figure 6. Arcola Creek Estuary**

The Arcola Creek Watershed includes a marsh and estuary just above the mouth of the river where it empties into Lake Erie (Figure 6). An estuary is a special area where river and lake waters mix in a transition zone to create critical habitat for many plants and animals. The Arcola Creek Estuary is one of only two natural estuaries that remain along the southern shores of Lake Erie in Ohio. The other natural estuary is Old Woman Creek, a National Estuarine Research Reserve near Huron Ohio. Estuaries are some of the most productive ecosystems in the world and are important stopover areas for migrating waterfowl and birds, nurseries for fish, and habitat for numerous species of amphibians.

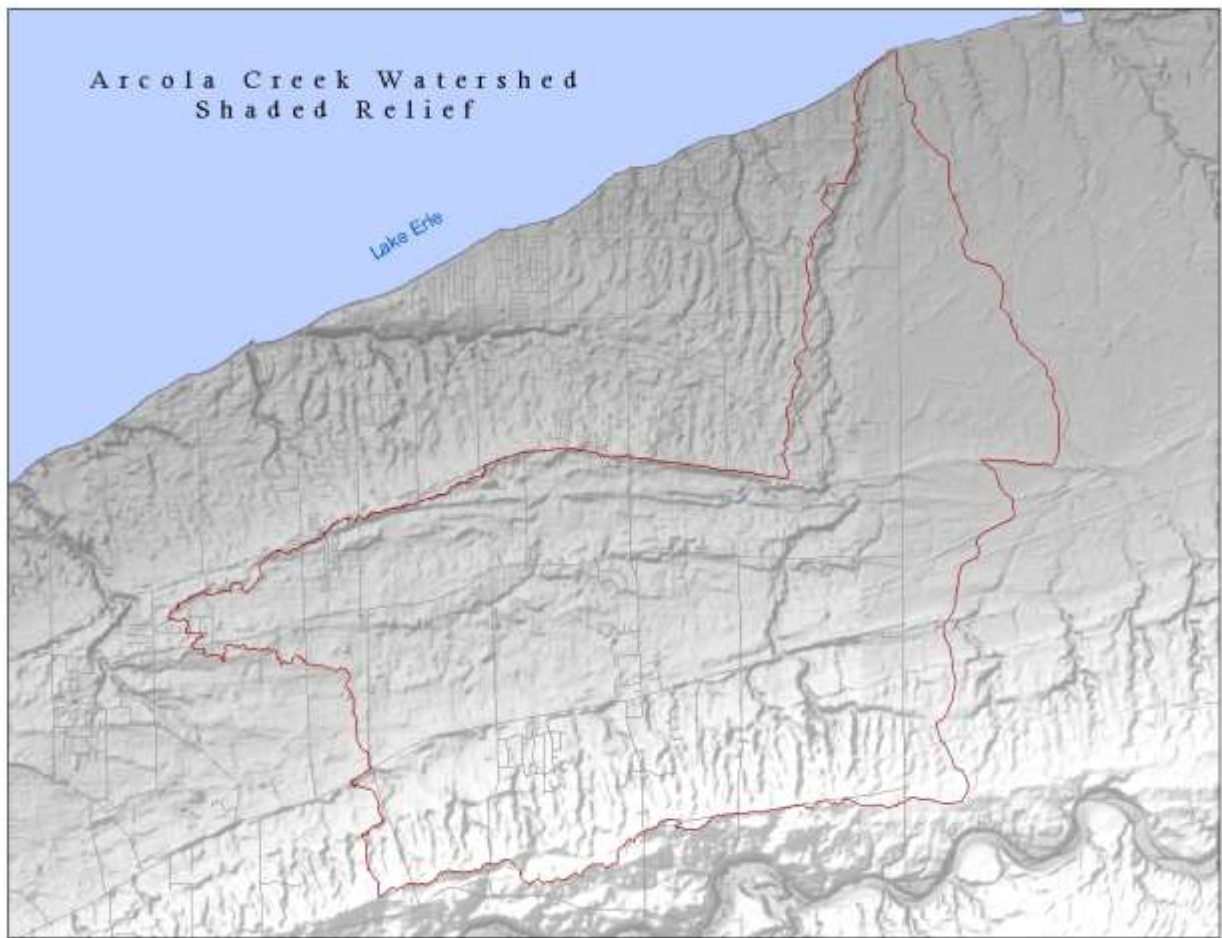
**Figure 8. Topography- Shaded Relief View of Arcola Creek Watershed**

The Arcola Creek Watershed is a part of the glaciated plateau of Ohio and underlain by the Glaciated Plateau to the south and the Lake Plain to the north. The Portage Escarpment delineates the boundary between the two landforms (Figure 8).

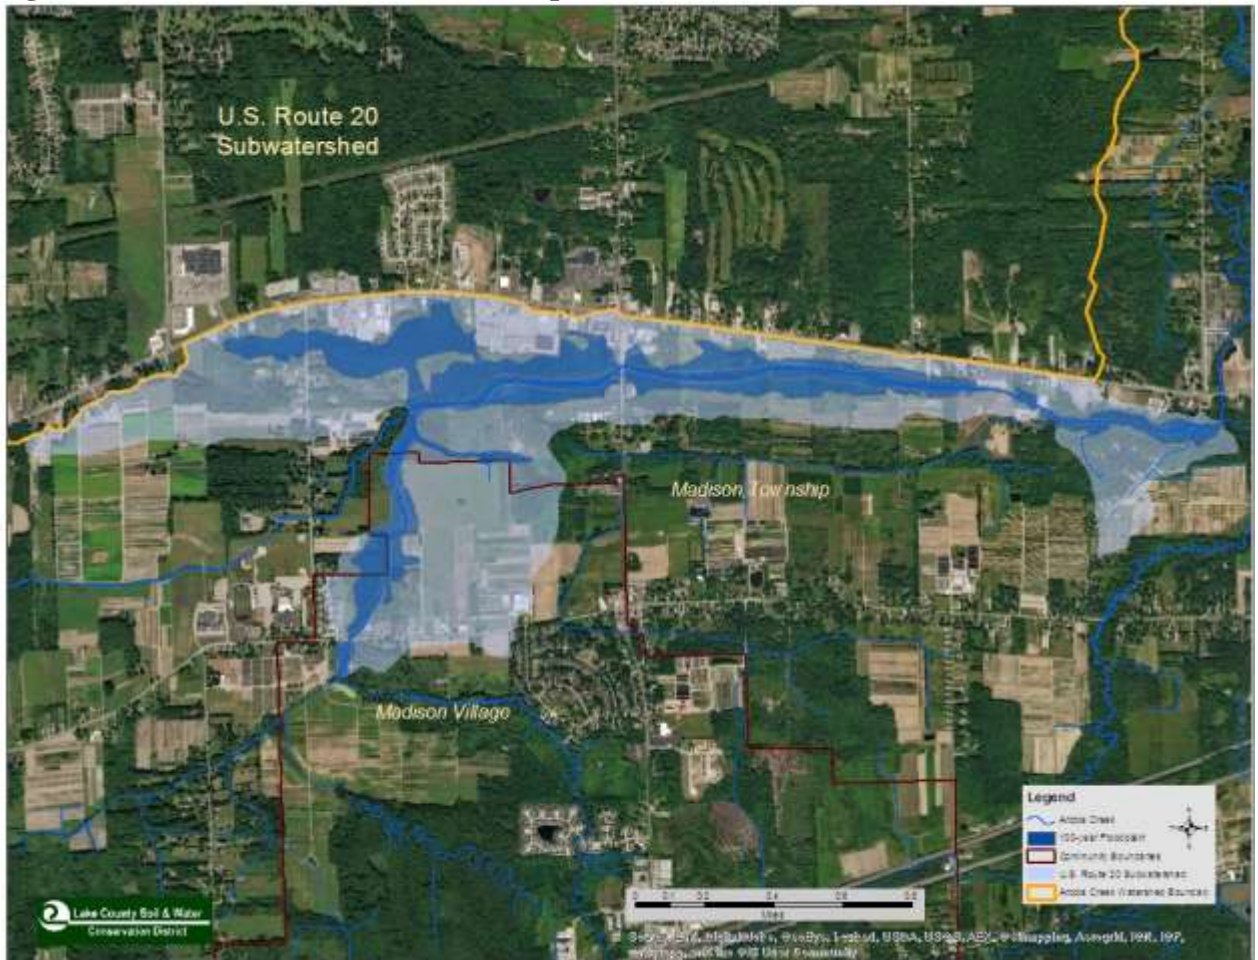
**Figure 32. U.S. Route 20 100-Year Floodplain**

There are extensive areas of 100-year floodplain along the main channel and adjacent to Burns Road (Figure 32). 26.5% of the subwatershed is in the 100-year floodplain. The channel is incised and there is limited access to the floodplain. The channel has been historically modified and dredged spoils have been levied along the channel to increase flood capacity within the channel. Other modifications include over-widening, deepening and straightening, which have resulted in a loss of stream function. On-line ponds have been constructed, further reducing the habitat by increasing average stream temperatures and disrupting the natural hydrology.

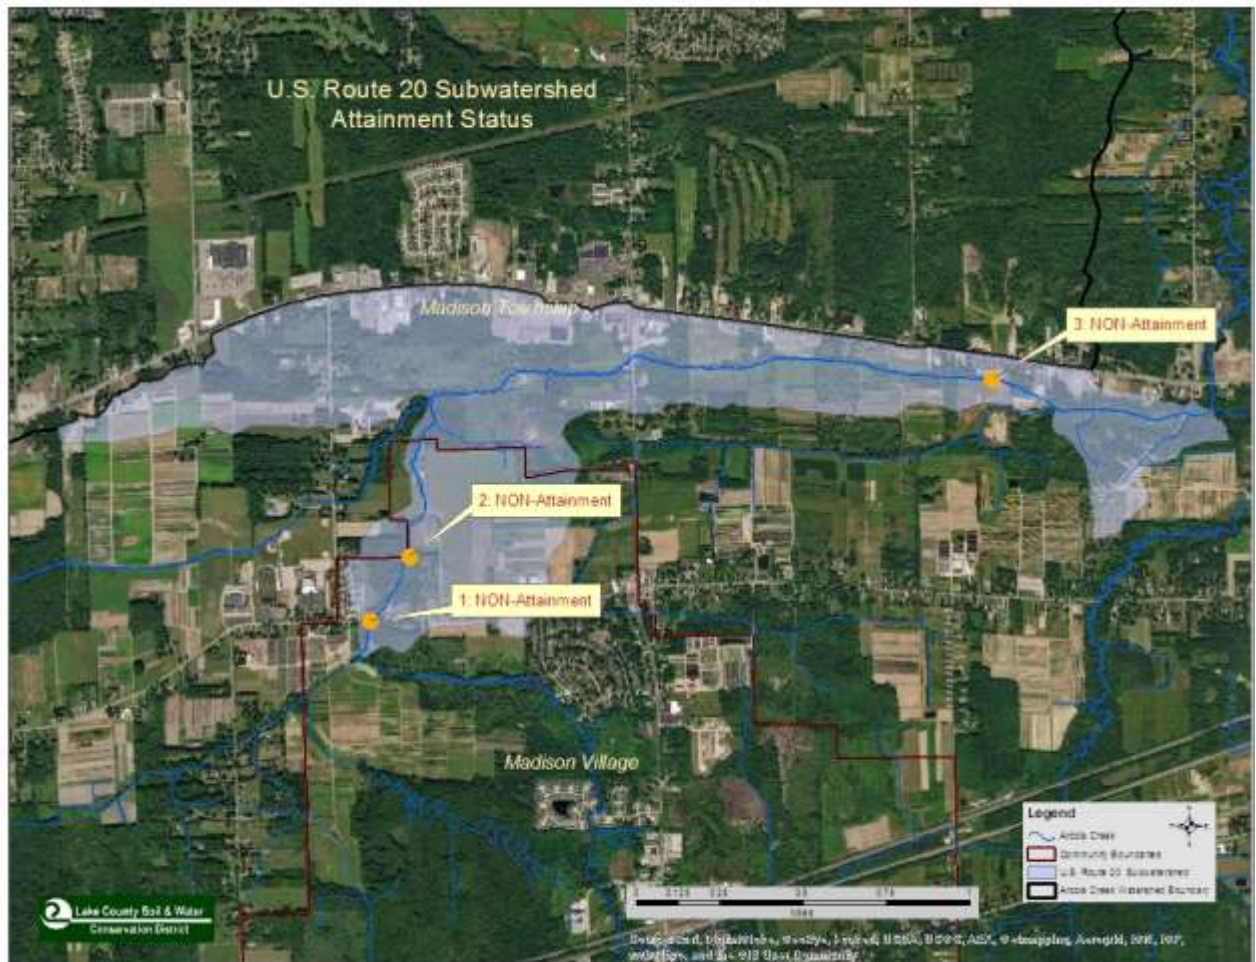
**Figure 36. Critical Area 1 Attainment Status**

The three points sampled by the OEPA in 2015 in the U.S. Route 20 subwatershed (Figure 36) were all in Non-Attainment status of Warmwater Habitat (Figure 35). One QHEI score was Fair (56), and two were Poor (44 and 49); the Index of biotic integrity (IBI) scores were two Fair (30 and 34) and one Poor (26), and the Invertebrate Community Index (ICI) scores were one Fair, one Poor and one Good (38) (Figure 35).

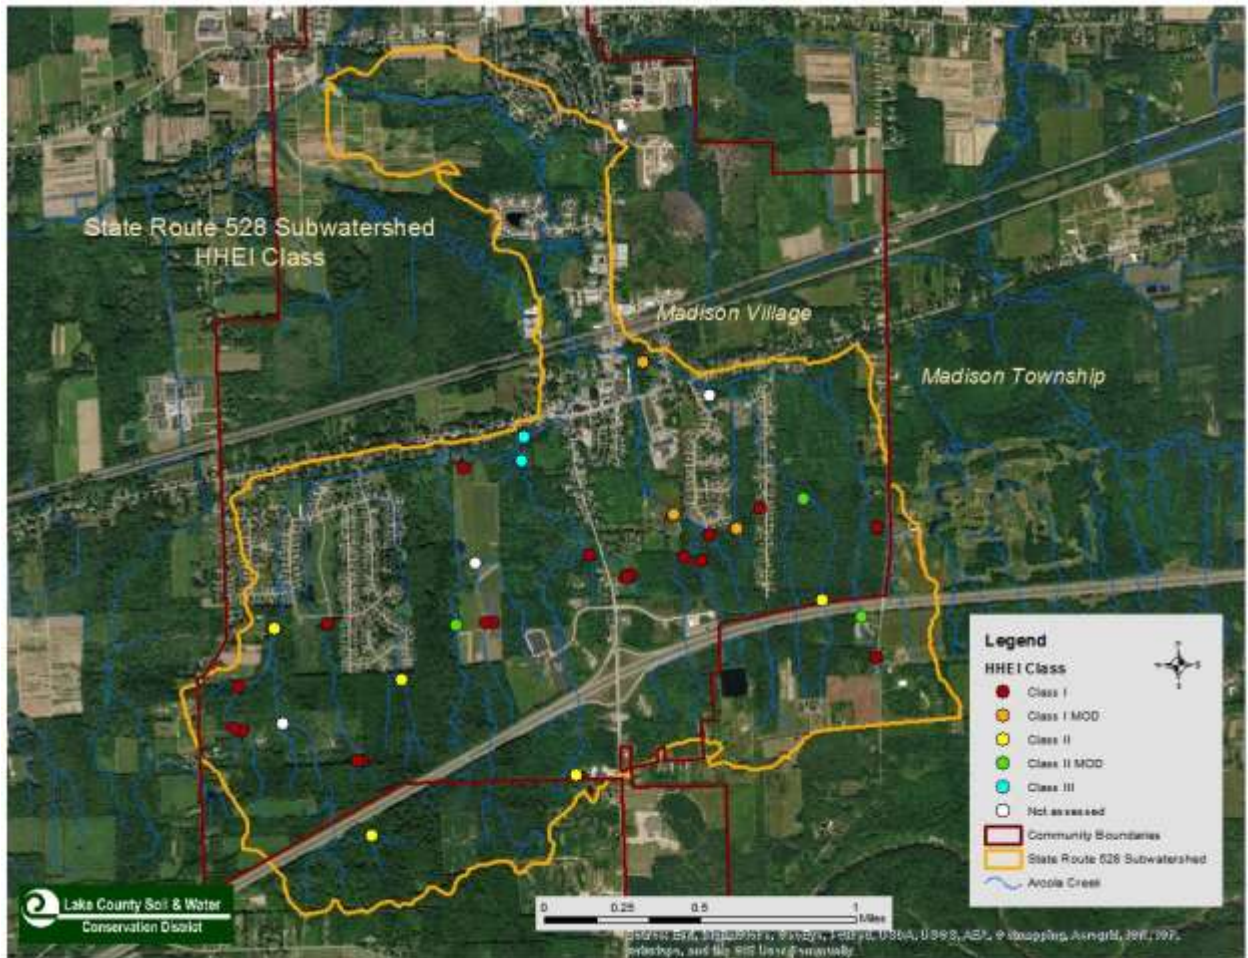
**Figure 46. State Route 528 HHEI Stream Class**

By HHEI class, **67.7%** are Class I; **25.8%** are Class II and **6.5%** are Class III (Figures 45 and 46). By HMFEI class, **91%** are Class I; **3%** are Class II and **6%** are Class III (Figures 47 and 48).

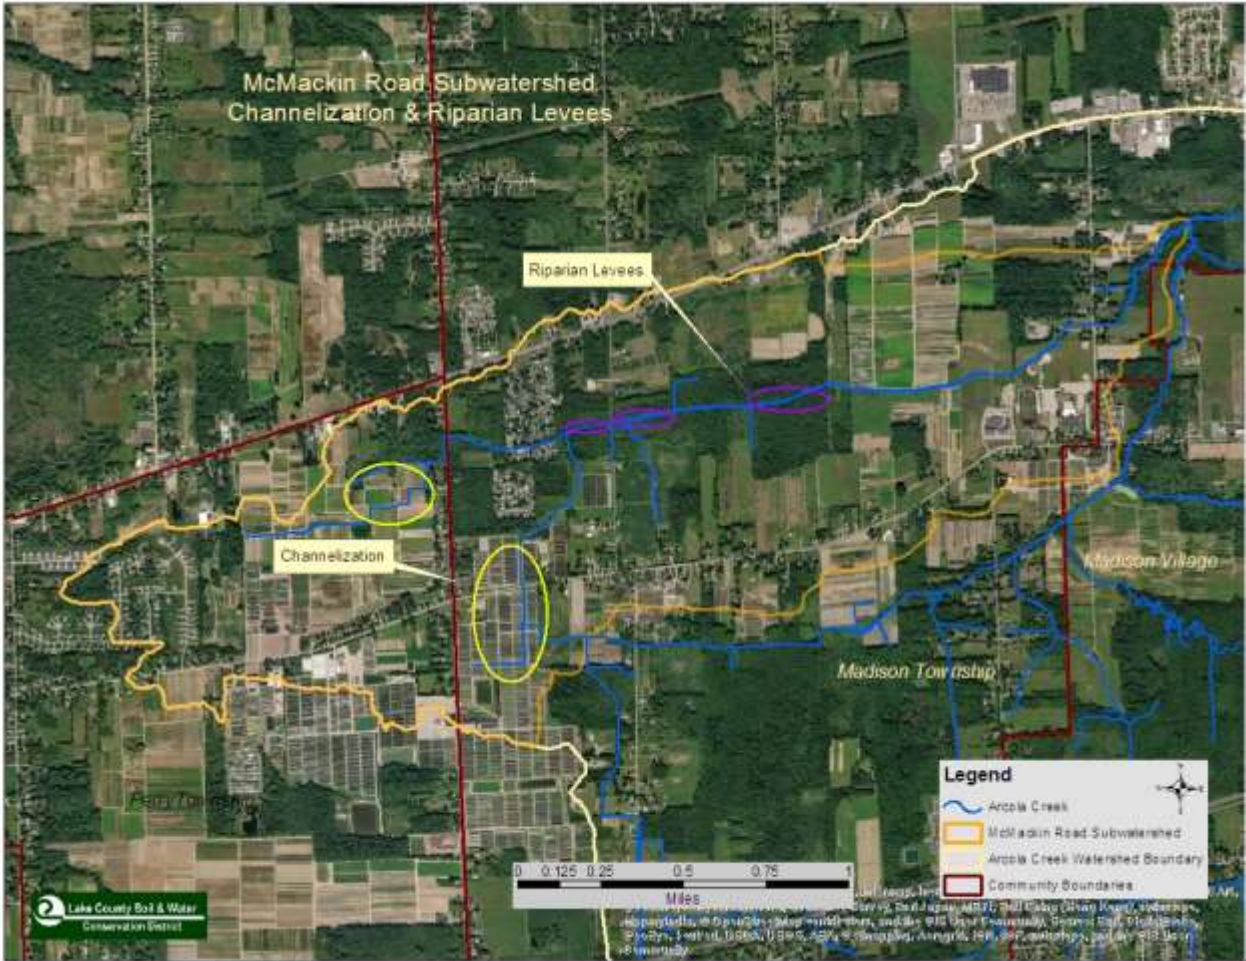
Figure 53: Channelization and Riparian Levees

Areas of channelization can be easily identified from the map as the straight and right-angled lines (Figure 53). Some areas where the channels were cleaned prior to the creation of the Lake County Stormwater Management Department (SMD) have had the spoils mounded on the channel banks. These areas have been identified by the SMD as being in the McMackin subwatershed east and west of where the Arcola crosses McMackin Road (Figure 53). This area, known locally as McMackin Ditch has been notorious for slow moving flow. The spoil areas have been there so long that large trees are growing in it, restricting the flow on the north side of the channel.

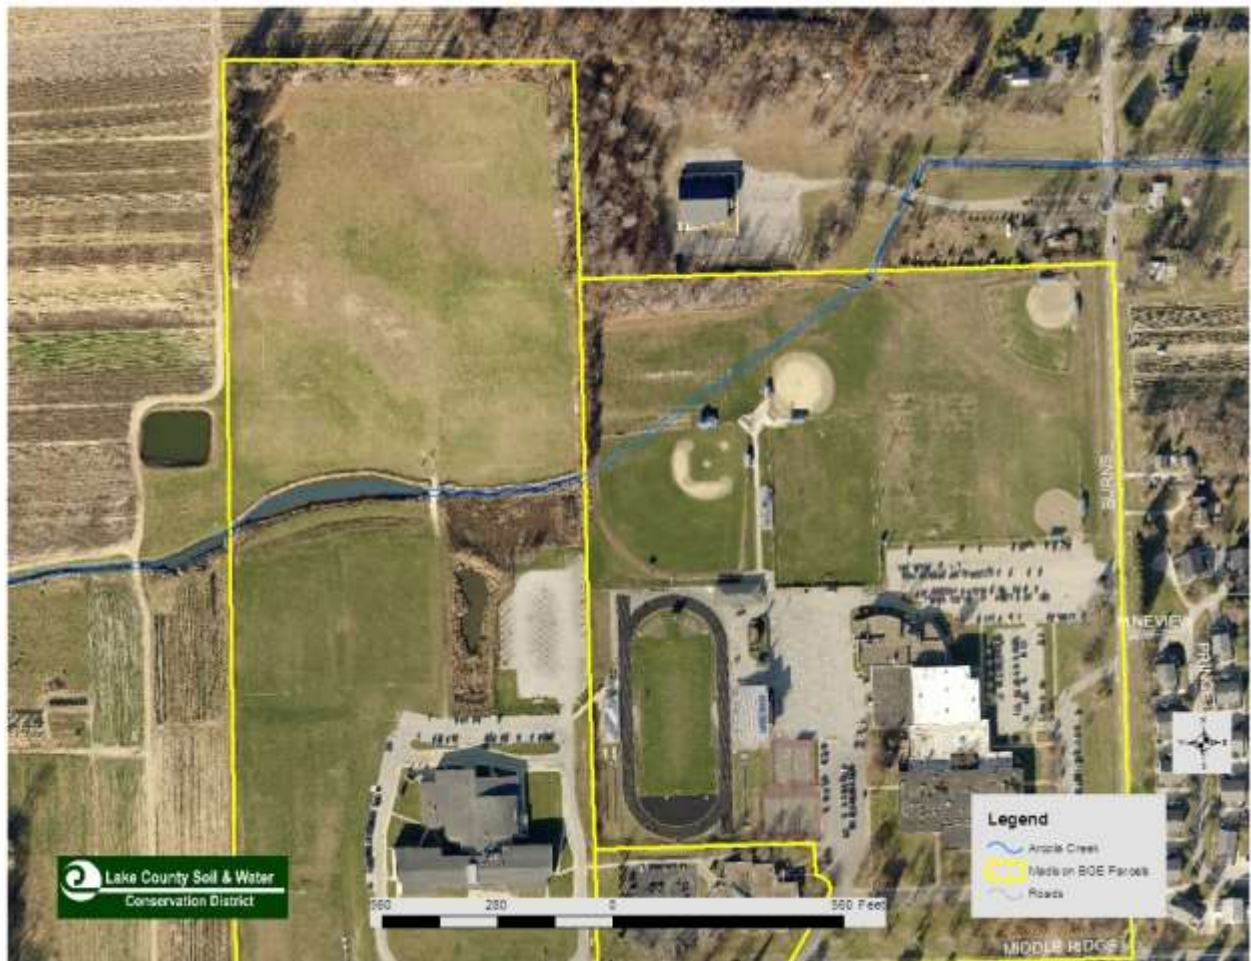
**Figure 58. Madison BOE Property**

Arcola Creek has been impacted by channel modifications in this subwatershed, by straightening, relocating and ditching. It has been buried to make room for baseball fields on the Madison High School (Madison Board of Education or BOE) property (Figure 58) and widened to provide irrigation water for a former nursery. The HHEI score at that location is 42, which is “poor”. The property is close to the confluence of all three Critical Areas (Figure 59). Daylighting of Arcola Creek by relocating it around the ball fields and restoring the channel morphology will greatly improve its hydrological function.
