Big Creek  
HUC-12: 041100040606  
Nine-Element  
Nonpoint Source Implementation Strategy (NPS-IS)

Version 1.2  
March 9, 2020  
Approved: April 1, 2020

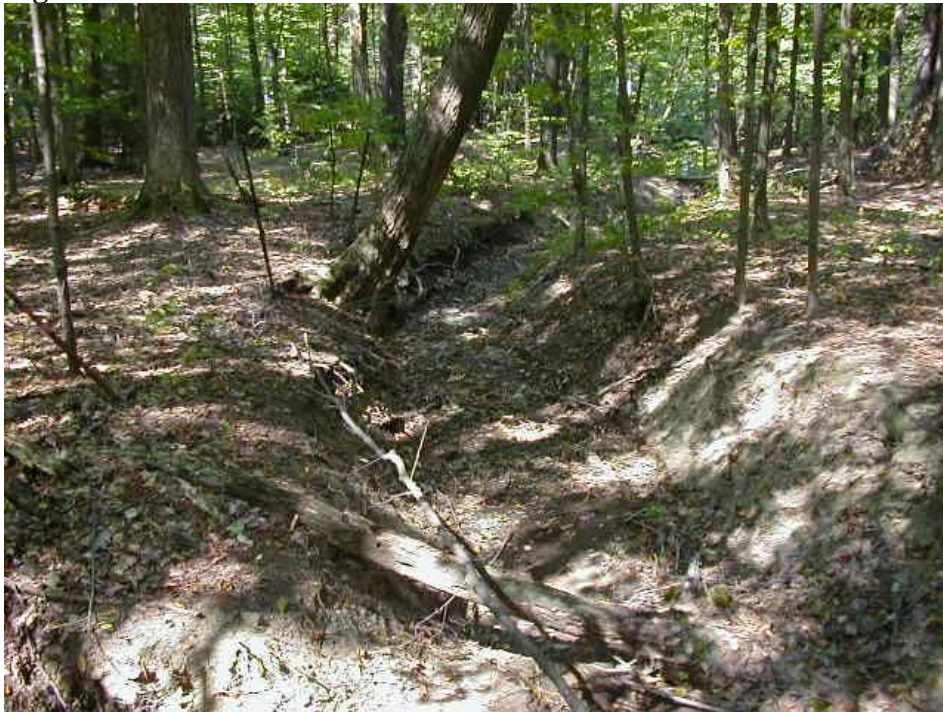
**Figure 21. Class I Stream in East Creek Subwatershed**

recent with no recovery. Figures 21, 22, 23 and 24 illustrate different stream classifications within the watershed.

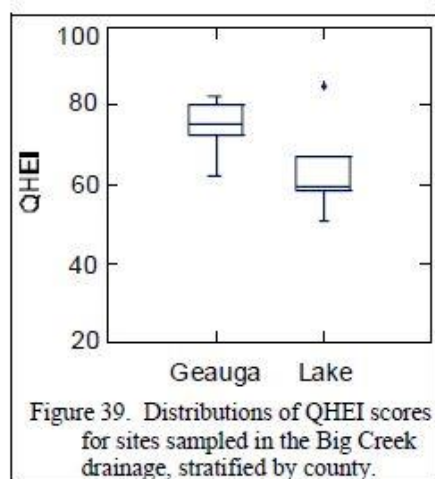
**Figure 35. Aquatic Life Use Attainment for the Big Creek Subwatershed, 2003**

The aquatic life use attainment from 2003 is shown below (Figure 35). The EPA uses the Index of Biotic Integrity (IBI), Modified Index of Well-being (MIwb) and Invertebrate Community Index (ICI) as measures of aquatic life use. The Qualitative Habitat Evaluation Index (QHEI) is also used as a measure of the ability of the physical habitat to support a biotic community. The thresholds for attainment are shown in Figure 36.

River Mile	IBI	MIwb	ICI	QHEI	Status	Causes	Sources
16.2/16.1	58	--	22	62.0	Partial	Habitat Alteration	Urban Runoff
16	52	--	28	82.0	Partial		Urban Runoff
14/13.8	40	--	44	75.0	Full		
9.3/9.5	48	--	--	85.0	Full		
4.9/4.8	38	7.9	50	66.5	Full		
2.5/2.7	44	7.1	54	50.5	Partial	Natural Limits

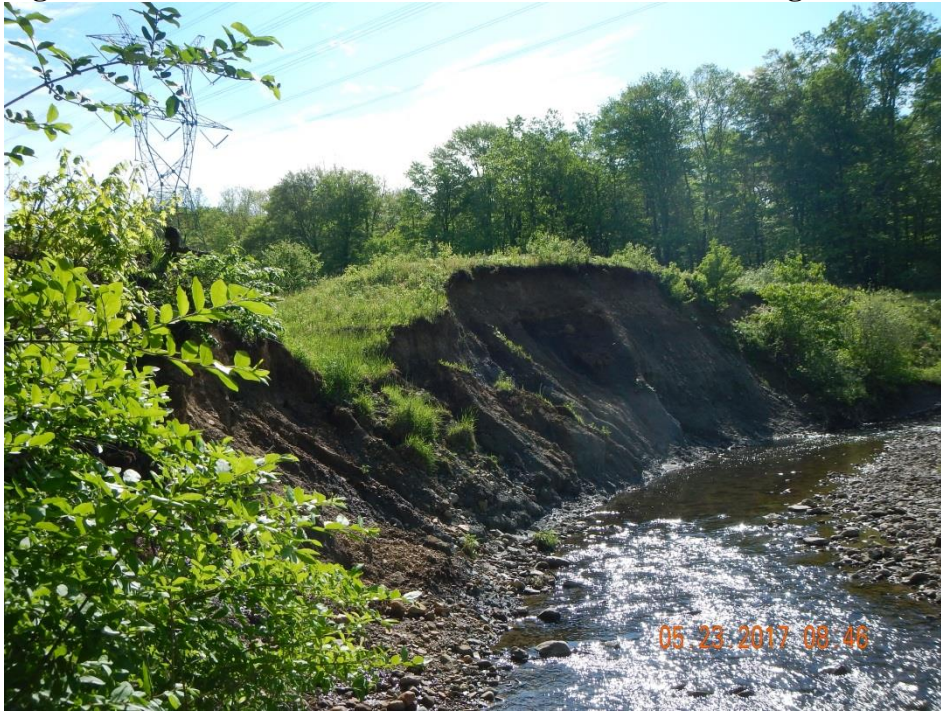
**Figure 37. Streambank Erosion and Sedimentation on Big Creek**

The stormwater runoff volume has caused streambank erosion, channel scour and bank failure in the headwaters as channels resize (Figure 37) and sedimentation is evident (Figure 38). Channel armoring has been installed in several locations to reduce the channel degradation (Figure 39).
