BRIDGE INSPECTION REPORTS

VROOMAN ROAD BRIDGE OVER THE GRAND RIVER

**SFN 4337107
LEROY TOWNSHIP
LAKE COUNTY, OHIO**

December, 2002

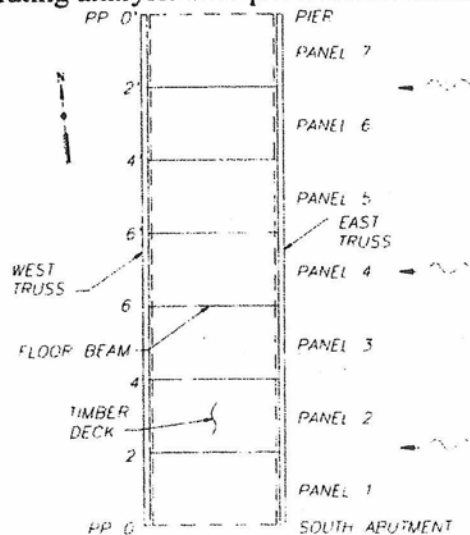
Figure 1 - Span 1 Framing Plan & Member Identification
(Span 2 similar)

As defined by the National Highway Institute, the lower chord and diagonal segments in tension are classified as fracture critical members. Though the floorbeams are spaced less than 14 feet, they are considered as being fracture critical because the floor system above does not consist of continuous span stringers.

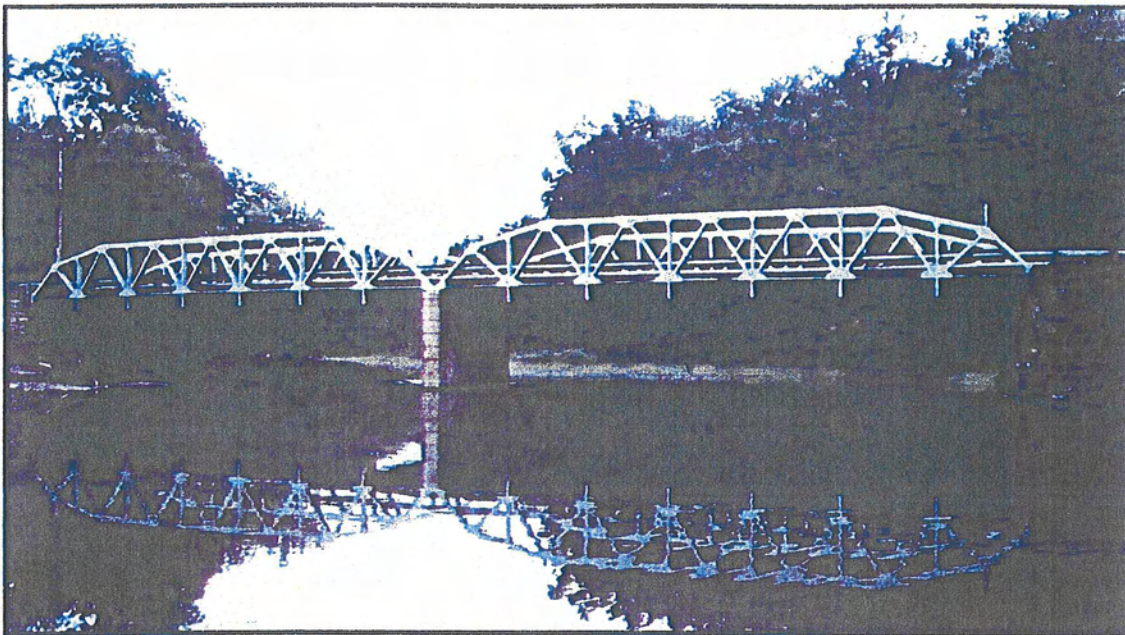
Photo 1 – West Elevation

The Vrooman Road Bridge (SFN 4337107) crosses the Grand River on the border between Perry Township and Leroy Township, 0.2 miles south of South Ridge Road (State Route 84). It is two-span steel Warren polygonal pony truss structure built in 1951. Each span is approximately 88'-4" center-to-center of truss bearings, with an overall structure length of 179'-4 1/2". The trusses are spaced 23'-0" center-to-center. A galvanized steel guardrail is attached to the interior of the truss verticals. The bridge is posted with a 24-ton load limit. Photos 1 and 2 show the Elevation and End Views respectively.

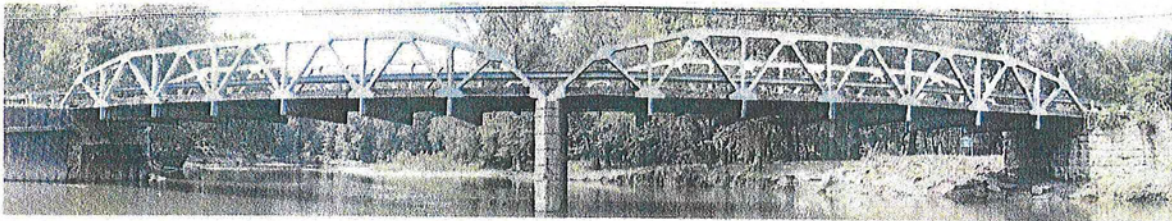
The Vrooman Road Bridge (SFN 4337107) crosses the Grand River on the border of Perry and Leroy Townships in Lake County. The bridge carries two lanes of traffic. The structure consists of two single span Warren pony trusses on wall-type masonry abutments and a wall-type reinforced concrete pier. (See Picture #1.) The welded steel trusses were built in 1952 by the Ohio Bridge Company. The structure was inundated by the recent flooding of the Grand River in late July. Large amounts of debris from the flood was entangled with the superstructure and trapped against the substructure. The bridge is posted with a 16-ton load limit. The bridge has been closed to highway traffic since the high water event.

Picture #1 - Looking downstream at bridge.
