Mentor Marsh Watershed Impairments and Problems

Summary

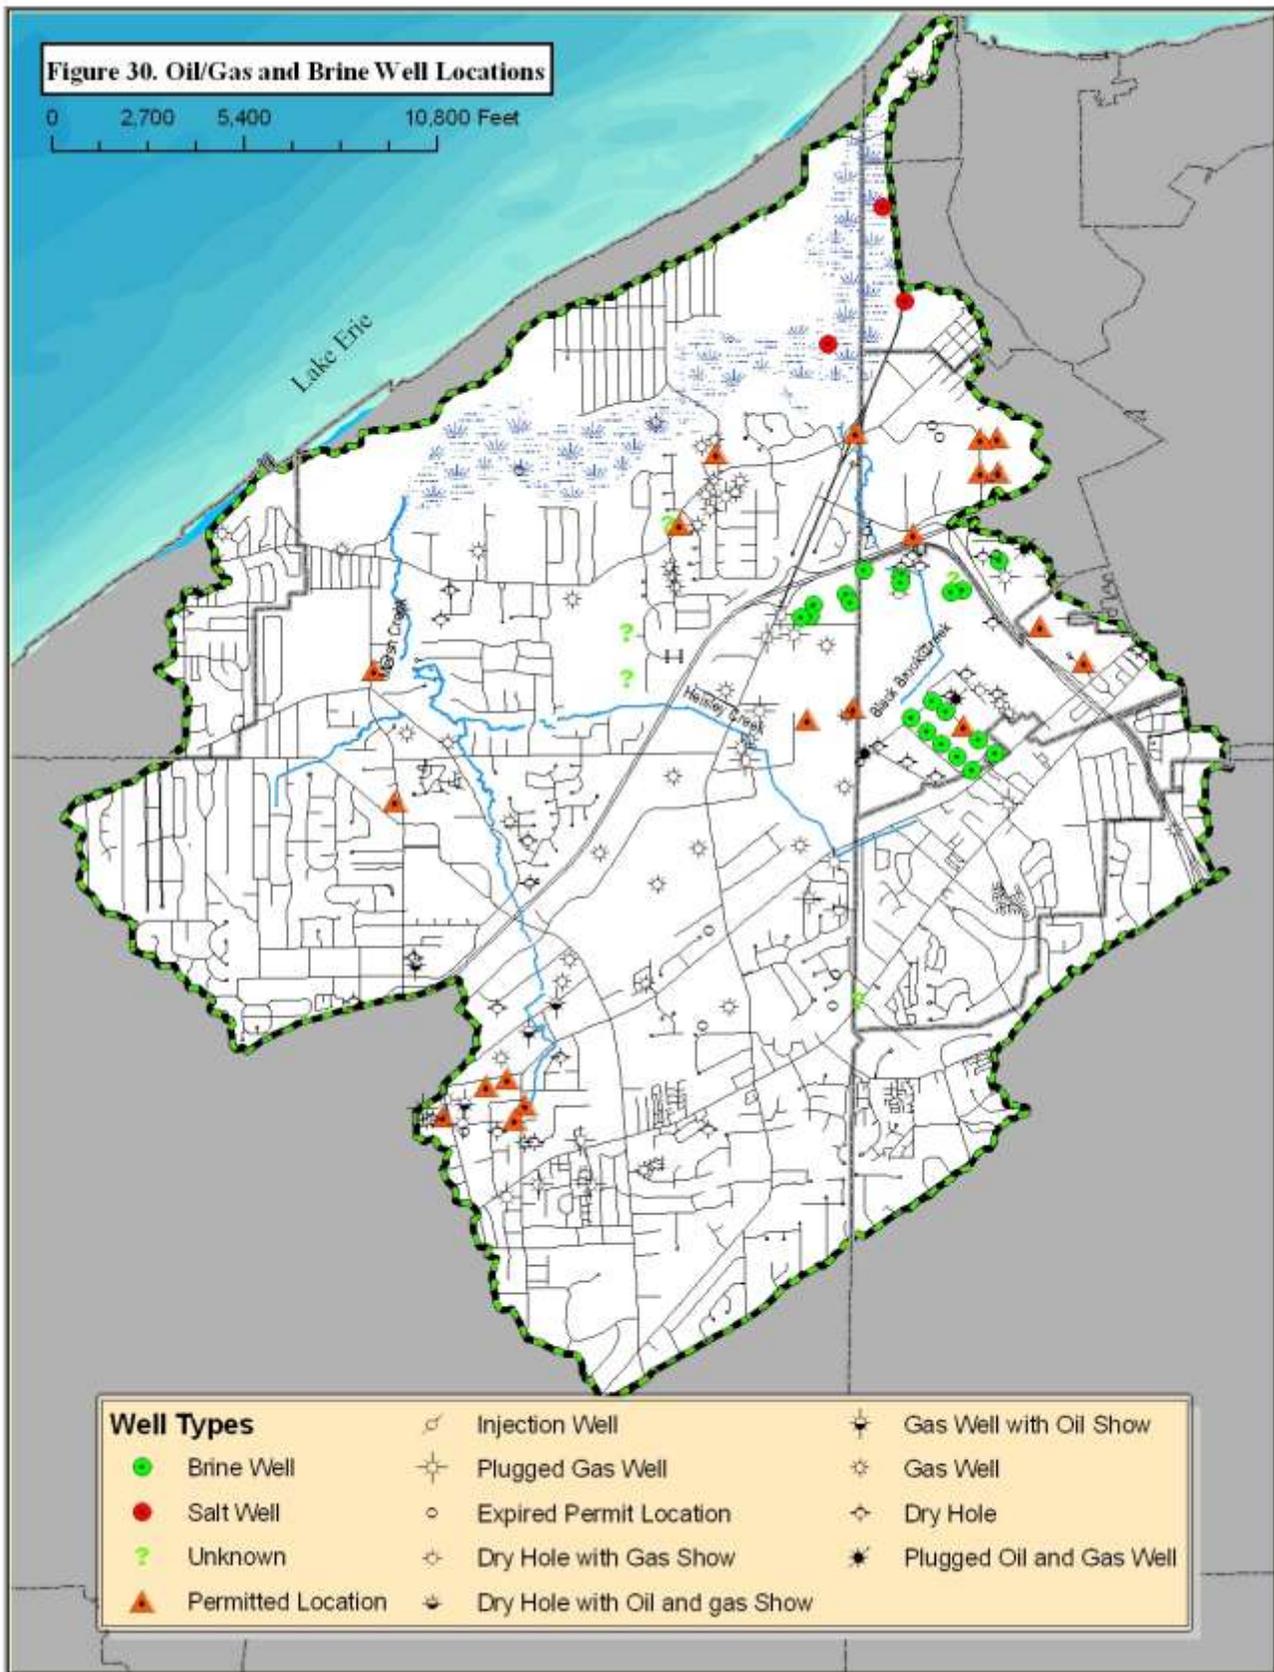
Figure 30. Oil/Gas and Brine Well Locations

Figure 30 shows the location of the oil and gas wells in the watershed. Figure 31 shows the location of the salt landfill along the mouth of Blackbrook Creek
