Paine Creek
HUC-12: 041100040604
Nine-Element
Nonpoint Source Implementation
Strategy (NPS-IS)

Version 1.0 Draft
December 10, 2019

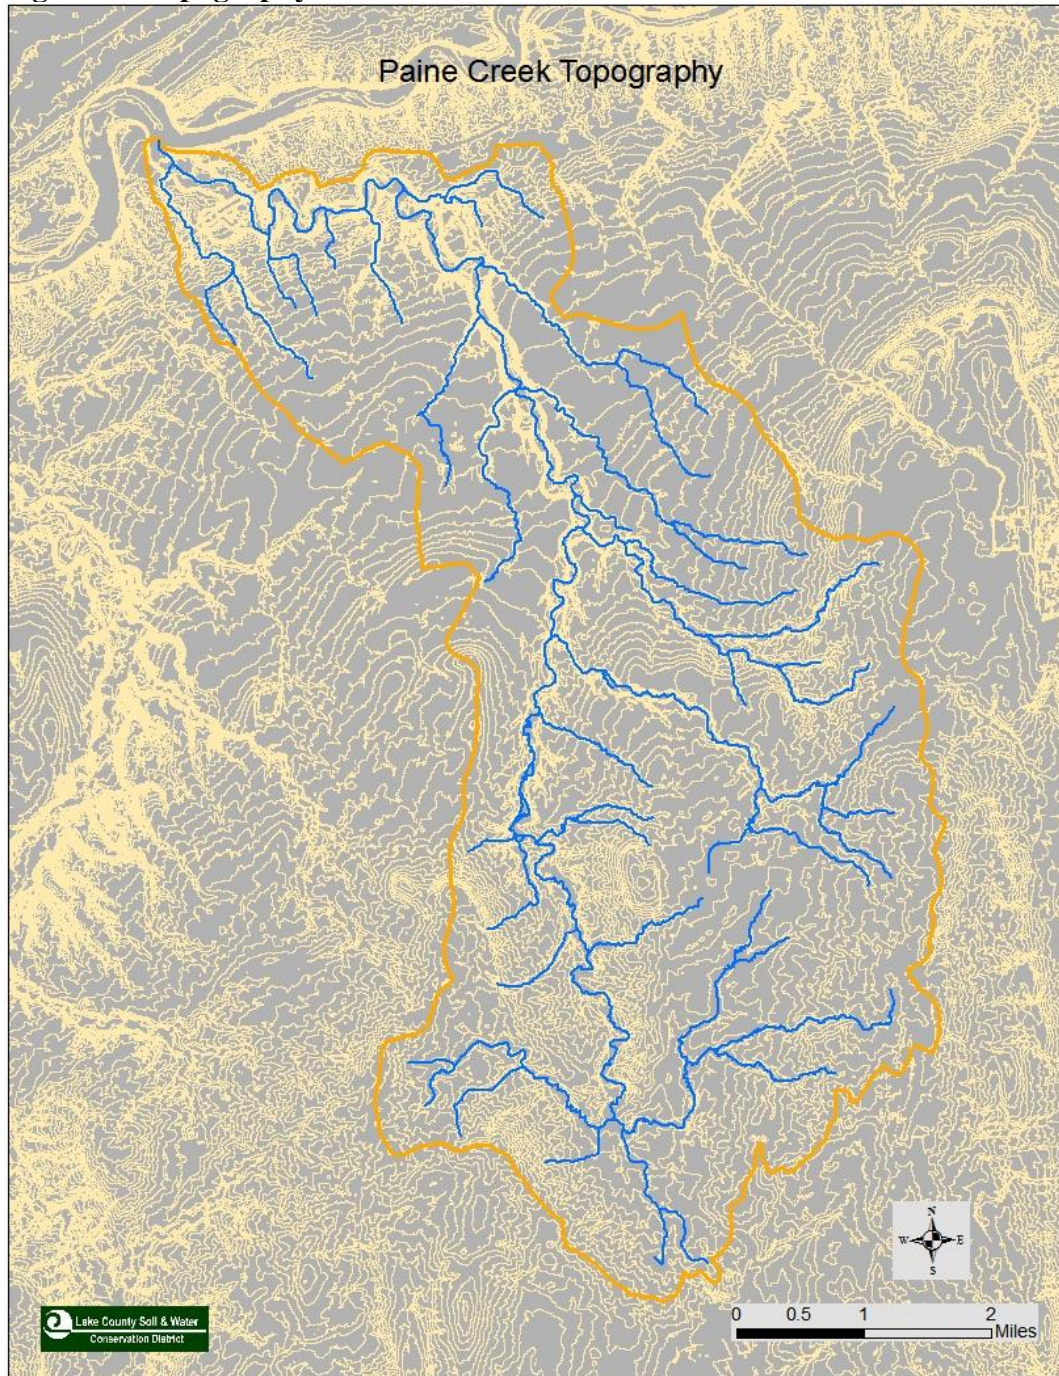
Figure 5. Topography

The Paine Creek Watershed's elevation ranges from 1310 feet in the headwaters to 640 feet where it empties into the Grand River mainstem (Figures 5 and 6). It is located in the Allegheny Plateau physiographic region, which is characterized by mid-elevation hills separated by numerous narrow stream-cut valleys, and an abundance of rivers and streams. The watershed is at the northernmost extent of the Allegheny Plateau; the Lake Plain region begins at the mouth of Paine Creek. This region of the Plateau was glaciated.

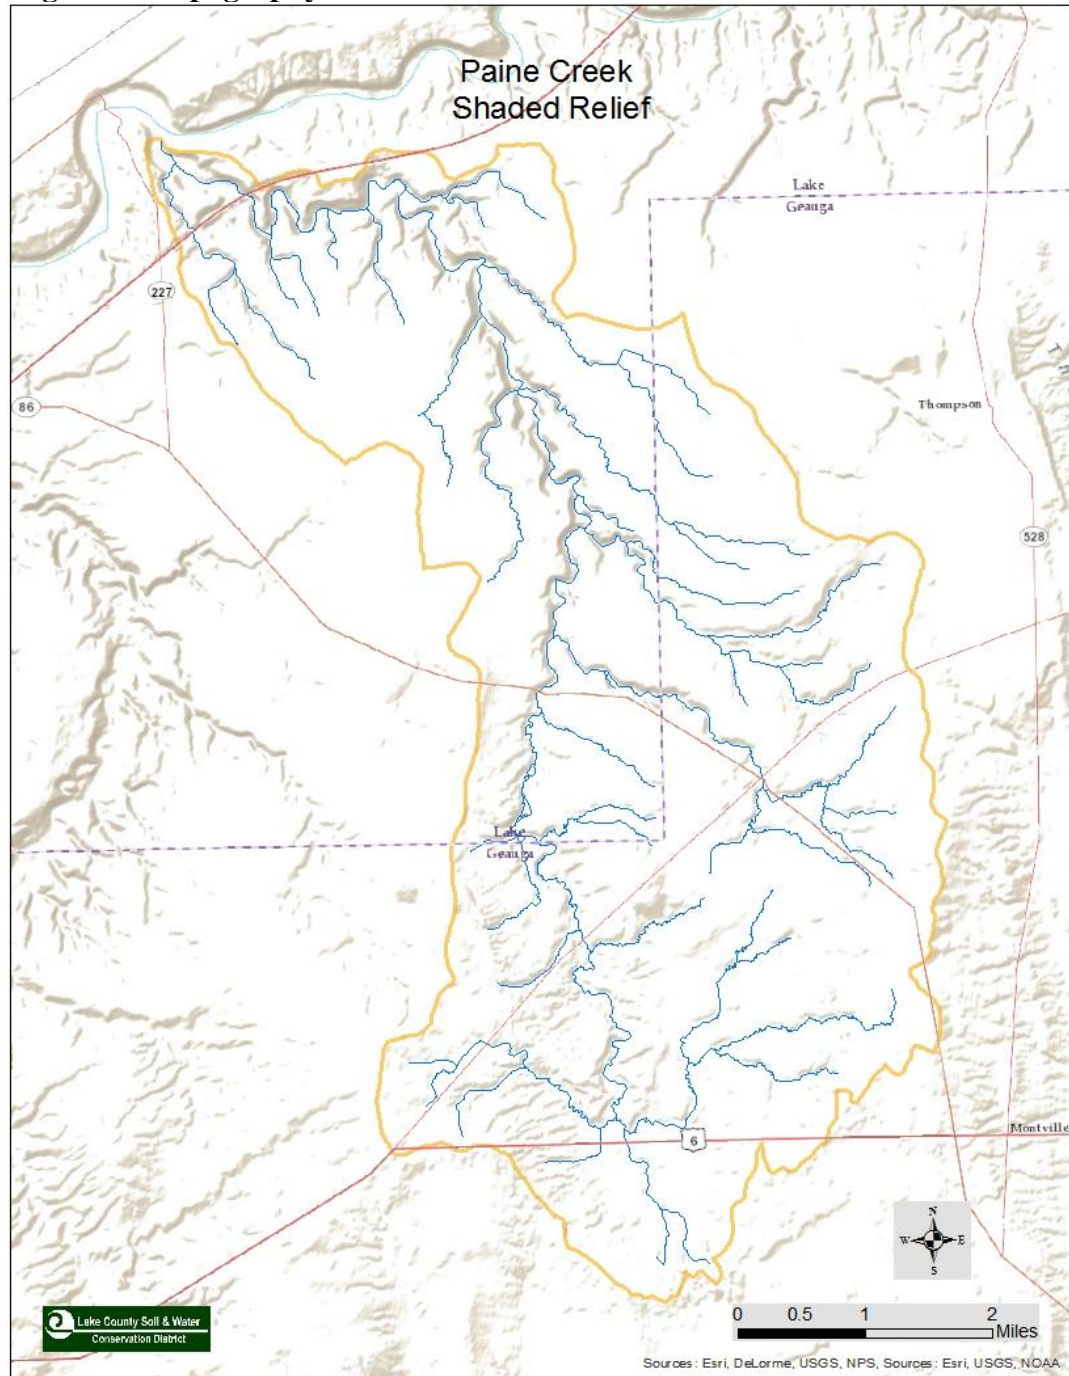
Figure 6. Topography- Shaded Relief View

The majority of the watershed area is ground moraine, which is flat to gently undulating. There are hummocky ridges in the headwaters area in between the ground moraine features. The hummocky ridges can be clearly seen in the shaded relief map (Figure 6). The end moraine features are at the lower end of the watershed, along with deposits in present and former floodplains at the lowest stretch of Paine Creek.

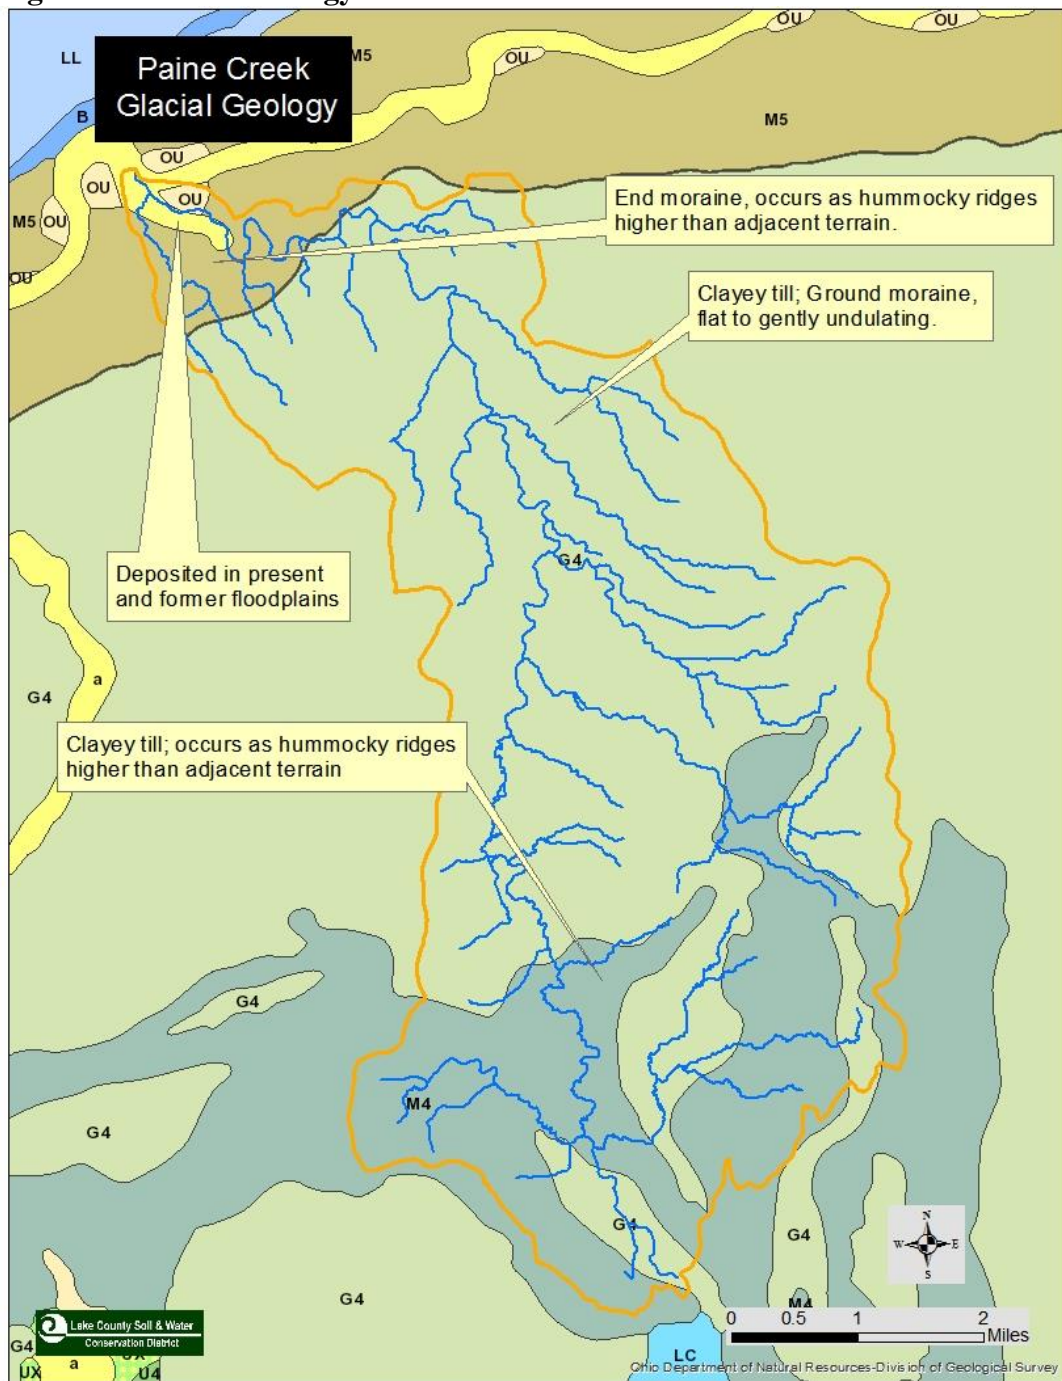
Figure 7. Glacial Geology

Four glacial features are found in the watershed (Figure 7):

1. End moraine
2. Ground moraine
3. Deposits in present and former floodplains

4. Hummocky ridges

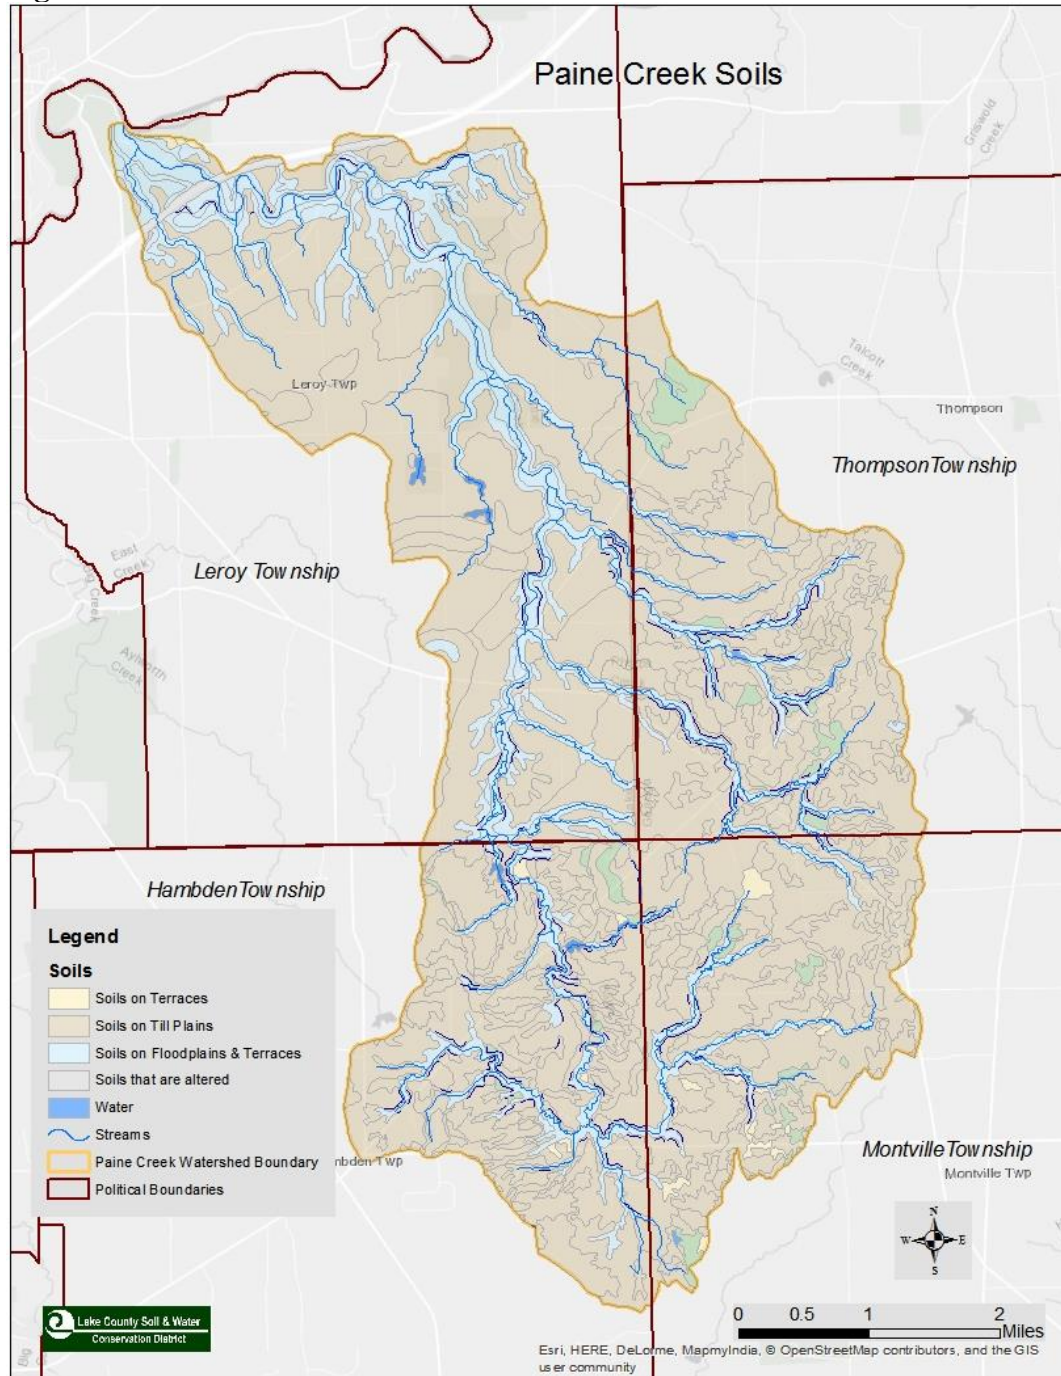
Figure 8. Soils

The soils in the watershed (Figure 8) reflect the glacial history of the region and can be divided into five categories:

1. Soils on till plains
2. Soils on floodplains
3. Soils on terraces
4. Soils on hills
5. Soils that have been altered

The largest area in the watershed is comprised of soils on till plains, followed by soils on floodplains. Soils on terraces and hills are nominal, and the small area of soils that have been altered is associated with Interstate-90 in the northwest portion of the watershed.

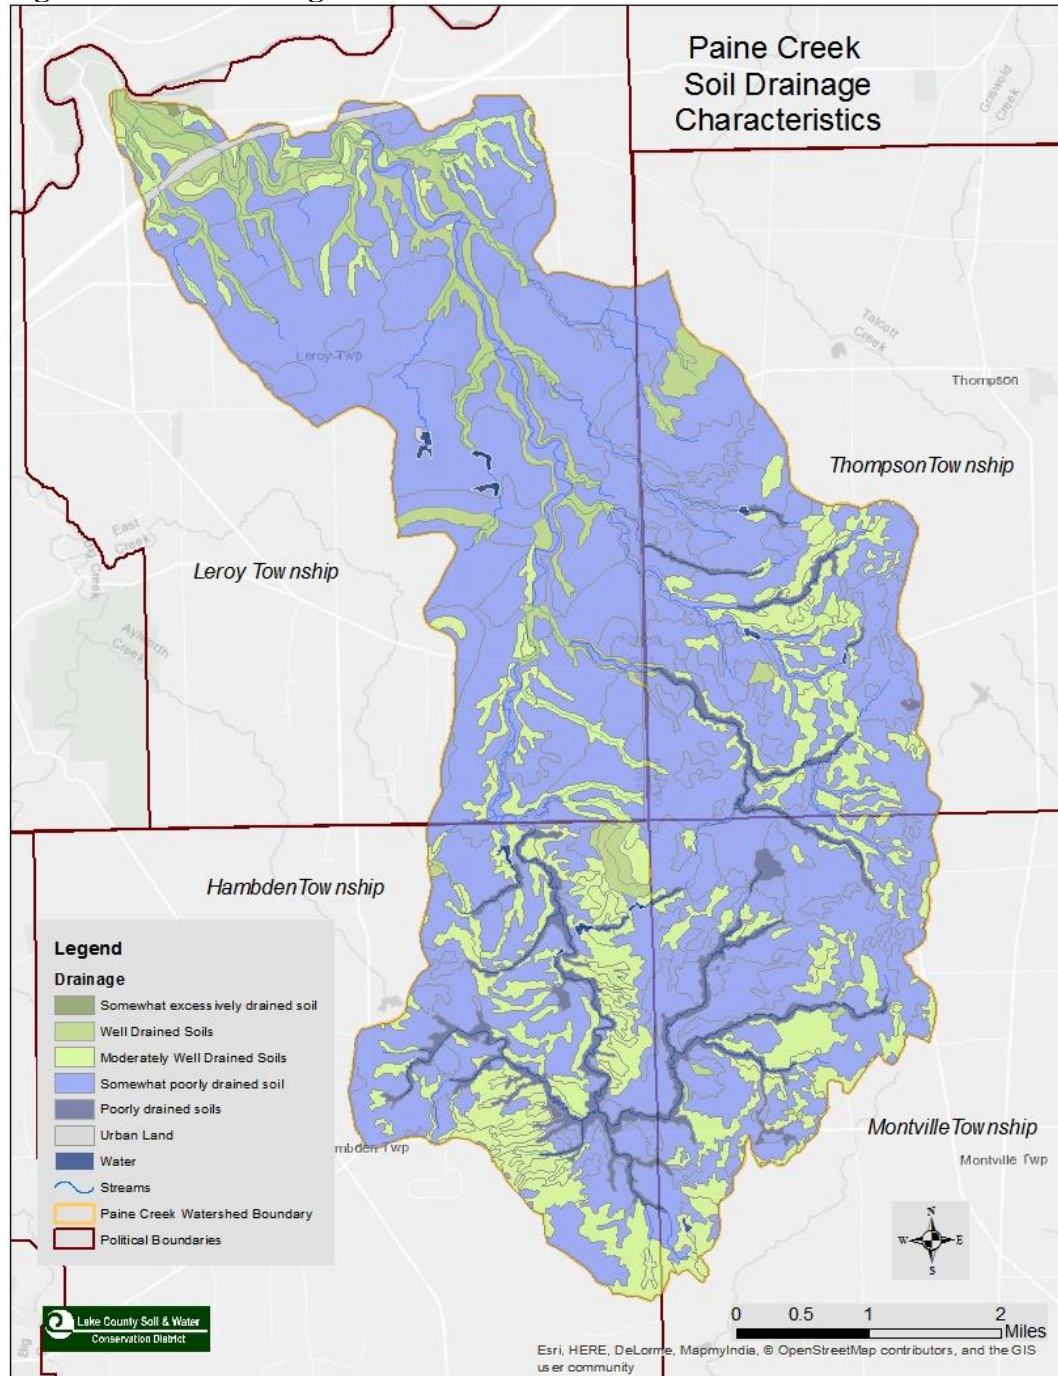
Figure 10. Soil Drainage Characteristics

68.8% of the soils are somewhat poorly drained (Figure 9). Soil drainage characteristics information is essential for siting Best Management Practices (BMPs) so that they will work properly. BMPs such as rain gardens and pervious pavers that are based on infiltration are best suited for well drained soils (in shades of green, Figure 10), whereas wetlands and on-site storage BMPs should be utilized in hydric soils (in shades of blue, Figure 10).

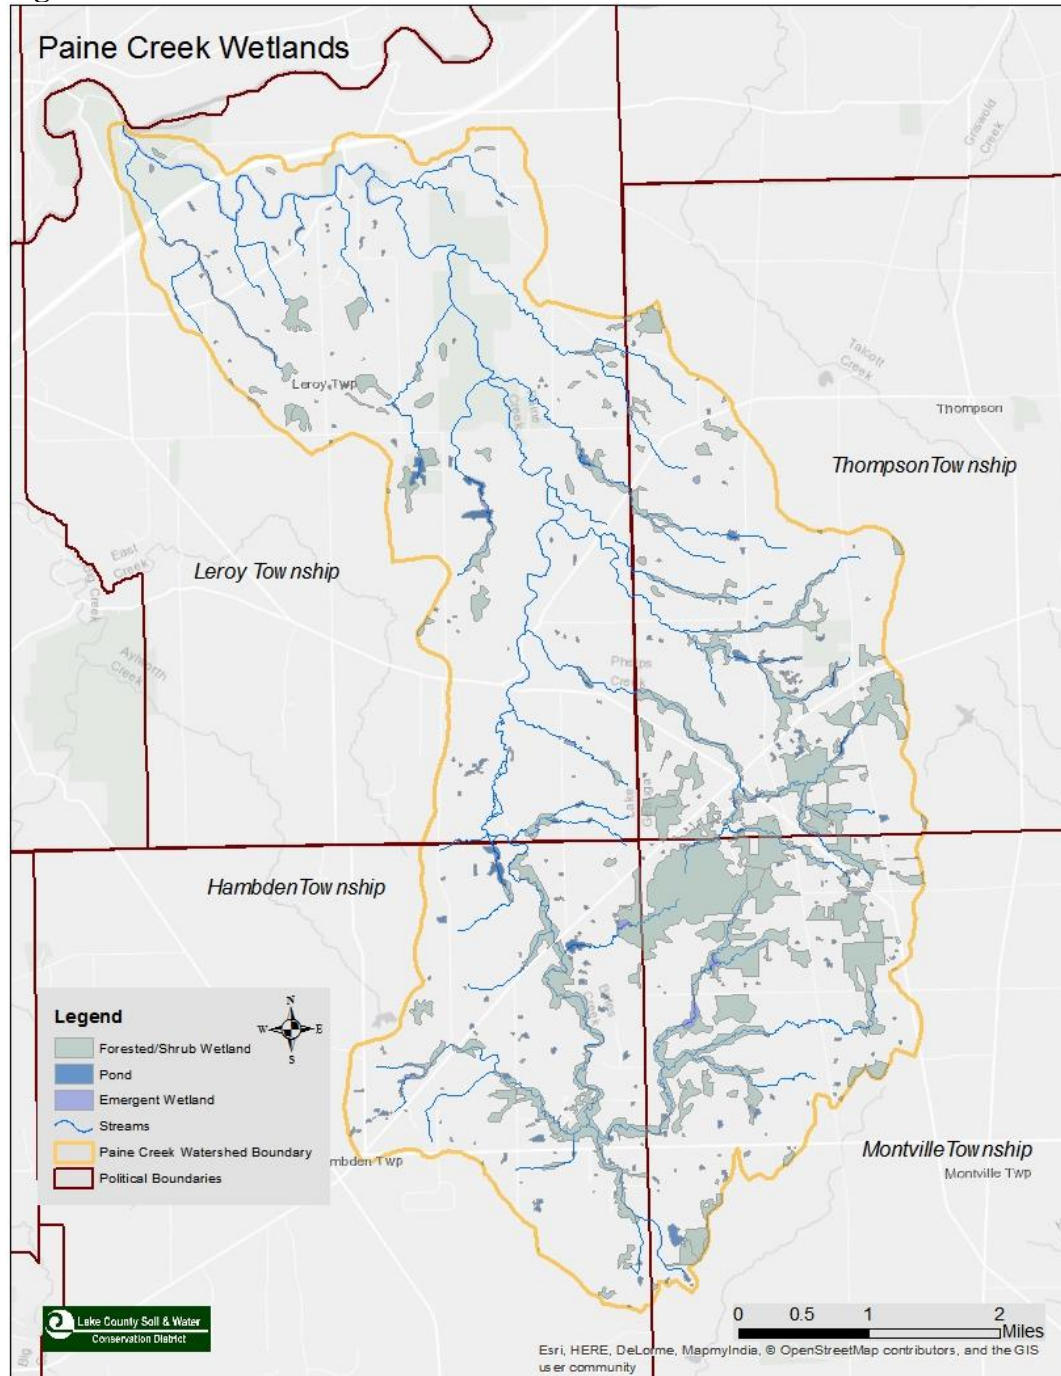
Figure 11: Wetlands

12% of the land in the watershed is covered by water and wetlands (Figure 11). (Federal Geographic Data Committee Wetland Mapping Standard for the conterminous United States (CONUS)). The breakdown of wetland type is as follows:

- Forested/shrub wetland 90.2%
- Pond 8.3%
- Emergent wetland 1.5%

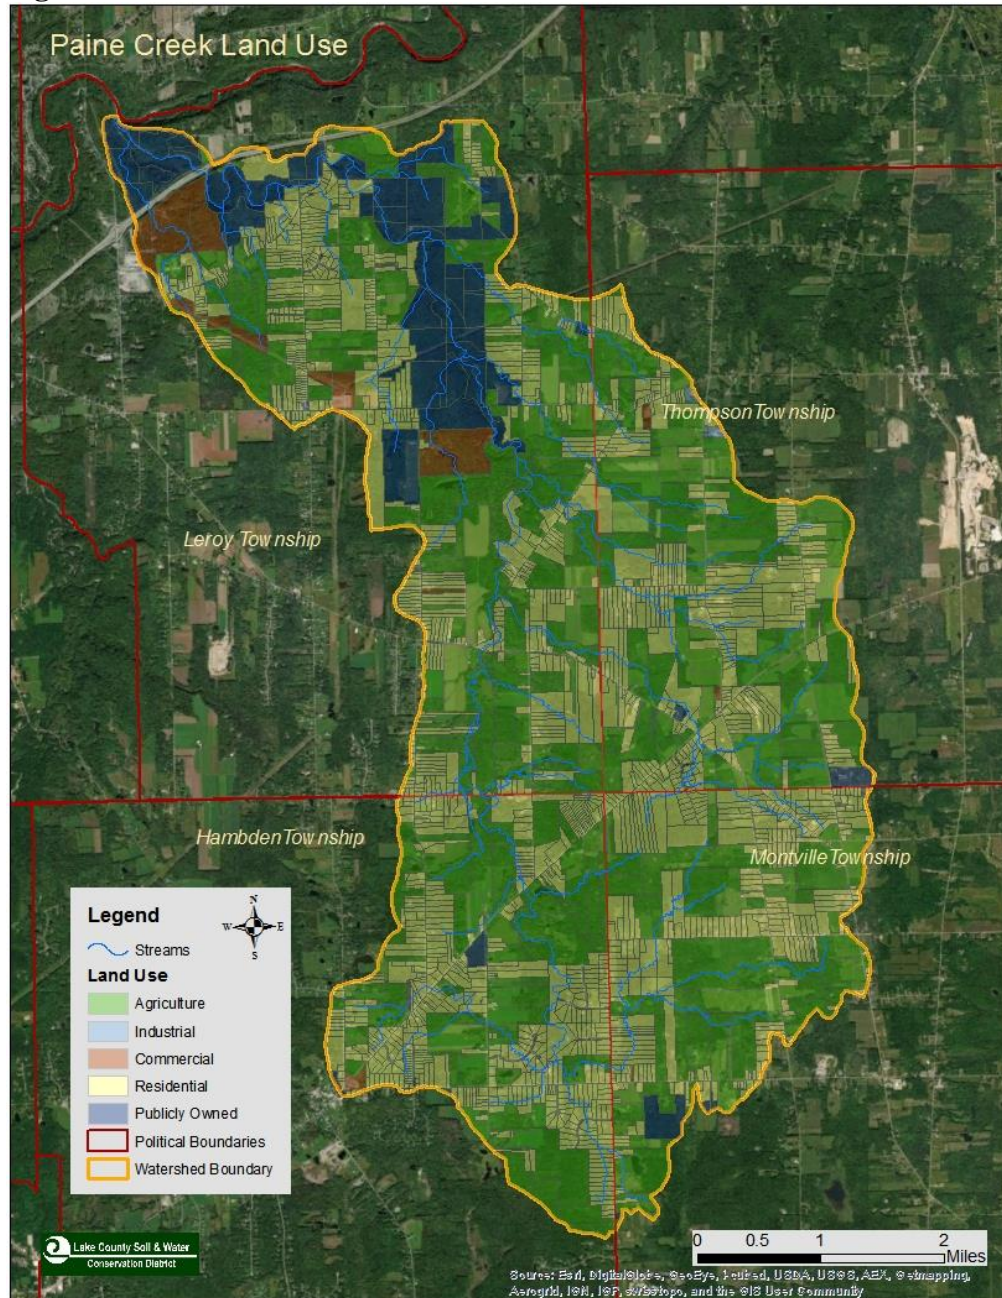
Figure 14. Land Use

Land Use data from the 2019 Lake County parcel data and the 2018 Geauga County parcel data shows a little different picture (Figure 13). Agricultural land use includes forested lands in this dataset; urban land uses include residential, industrial and commercial. The data from each county is shown separately and as a whole because there are notable differences. Geauga has more land in agriculture and more residential land; Lake has a much higher percentage of public land due to Lake Metroparks' preservation of the mainstem of Paine Creek (Figure 14). The updated parcel data shows much higher urban land uses at 41%.

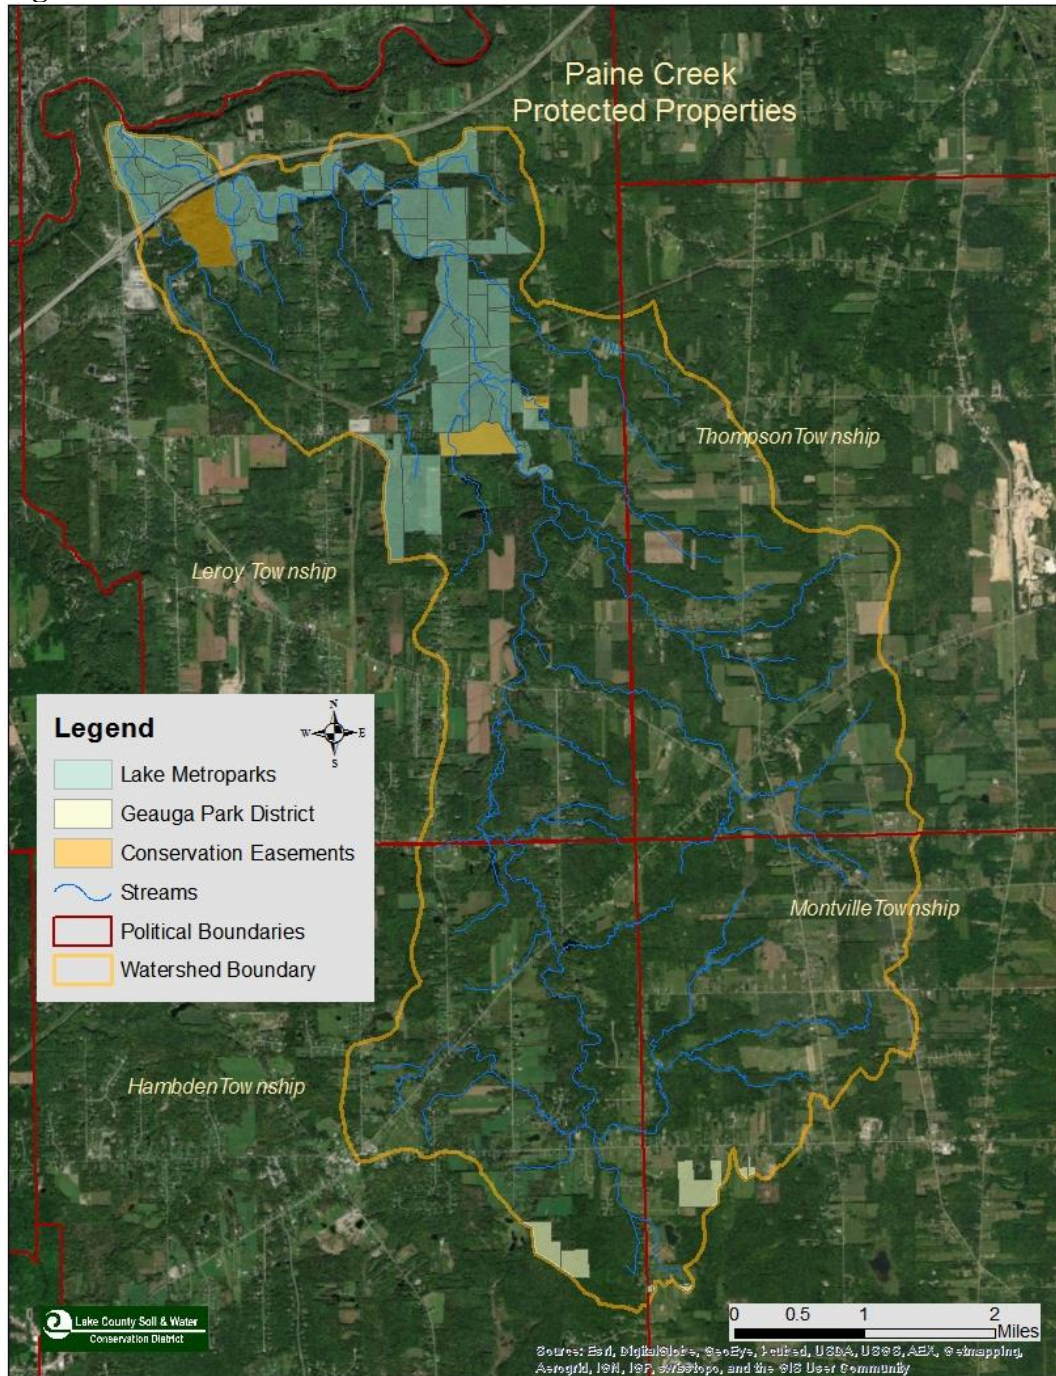
Figure 15. Protected Lands

About 10.6% of the land is protected (Figure 15). 1,595.14 acres are owned by Lake Metroparks, 139 acres are owned by the Geauga Park District, and 218 acres are protected with deed restrictions held either by Lake Metroparks or Western Reserve Land Conservancy. A close-up view of the protected areas in Lake County shows the efforts to preserve the special resource of the steep wooded riparian corridor of Paine Creek (Figures 16 & 18). Paine Creek Falls is contained within the Lake Metroparks property (Figures 16 & 17).

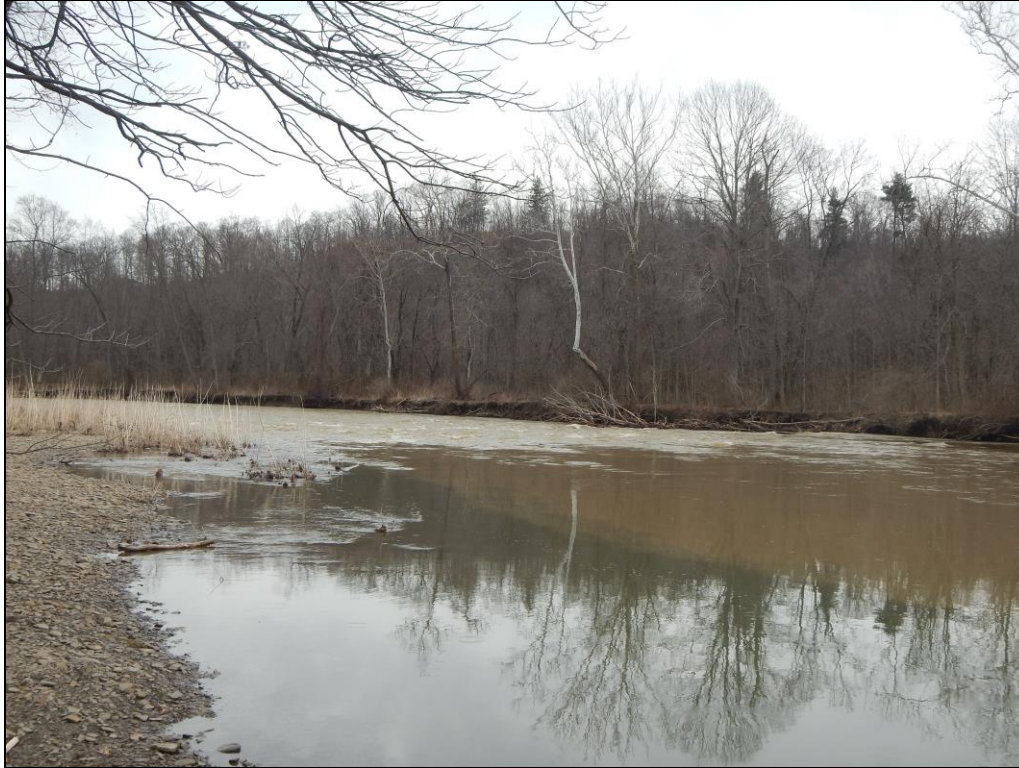
Figure 20. Water Quality Comparison: Paine Creek and the Grand River

The high percentages of forested land and the low percentages of developed and impervious land have helped to maintain the water quality in this watershed. Figure 20 shows the mouth of the Paine Creek watershed as Paine Creek empties (on the left- clear water) into the Grand River mainstem (on the right- sediment laden) in the spring of 2019.

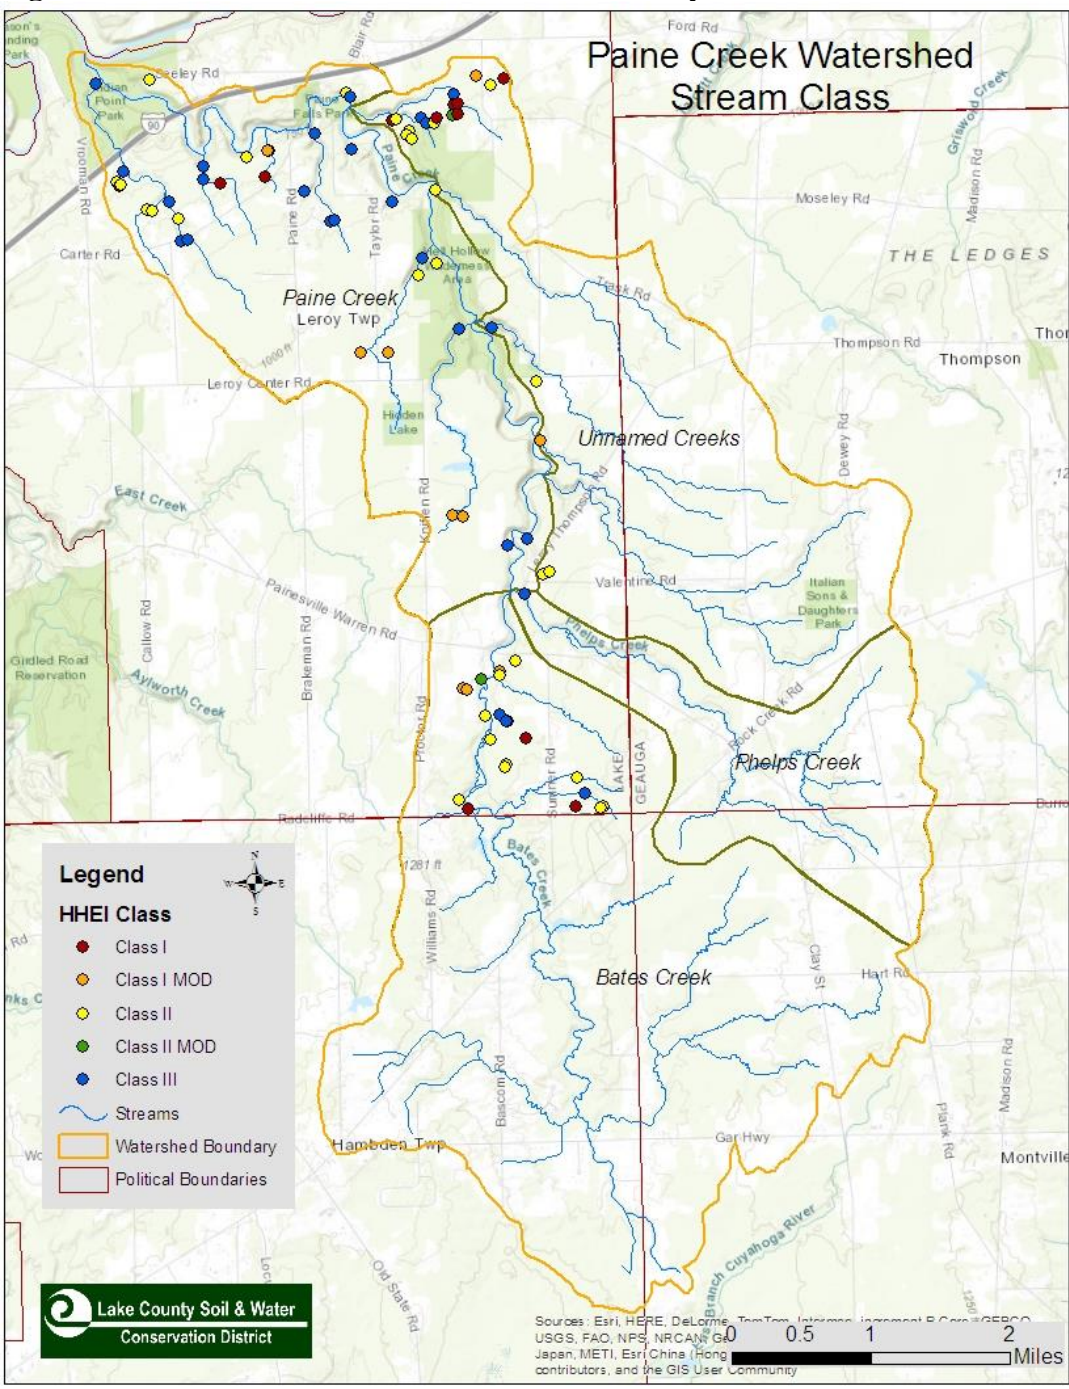
Figure 26. HHEI Stream Class for the Lake County Section

The Class is determined by the assessment of the biological community and the presence or lack of indicator species. See Figure 29 and the subsequent text for a description of the three classes of Primary Headwater Habitat (PHWH) streams found in Ohio. By HHEI class, 71% of the streams in the Paine Creek Watershed are in the Class II and Class III categories (Figures 24, 25, 26 and 27). By HMFEI class, the highest percentage had no biology data- at 57.8%, followed by 21.7% as Class II.

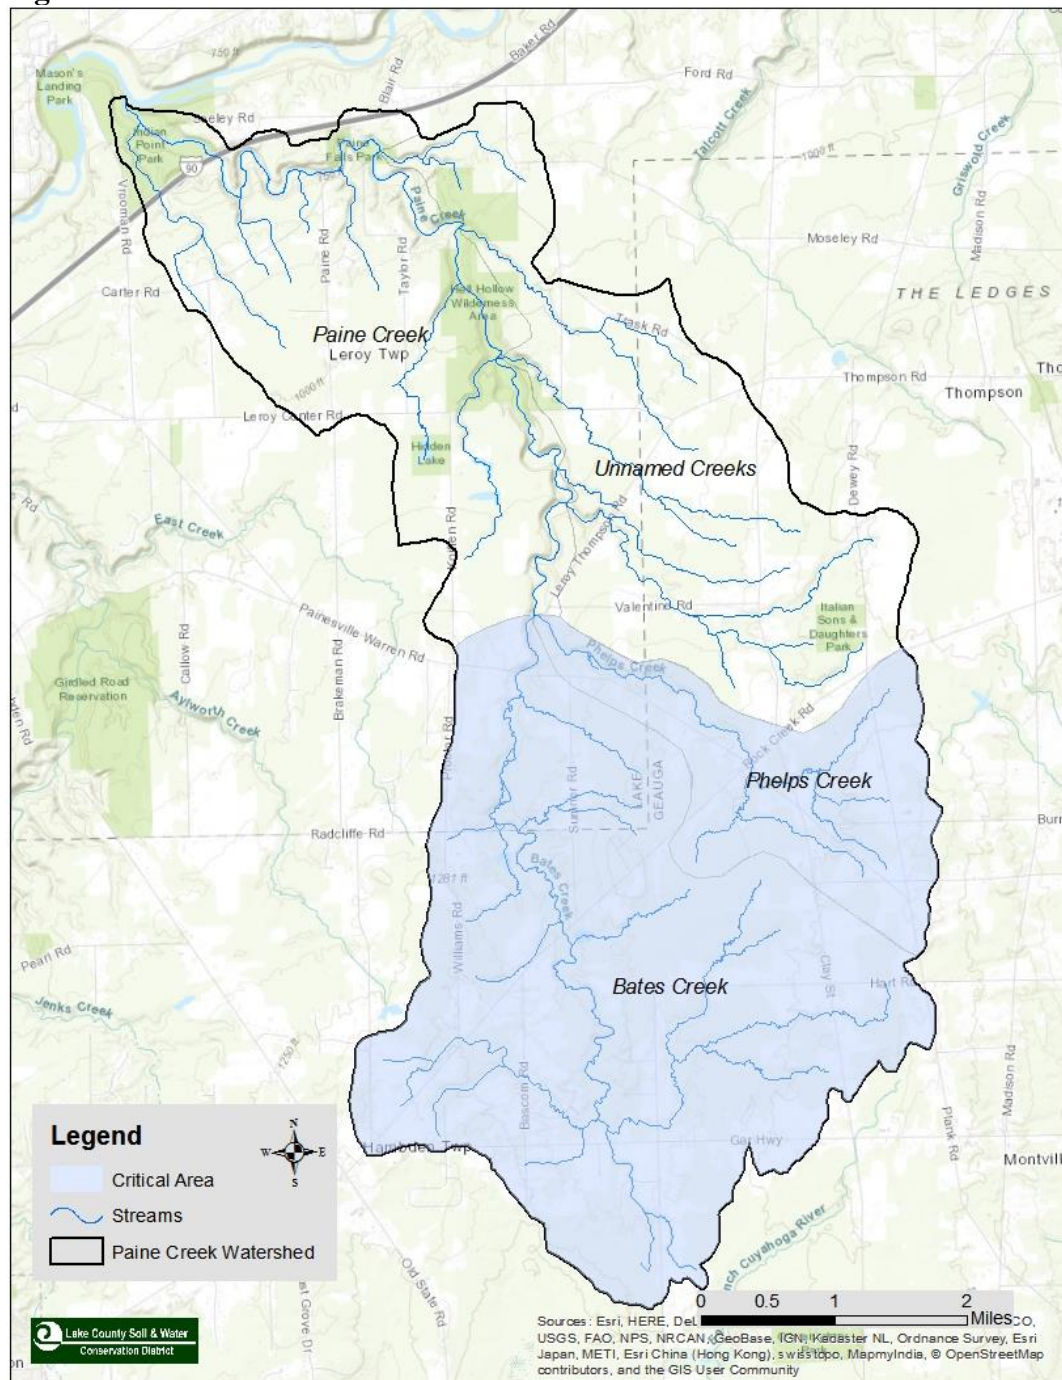
Figure 29. Critical Area

The Critical Area for the Paine Creek watershed is the headwaters of the watershed which include Bates Creek and Phelps Creek Subwatersheds (Figure 29). The Bates Creek Subwatershed is in Partial attainment of its WWH aquatic life use; however, this is due to natural causes and sources. Phelps Creek is in Full attainment of its CWH aquatic life use. Although much of the Paine Creek mainstem has been protected by Lake Metroparks, it is not the case in these critical headwater areas. Maintaining the wooded riparian buffer in the headwaters is an integral component for the health of coldwater and warmwater habitat biology of the entire watershed.

The Critical Area (Figure 29) drains 15.1 square miles: Leroy Township in Lake County, and Hambden, Montville and a small portion Thompson Townships in Geauga County. The average percentage of impervious area is 1.21% (StreamStats from 2011 data).

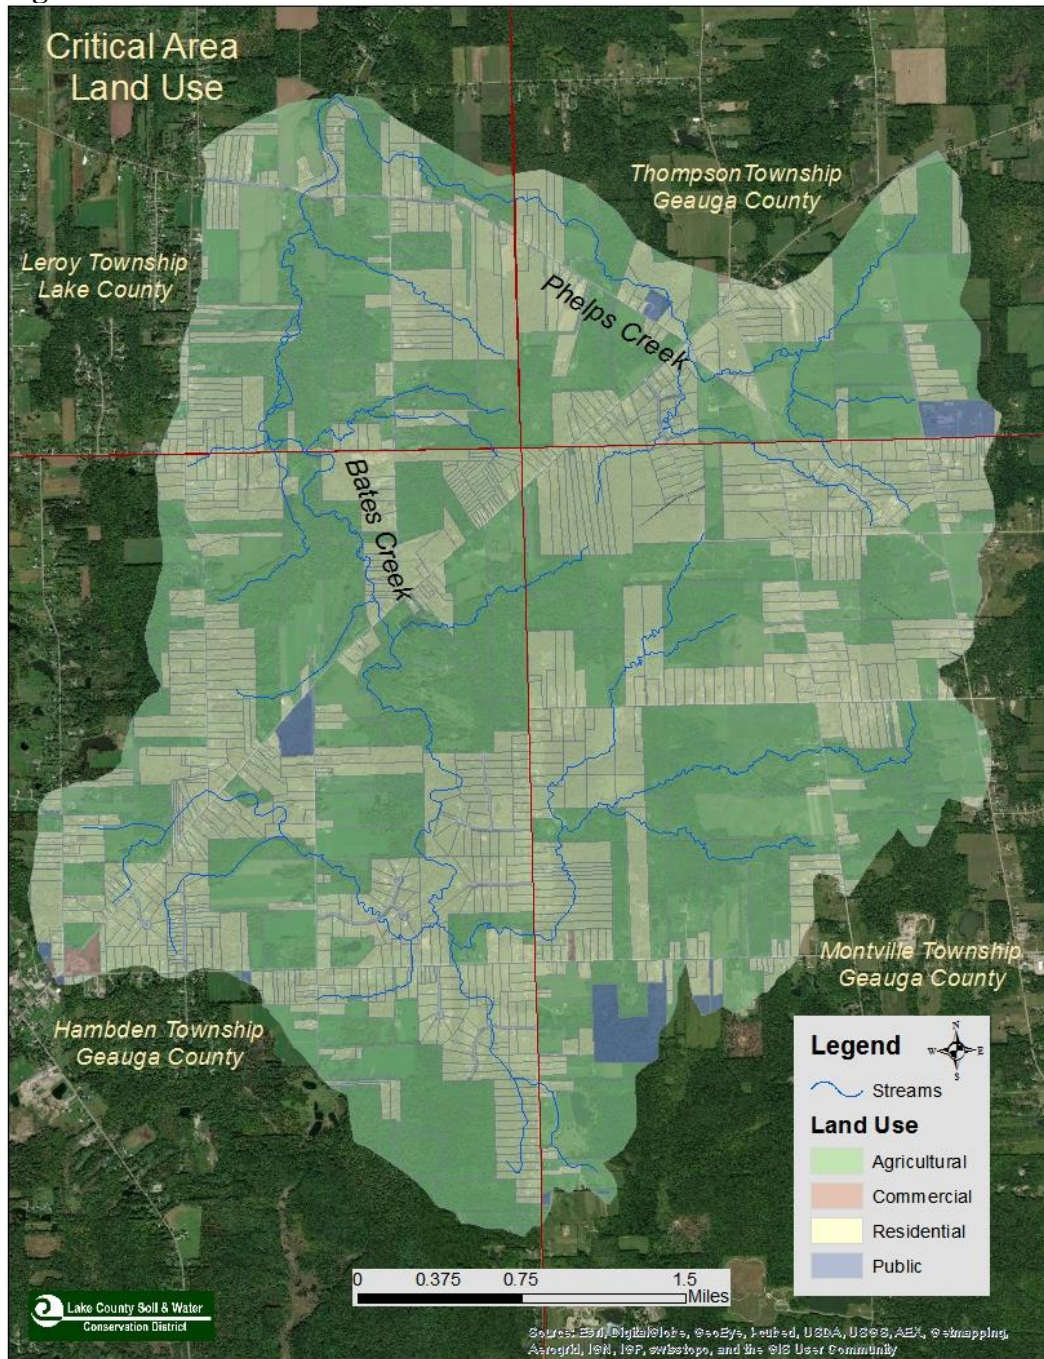
Figure 30. Critical Area Land Use

The land use is 51% agricultural (much of which is wooded) and 46.8% residential (Figures 30 and 31). There is very little industrial or commercial land use, so imperviousness in the watershed is minimal. The biggest threat to the subwatershed is development, as the watershed is approximately 3 miles from the City of Chardon, 7 miles from the City of Painesville and 4.5 miles from the U.S. Route 90 Vrooman Road interchange. Other factors that threaten the CWH and WWH attainment include a transition of land uses from agricultural to development because of aging land owners who may not have a younger generation wanting to farm, and logging of larger tracts without use of best management practices.

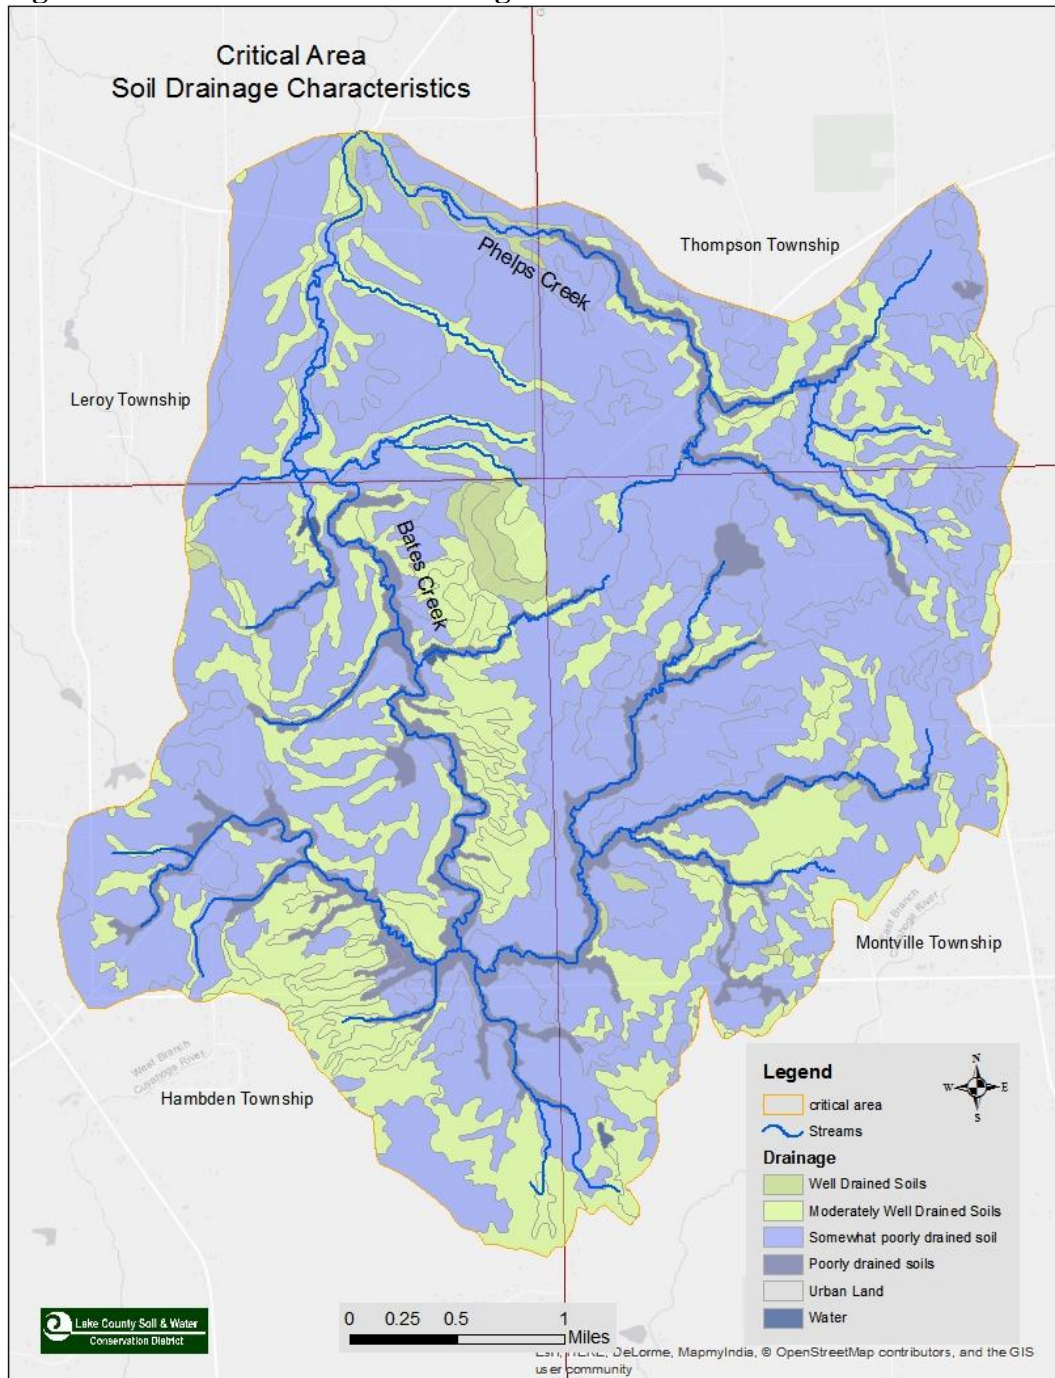
Figure 32. Critical Area Soil Drainage Characteristics

28.5% of the soils are well/moderately well drained; 63.3% are somewhat poorly drained and 8% are poorly drained, so 71.3% of the soils have somewhat poorly and poorly drainage characteristics (Figures 32 and 33). Any practices that rely on infiltration will need to be carefully sited.

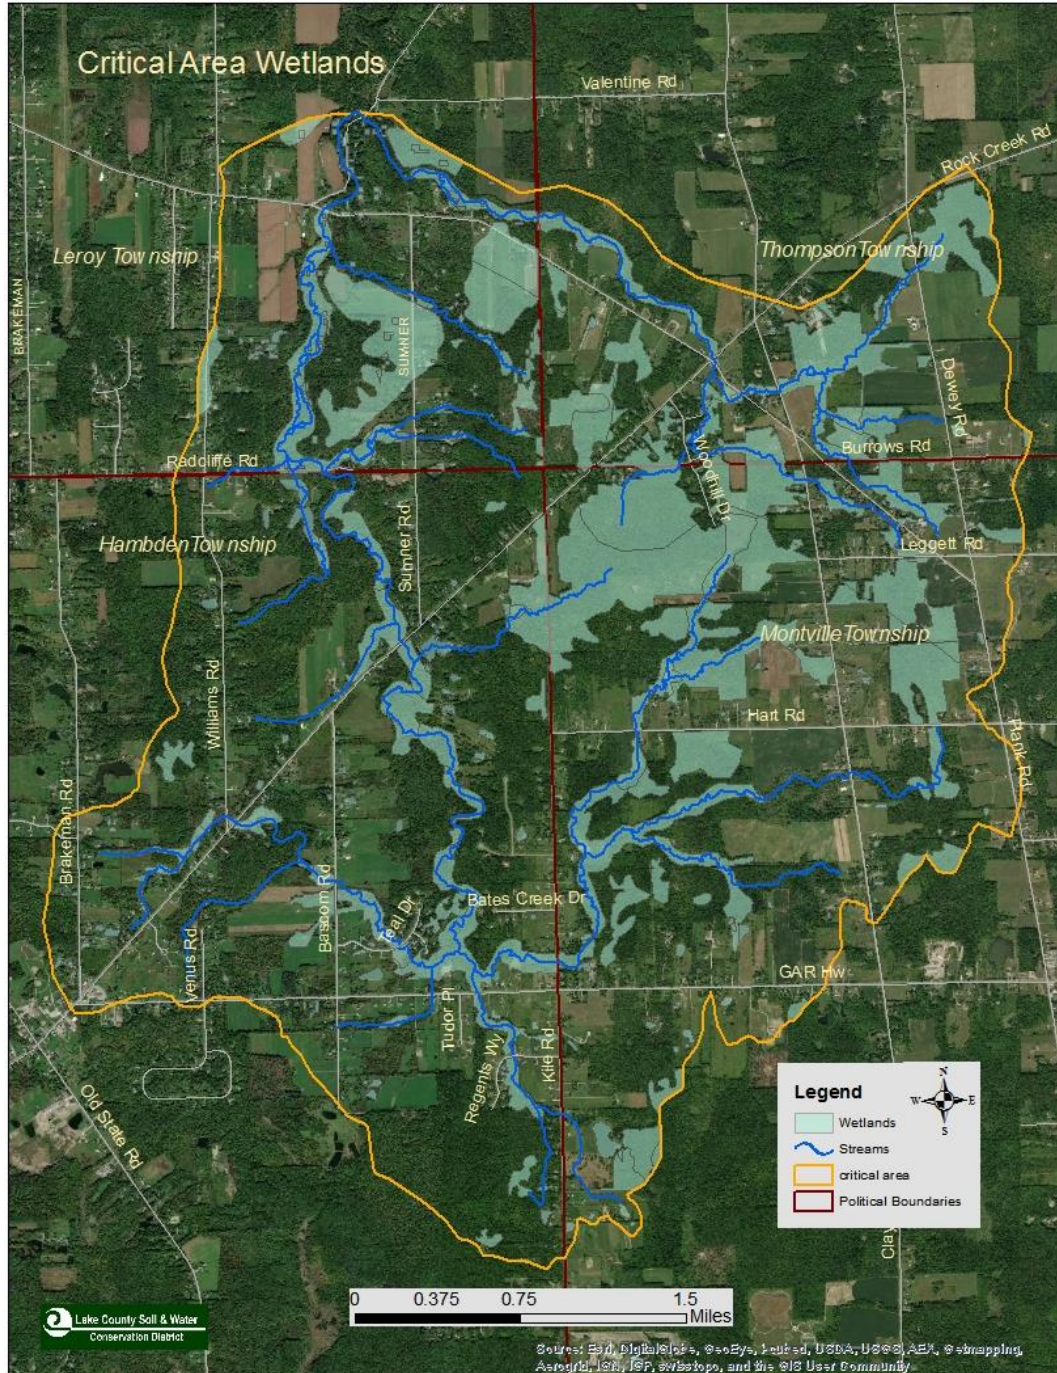
Figure 34. Critical Area Wetlands

22.5% of the Critical Area is wetlands. A large portion of that is streamside wetlands, which perform vital functions for improving water quality and regulating storm flows. Streamside wetlands also contain the largest variety of plant and animal species associated with streamside wetlands. Deforestation of these wetlands can lead to increased erosion and sedimentation, warmer water temperatures and subsequent decrease in water quality and aquatic use habitat. Wetlands Best Management Practices should be used to supplement upland forestry best management practices to reduce the potential adverse impacts of forest management activities on wetlands. (Forested Wetlands; Functions, Benefits and the Use of Best Management Practices. USDA # NA-PR-01-95)
